PHOTO REPORT

**MV SPIRIT OF NANTUCKET
Struck Subject Object
November 8, 2007
ABDC Ref. ABD07-0102-0 Ref EHM 1750
Crawford Ref. 1140048**

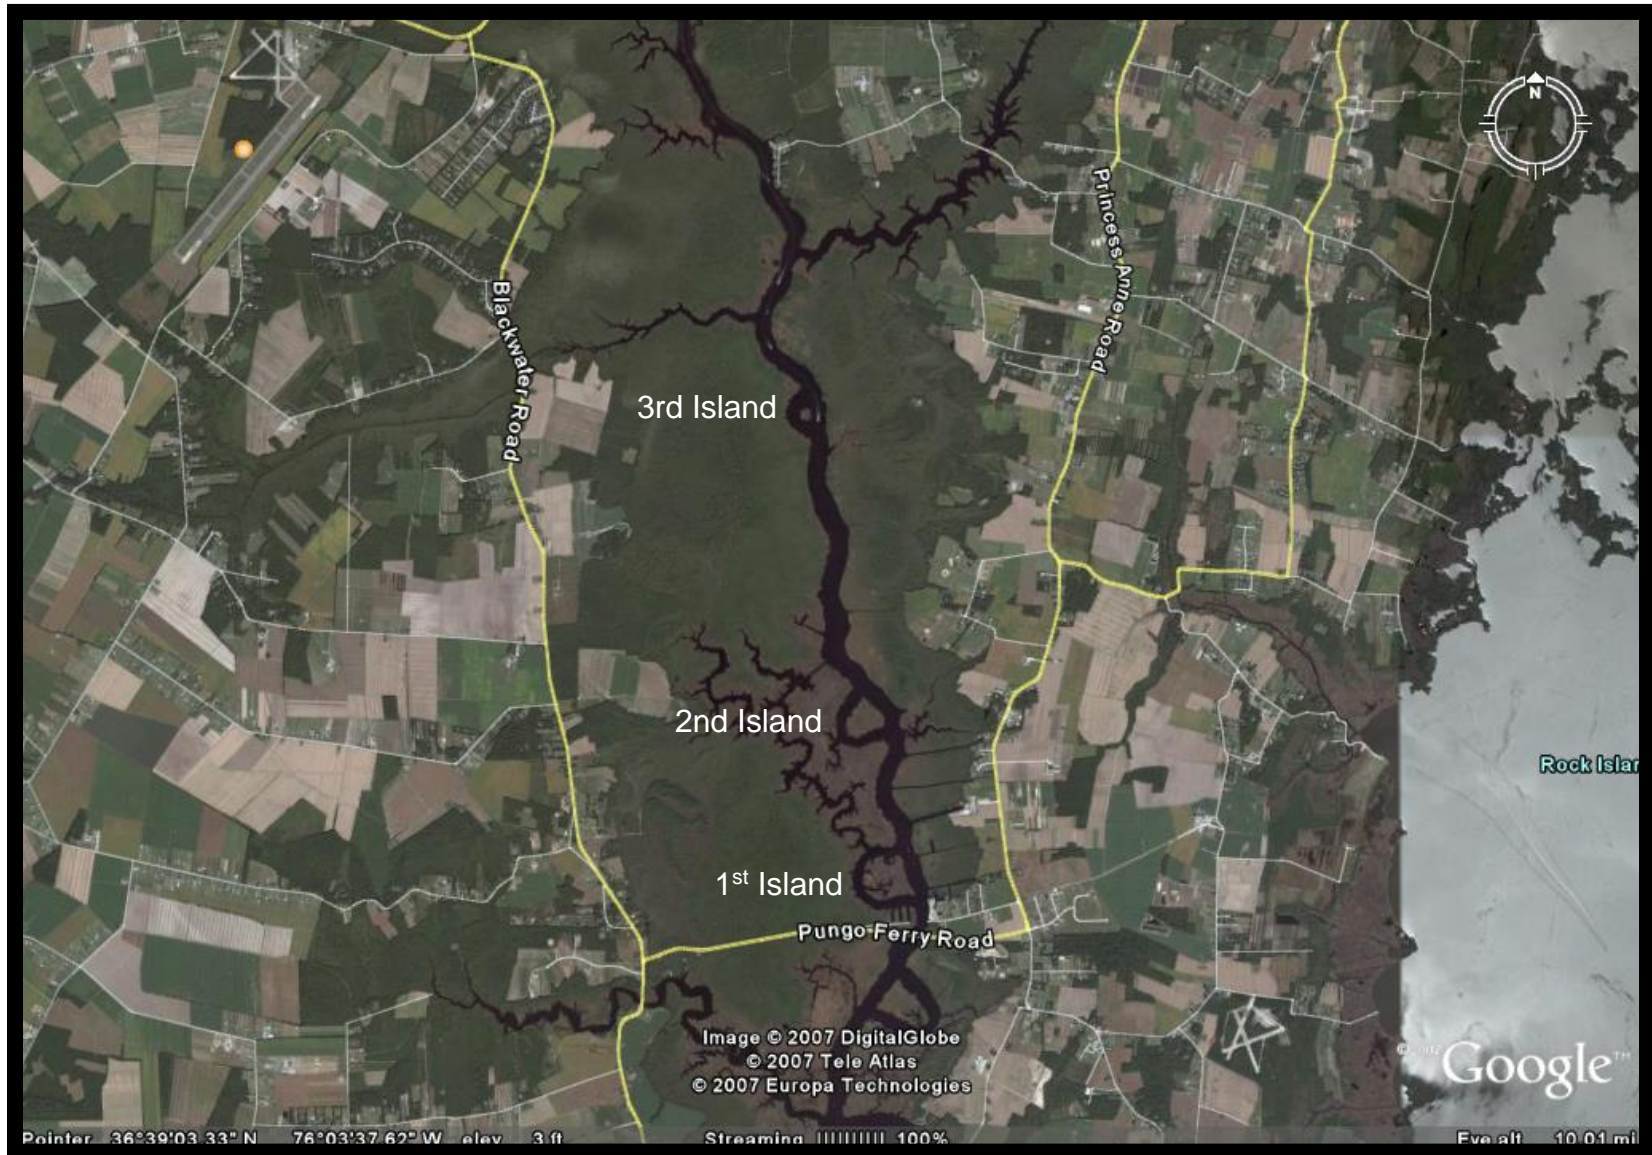
02 ICW - Pungo VA - Elevation 10mi
Note the three islands on the West side of the ICW

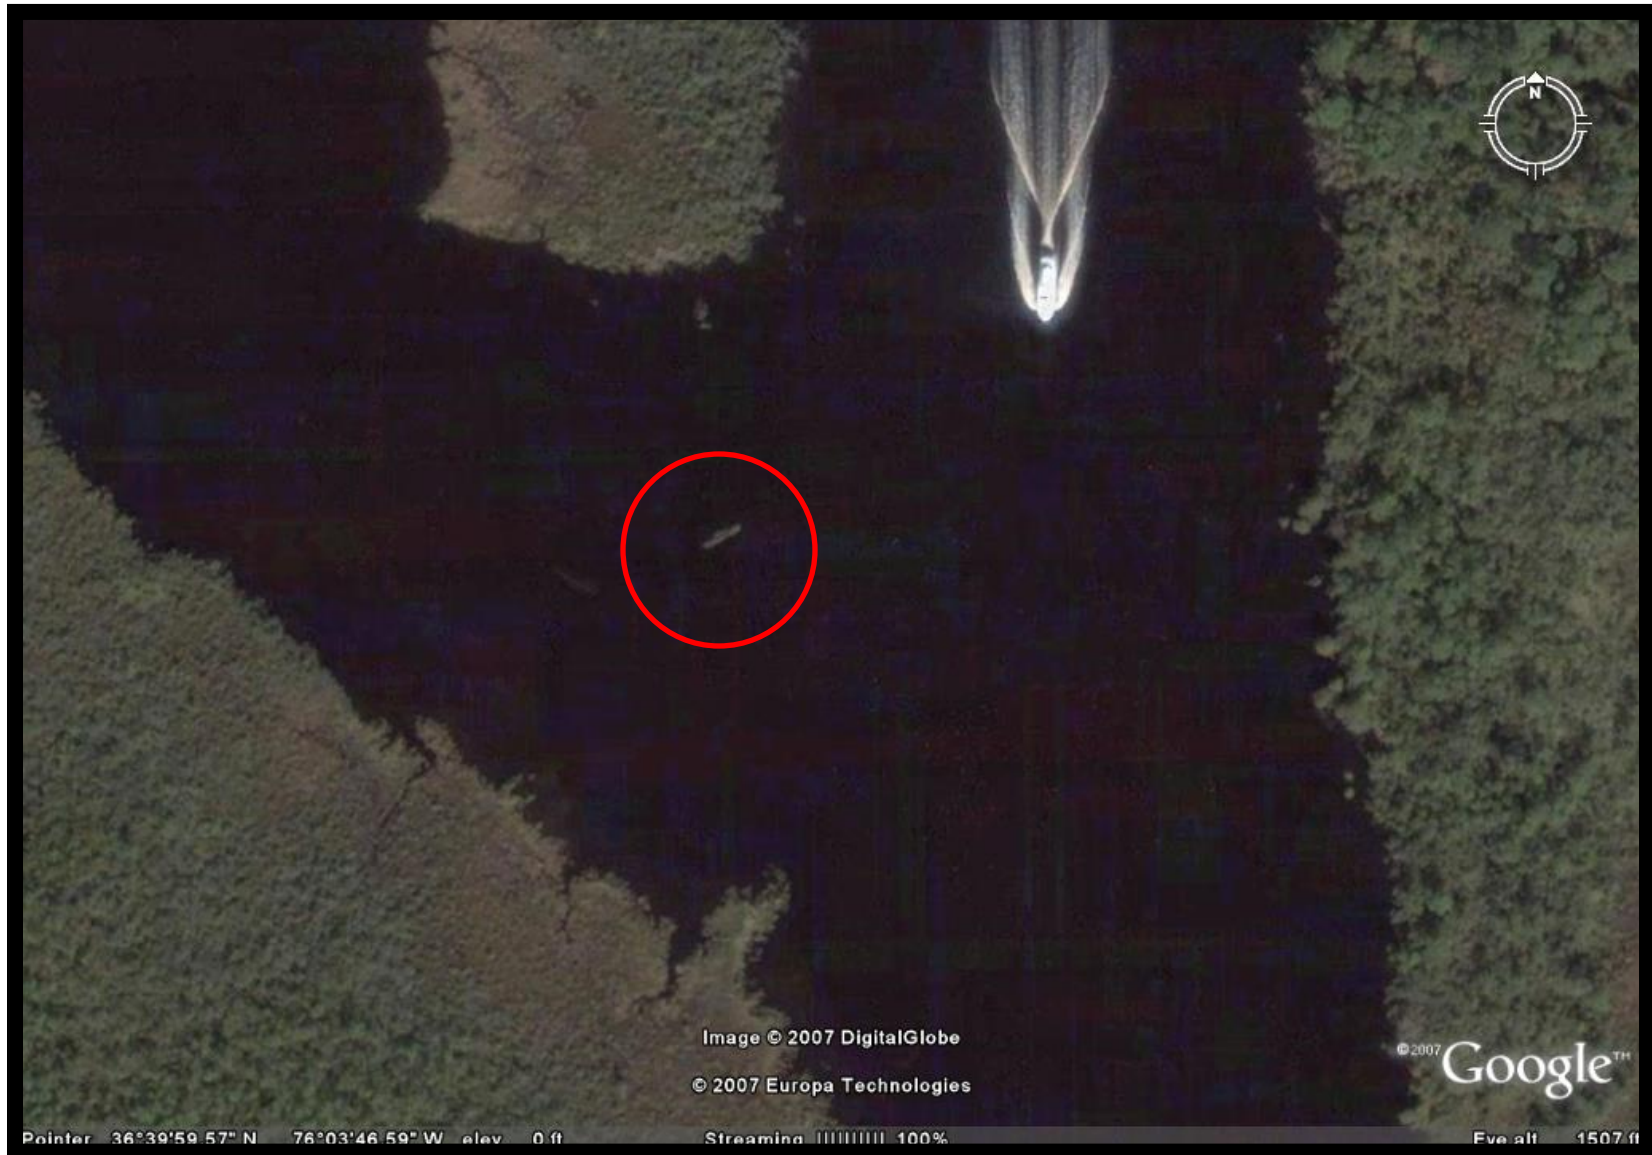
06 ICW - Pungo VA - Elevation 1,500 ft
Note the debris in the water South of the island

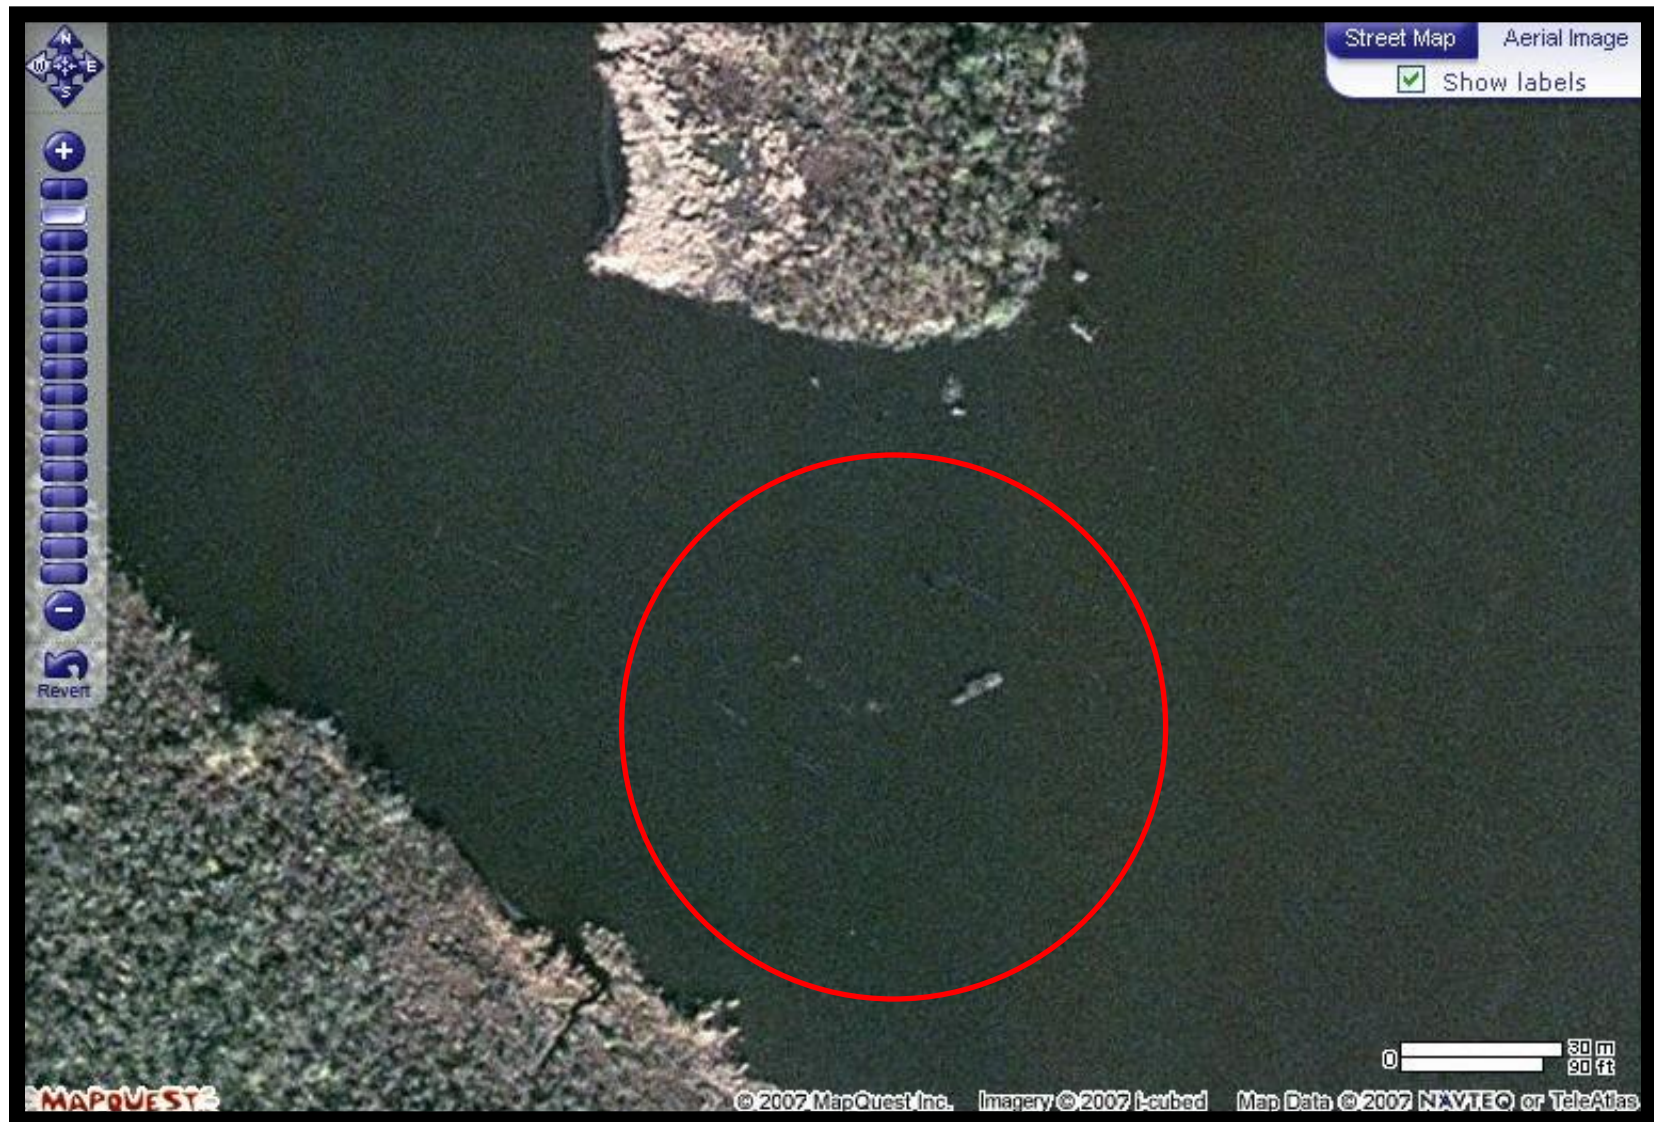
07 ICW - Pungo VA - Elevation 1,500 ft

This debris is outside the Federally maintained channel

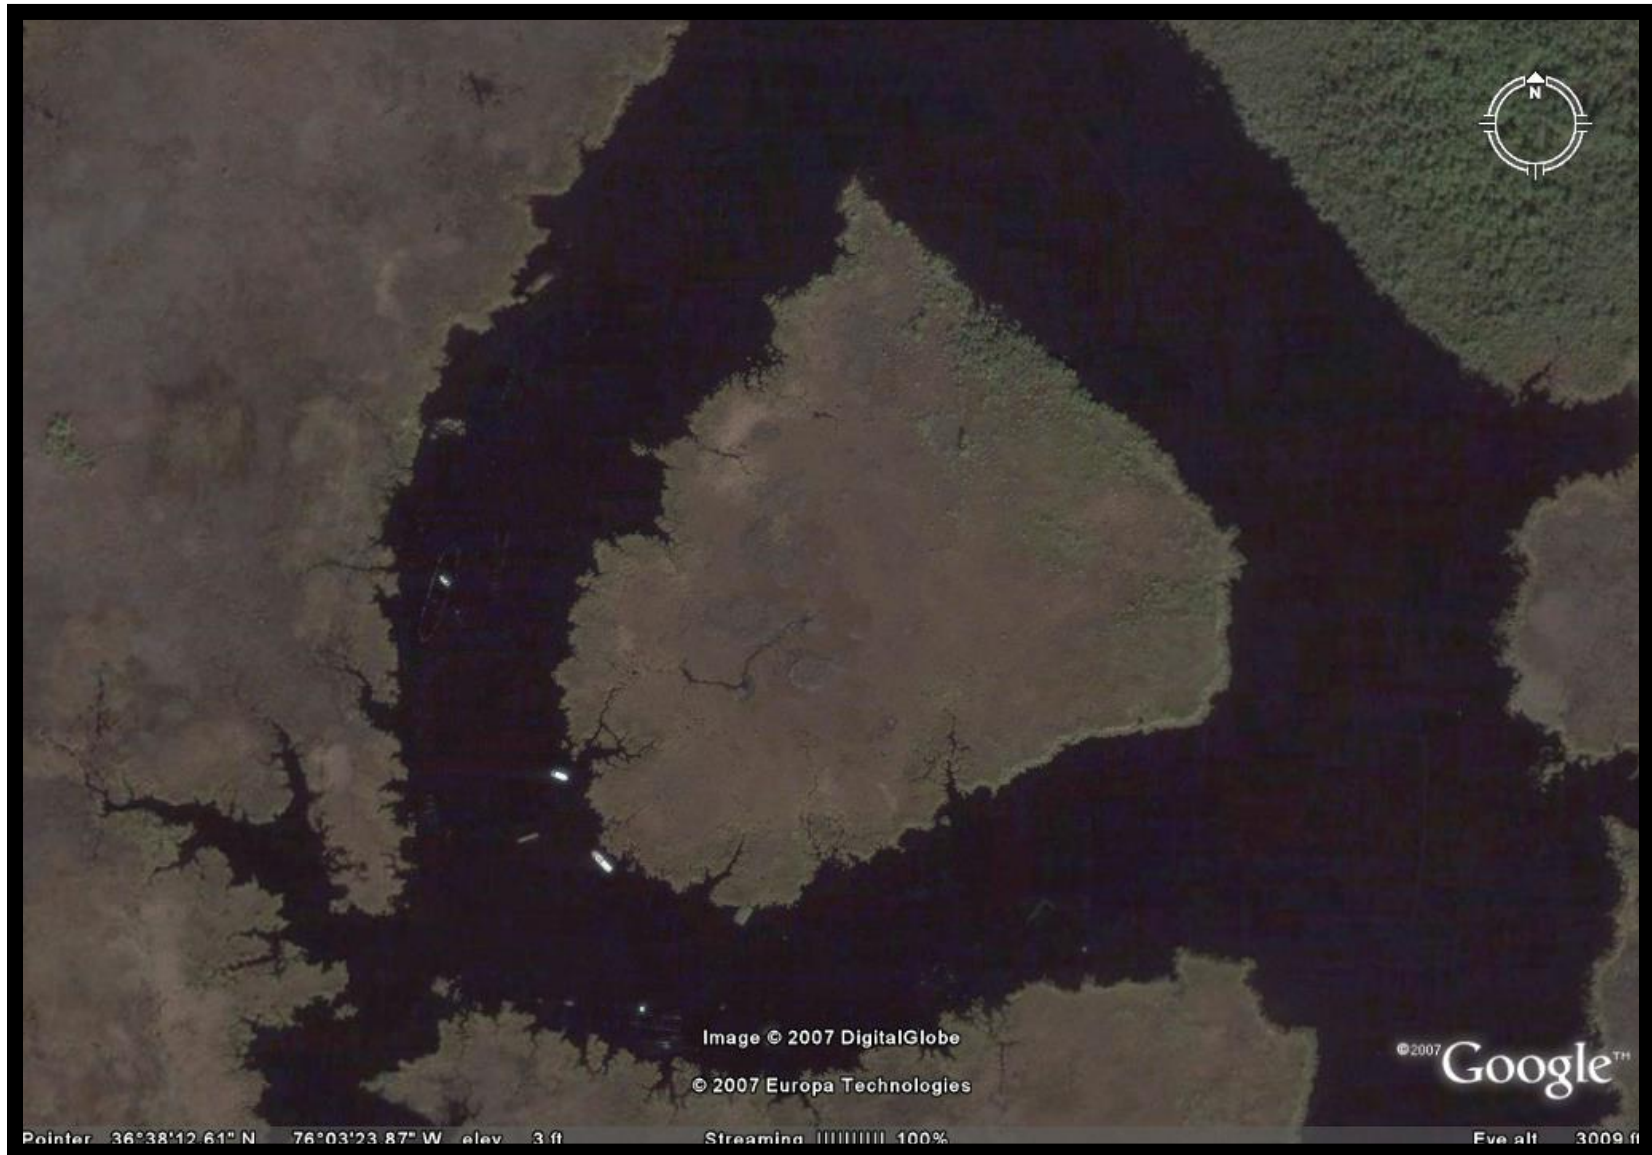
08 This is the 2nd Island North of Pungo Ferry and South of the object struck by the Spirit of Nantucket

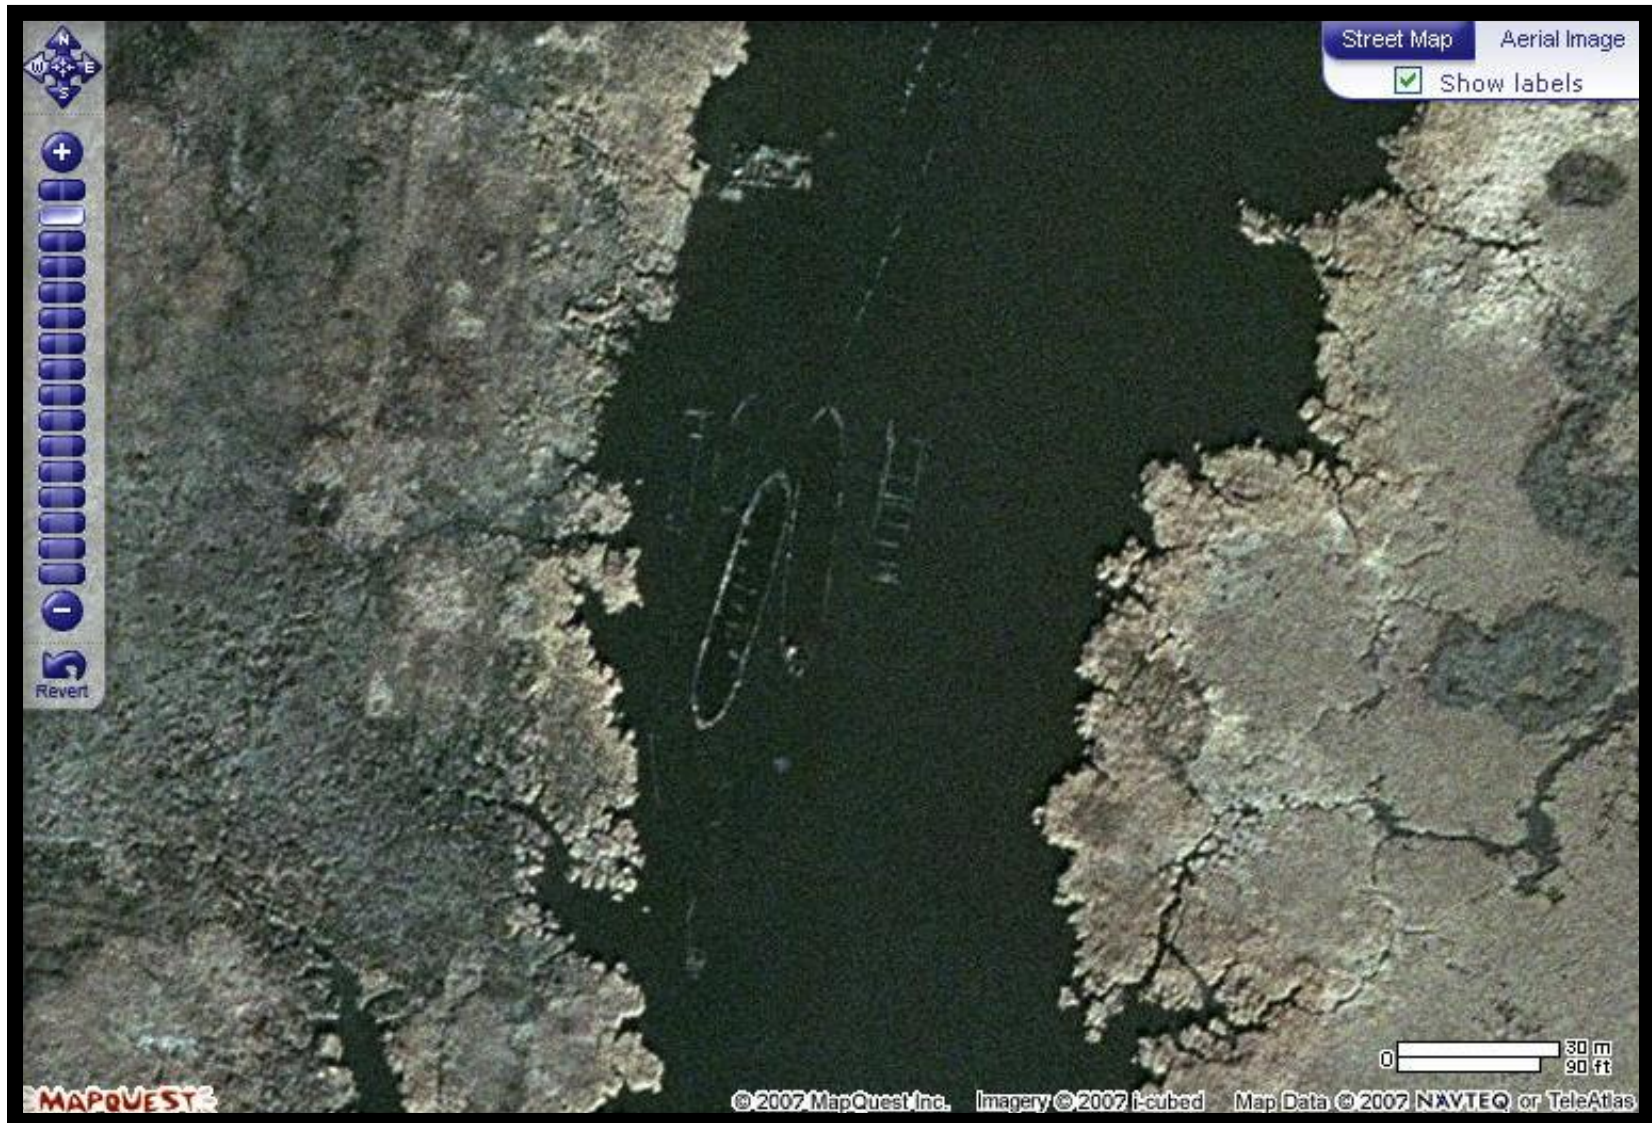
09 Note the extent of debris to the West of the 2nd Island

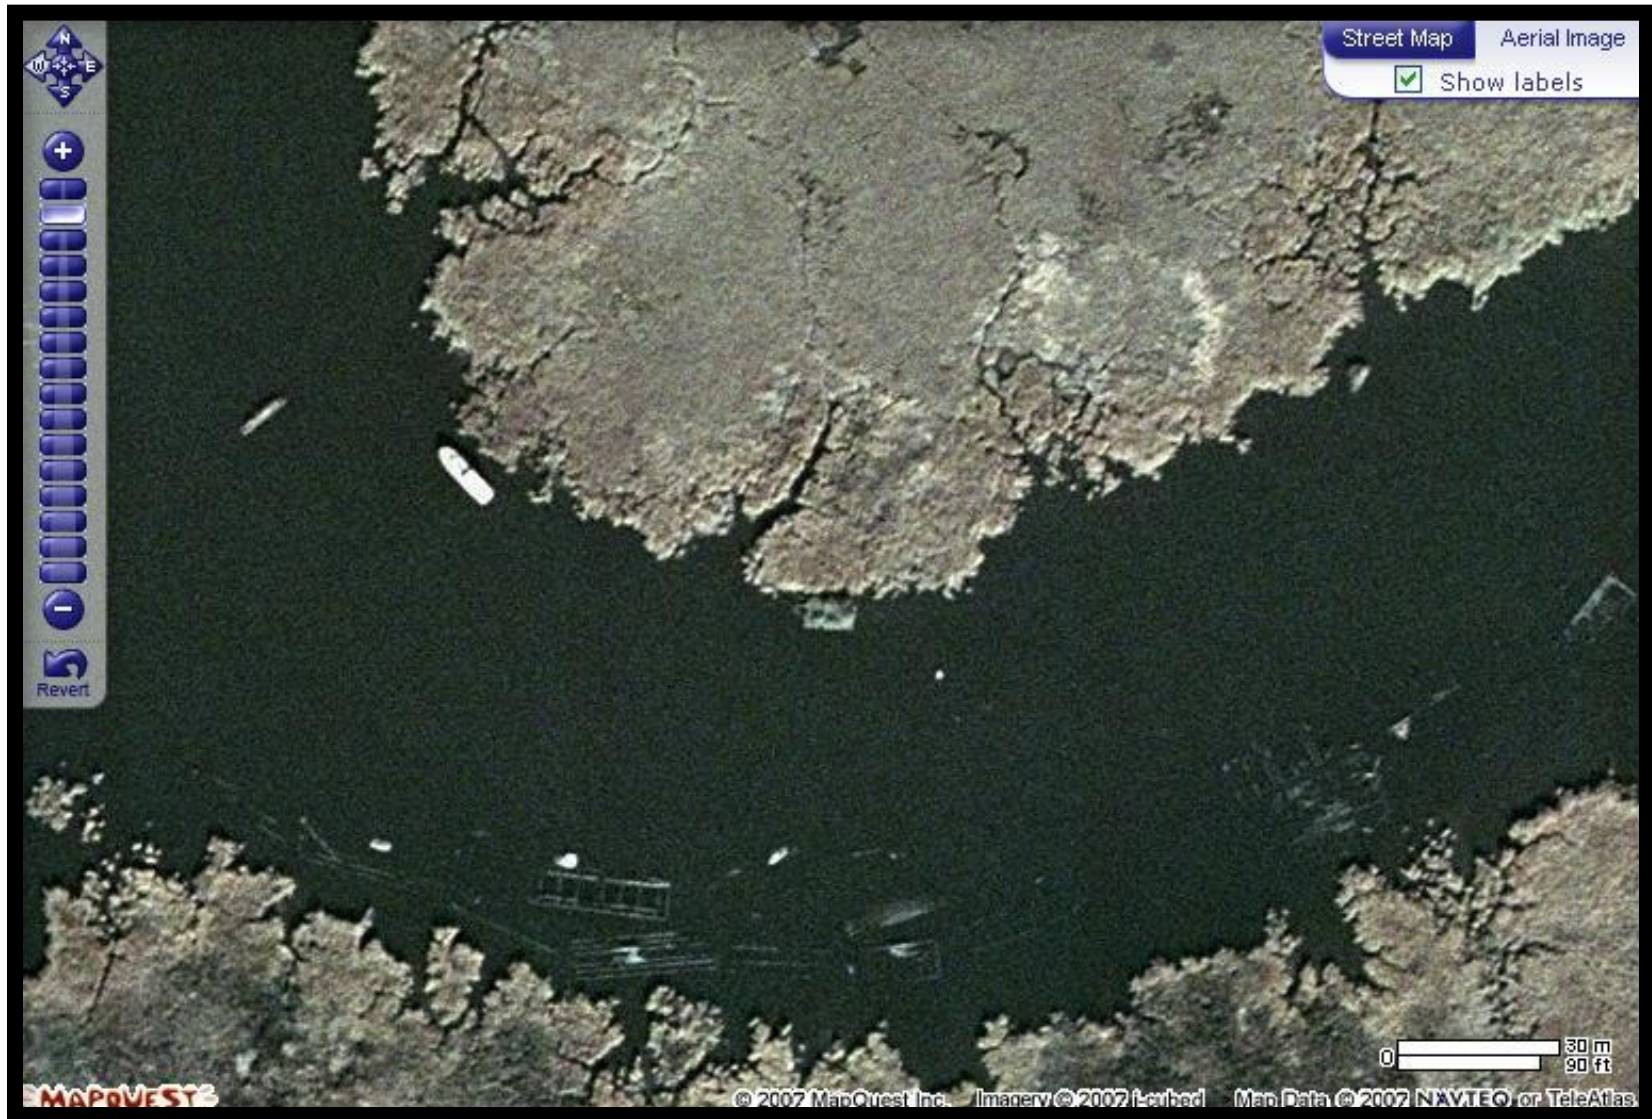
10 Note the extent of debris South of the 2nd Island
