FIELD REPORT: 2014 SEARCH FOR USS POMPANO

## 2014 SURVEY REPORT & SITE INVESTIGATION

Unknown Wreck Site, Tsugaru Strait, Japan

NOVEMBER 2014

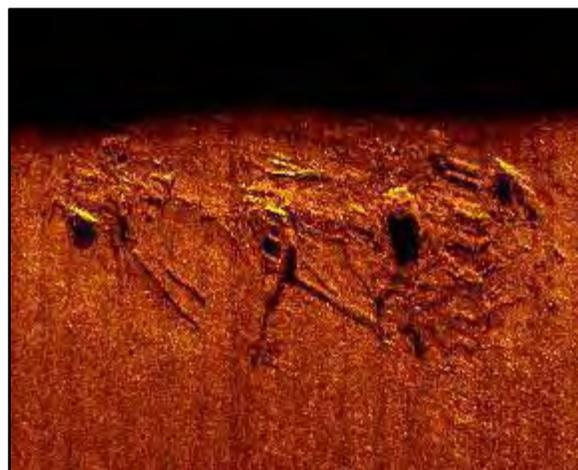
Figure 5: Side scan sonar image from FST of the wreck site from the 2013 survey.

Due to weather, equipment failure, and time constraints, the site was only minimally examined and not enough conclusive evidence was collected for NHHHC to determine if the wreck site was a submarine. A return survey was recommended in order to conclusively identify the site.

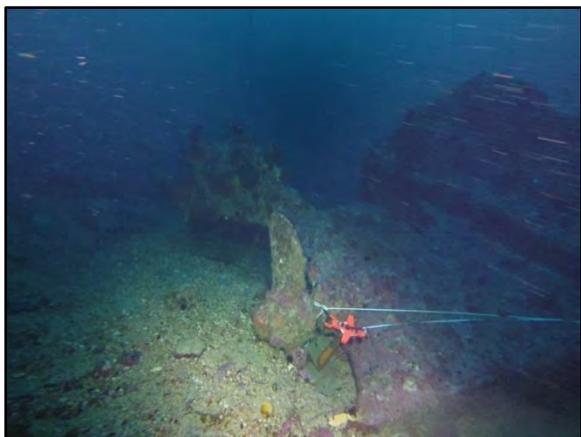
During the later dive from 1337 to 1430, the team located a propeller in the stern, to which they attached a go-line and buoy. In all, the screw propeller, a flange [10 to 15 ft. (3 to 4.6 m) forward of the screw], and a shaft or pipe like structure were recorded (Fig. 6). Visibility was good, but the current was running strong from 40 ft. (12 m) below to the surface.

Figure 6: Propeller and stern of wreck. Note 300 ft. tape and go line from ship for divers.

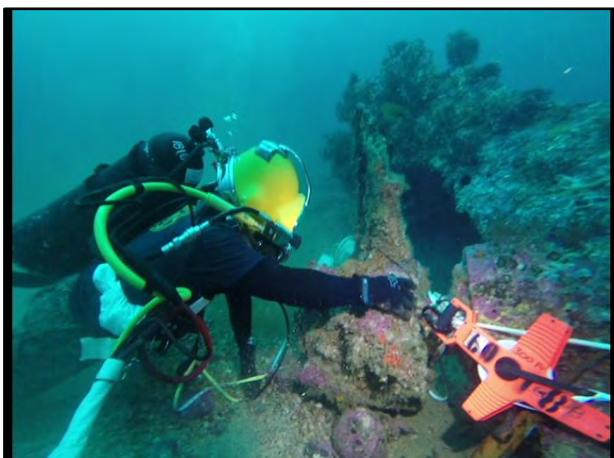
Figure 7: Diver inspects the propeller for any markings and notes missing blade.

The propeller was examined and Red diver determined that there were 4 blades, three of which were intact and one broken (Figs. 7-8). The extant propeller blades each measured 2 ft. 4 in. tall and 1 ft. 6 in. wide. The propeller hub measured 2 ft. and 1 in. Total maximum diameter of the propeller was 6 ft. 9 in. The shape of the blades was not symmetrical, consisting of a straighter edge to the left side of the blade and curved edge to the right. During this dive, a possible ladder and starboard side of the deck was noted.

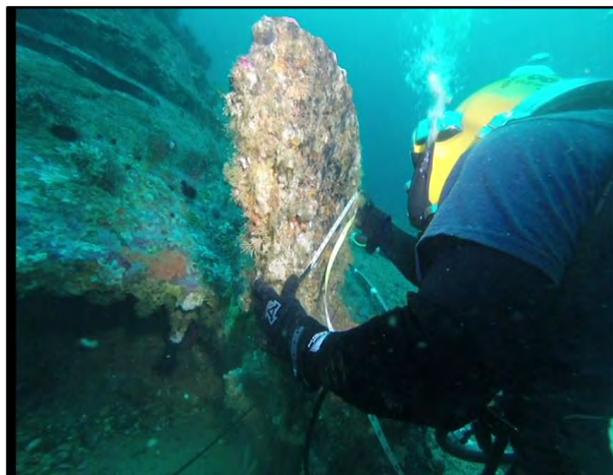
Figure 8: Diver measuring propeller.

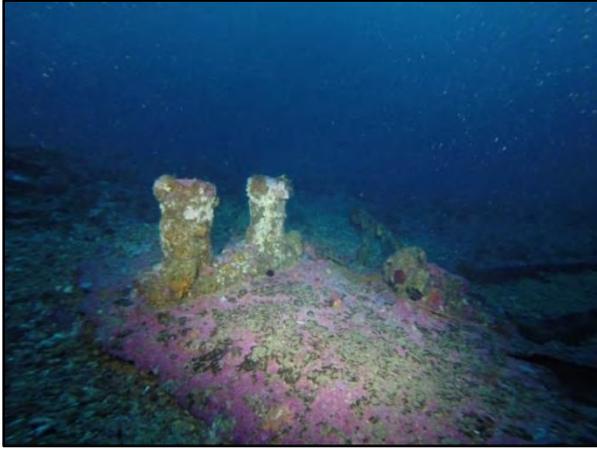
Figure 9: Large double bollard forward of the stern.

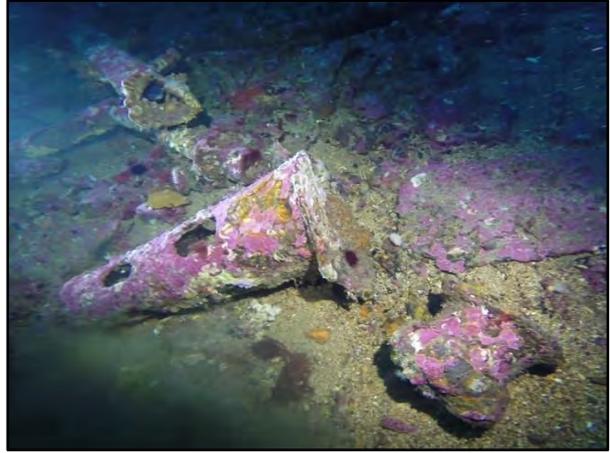
The structure identified in 2013 as a possible Warren girder was documented around the 35 ft. mark on the baseline. In the bow, a capstan or windless like structure (Fig. 10) and a length of chain was discovered and documented. The chain did not have stud links.

Figure 10: Capstan (aft), one of two noted on site.

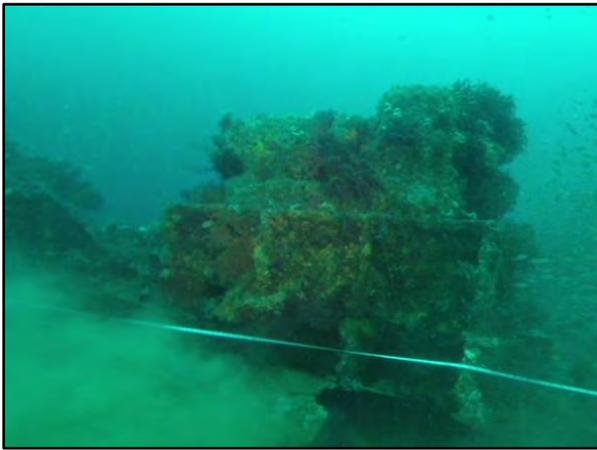
Figure 11: Reduction gears sitting on a platform, located forward of propeller and shaft remnants.

The ship gave the impression of being lightly constructed. No engine was observed, but propulsion machinery such as reduction gears (Fig.11), a boiler, and pads for other equipment were present. Winches were found in both the stern and bow sections. Also in the bow was a length of chain, but there were no visible anchors. Other identifiable structures included piping with flanges and decking fastened to beams with knees. The Warren truss structures, identified during both the 2013 and 2014 surveys, were likely part of a cargo crane or outriggers for fishing.

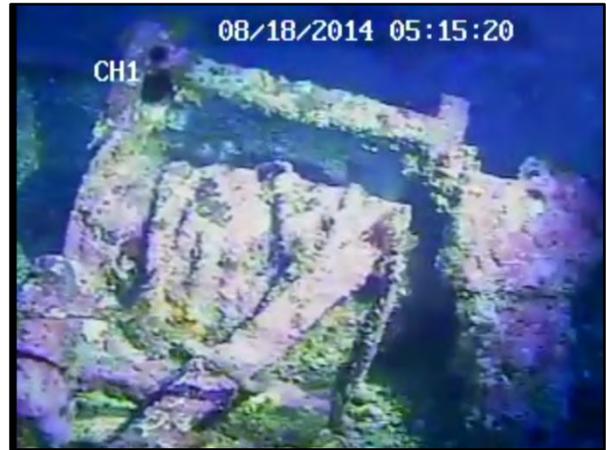
Figure 12: Winch found in aft half of the wreck.

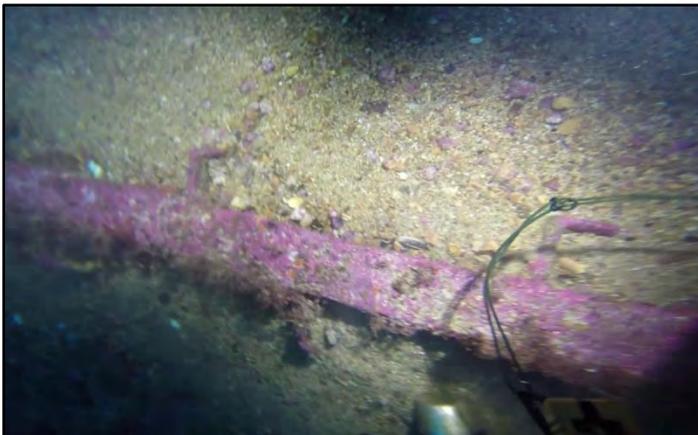
Figure 13: Possible mast.

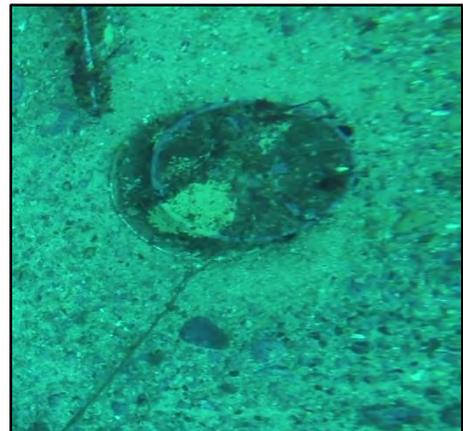
In addition, the large spherical feature that was identified in 2013 as a possible conning tower was explored and measured 11 ft., 6 in. in length. The bitt was measured to be 1 ft., 2 in. between the posts, and each post was 1 ft. in diameter and stood above a piece of attached deck by 1 ft., 8 in. Lastly, an intrusive fish or crab trap was discovered on the site (Fig. 14).

Figure 14: Fish or crab trap.

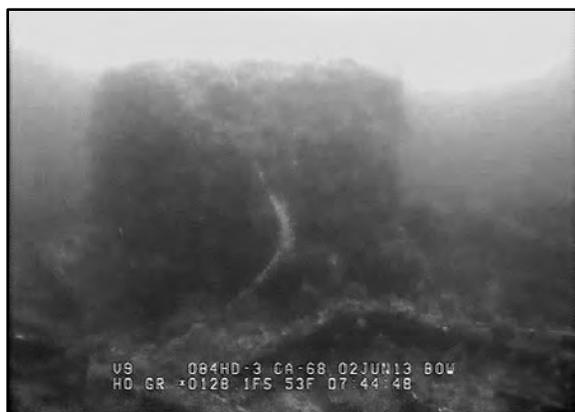
Figure 15: 2013 survey ROV video still identified as potentially representing the conning tower.

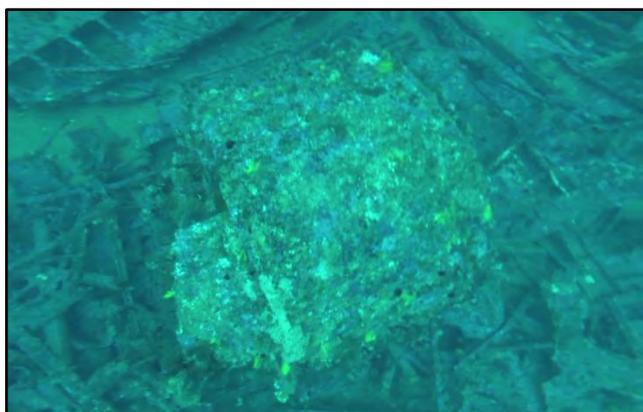
The first ROV dive occurred from 0820 to 0930. Although there was some current, the ROV worked very well and was able to hover over the wreck. The large spherical object was explored further for identification (Fig. 16-18). The shape was determined to be more rectangular than spherical as assessed during the 2013 survey (Fig. 15). The object was found to contain numerous tubes on the inside and there appeared to be an opening for a door and a hinge present (Fig. 17). In addition, mounting pads and pad eyes were noted as well as iron

knees near the stern. Therefore, the object was determined to likely be a boiler or some form of evaporator.

Figure 16: View of likely boiler from above.

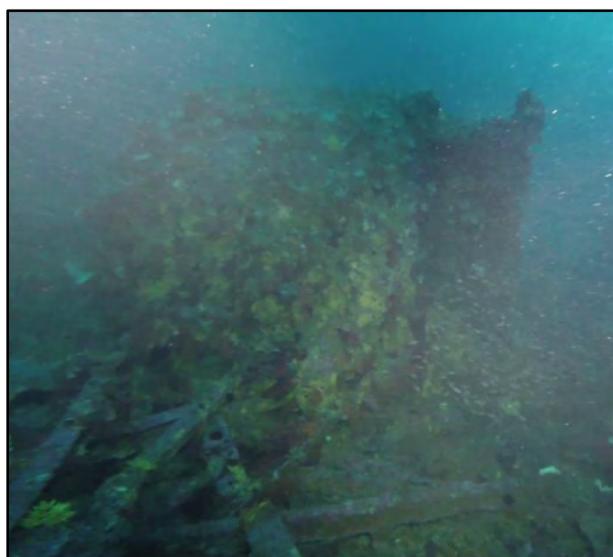
Figure 17: Side view of boiler, notice what appears to be a door opening on the right.

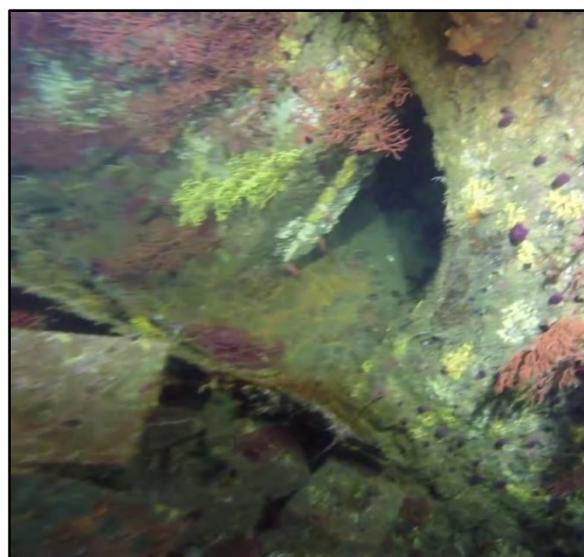
MDSU completed a series of 2 surface-supplied dives. Visibility was 20 ft. (6 m) and depth 132 ft. (40 m). During the first dive from 1036 to 1123, the divers examined the spherical structure, but their investigation suggested that it might be something else, possibly a boiler. The team measured an opening in the structure that was approximately 22 in. by 12 in. and noted that a number of square bricks or cement-like tiles were scattered around the structure (Fig. 16).

Figure 18: Opening into the boiler with scatter of bricks or tiles around opening.

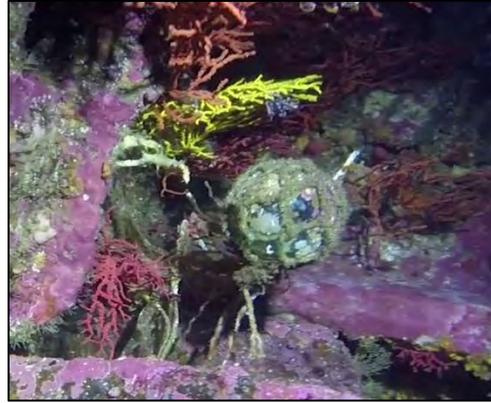
The date of the wreck is unknown, but the welded construction suggests sometime after the 1930s. No datable artifacts were found, however, a baseball-sized glass float was noticed tangled in the wreckage (Fig.18). Glass floats are hollow spheres used to keep afloat fishing nets (Pitch 2004). If not intrusive to the site, then the ship likely dates to a period when glass floats were in use. Glass floats were in use in Japan as early as 1910 and by the 1940s glass had replaced most wood and cork floats for much of the deep-sea commercial fishing industry. Although plastic is more commonly used in recent decades, glass floats are still utilized by some Asian fishermen and produced as collectables for tourists (Whitten 2014).

Figure 19: Glass fishing float

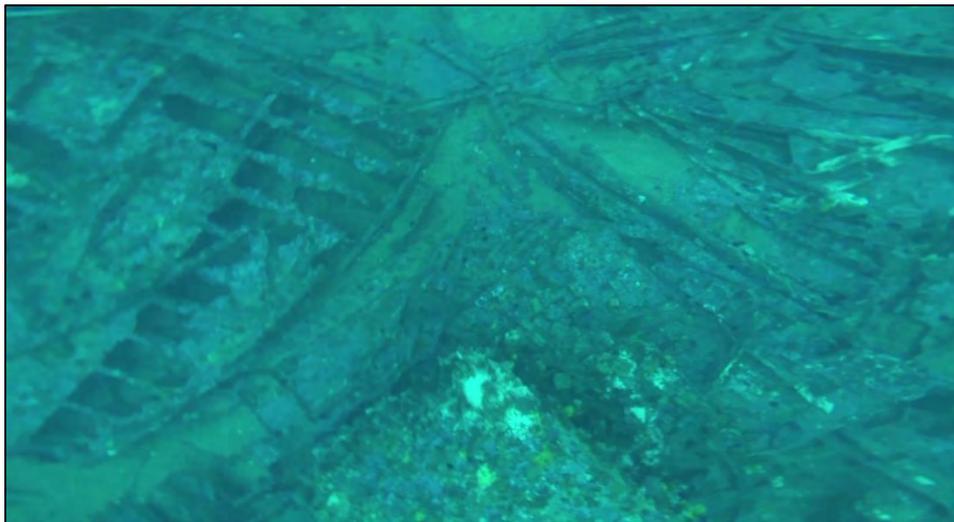
The wreck is extremely damaged and disarticulated. Very little of the outer hull remains intact and for the most part the wreckage consists of a scatter of frames,

beams, some deck plating, and machinery (Fig. 19-21). A small section of the stern, which contains the propeller and shaft, is the most articulated portion of the hull. The stern section lies on its port side with the starboard exposed in the water column. The ship had only the single screw with an estimated 4 blades. The blade shape appeared to be most similar to the type described as the chopper or the skew-back type (Smith and Slater 1998:26).

Figure 20: Overhead view of wreckage, upper surface of boiler in lower foreground.

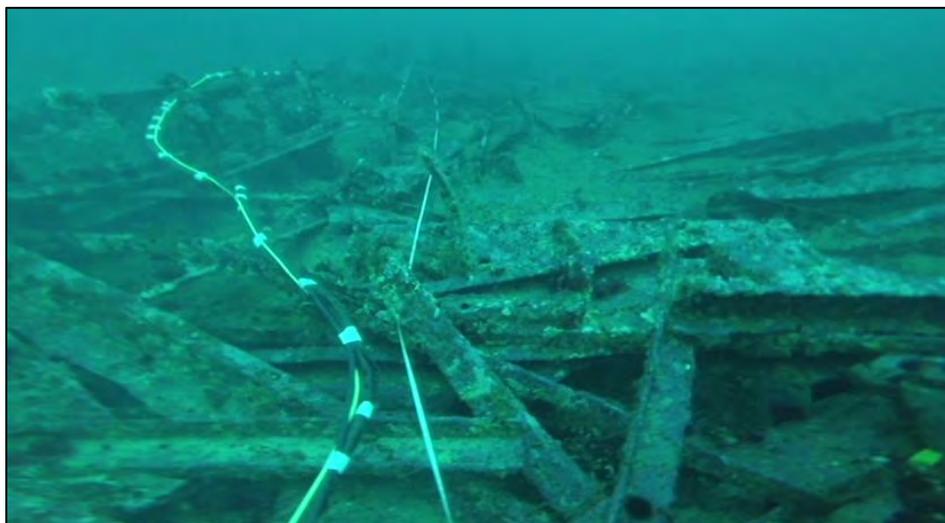
Figure 21: View of the wreck site forward looking aft.

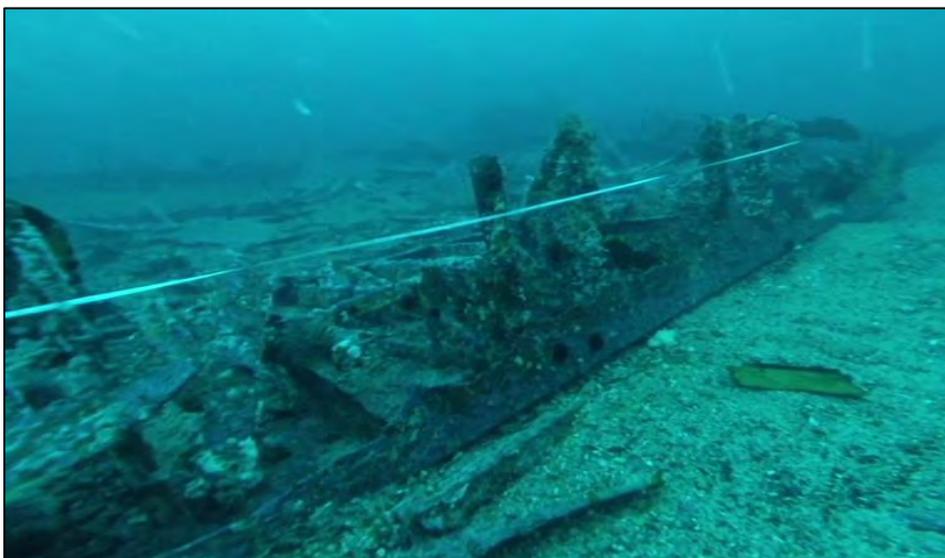
Figure 22: View of lower port side of wreckage looking forward. Keel possibly present at base of wreckage in the sand.
