GENERAL DATA

USS BOWFIN (SS287)

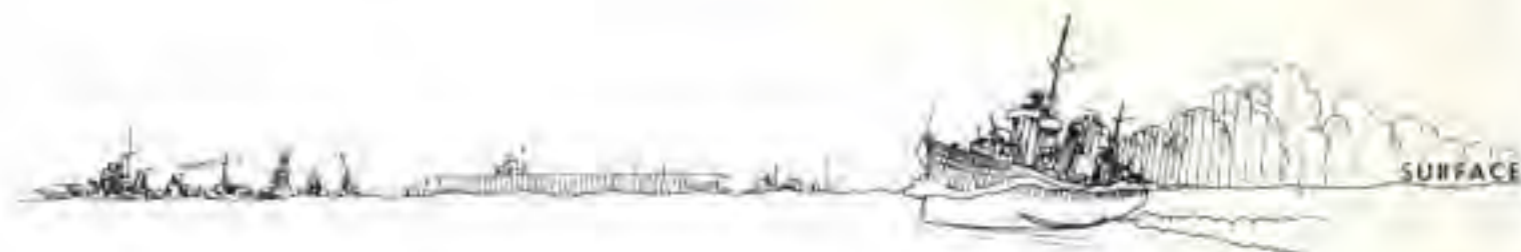
400' ———— MAXIMUM OPERATING DEPTH

It is important to understand the limited submerged operational capability of these boats. *They could not dive very much deeper than their own length.* The SS285-class was designed to operate at 400 feet maximum depth with a safety factor of 1.5. The "collapse depth," at which depth the pressure hull was designed to fail, was 400 x 1.5 or 600 feet. If a boat got out of control during a steep crash dive, or while being depth charged, in only a minute or less it could pass from 400 feet and safety to 600 feet and probable disaster. Most boats were trimmed light during deep submergence operations to make it easy to "pull out" if required. Safe submergence required a sensitive means of depth control and rather slow changes in depth. These boats were not designed to maneuver like modern nuclear submarines, which behave somewhat like an aircraft.

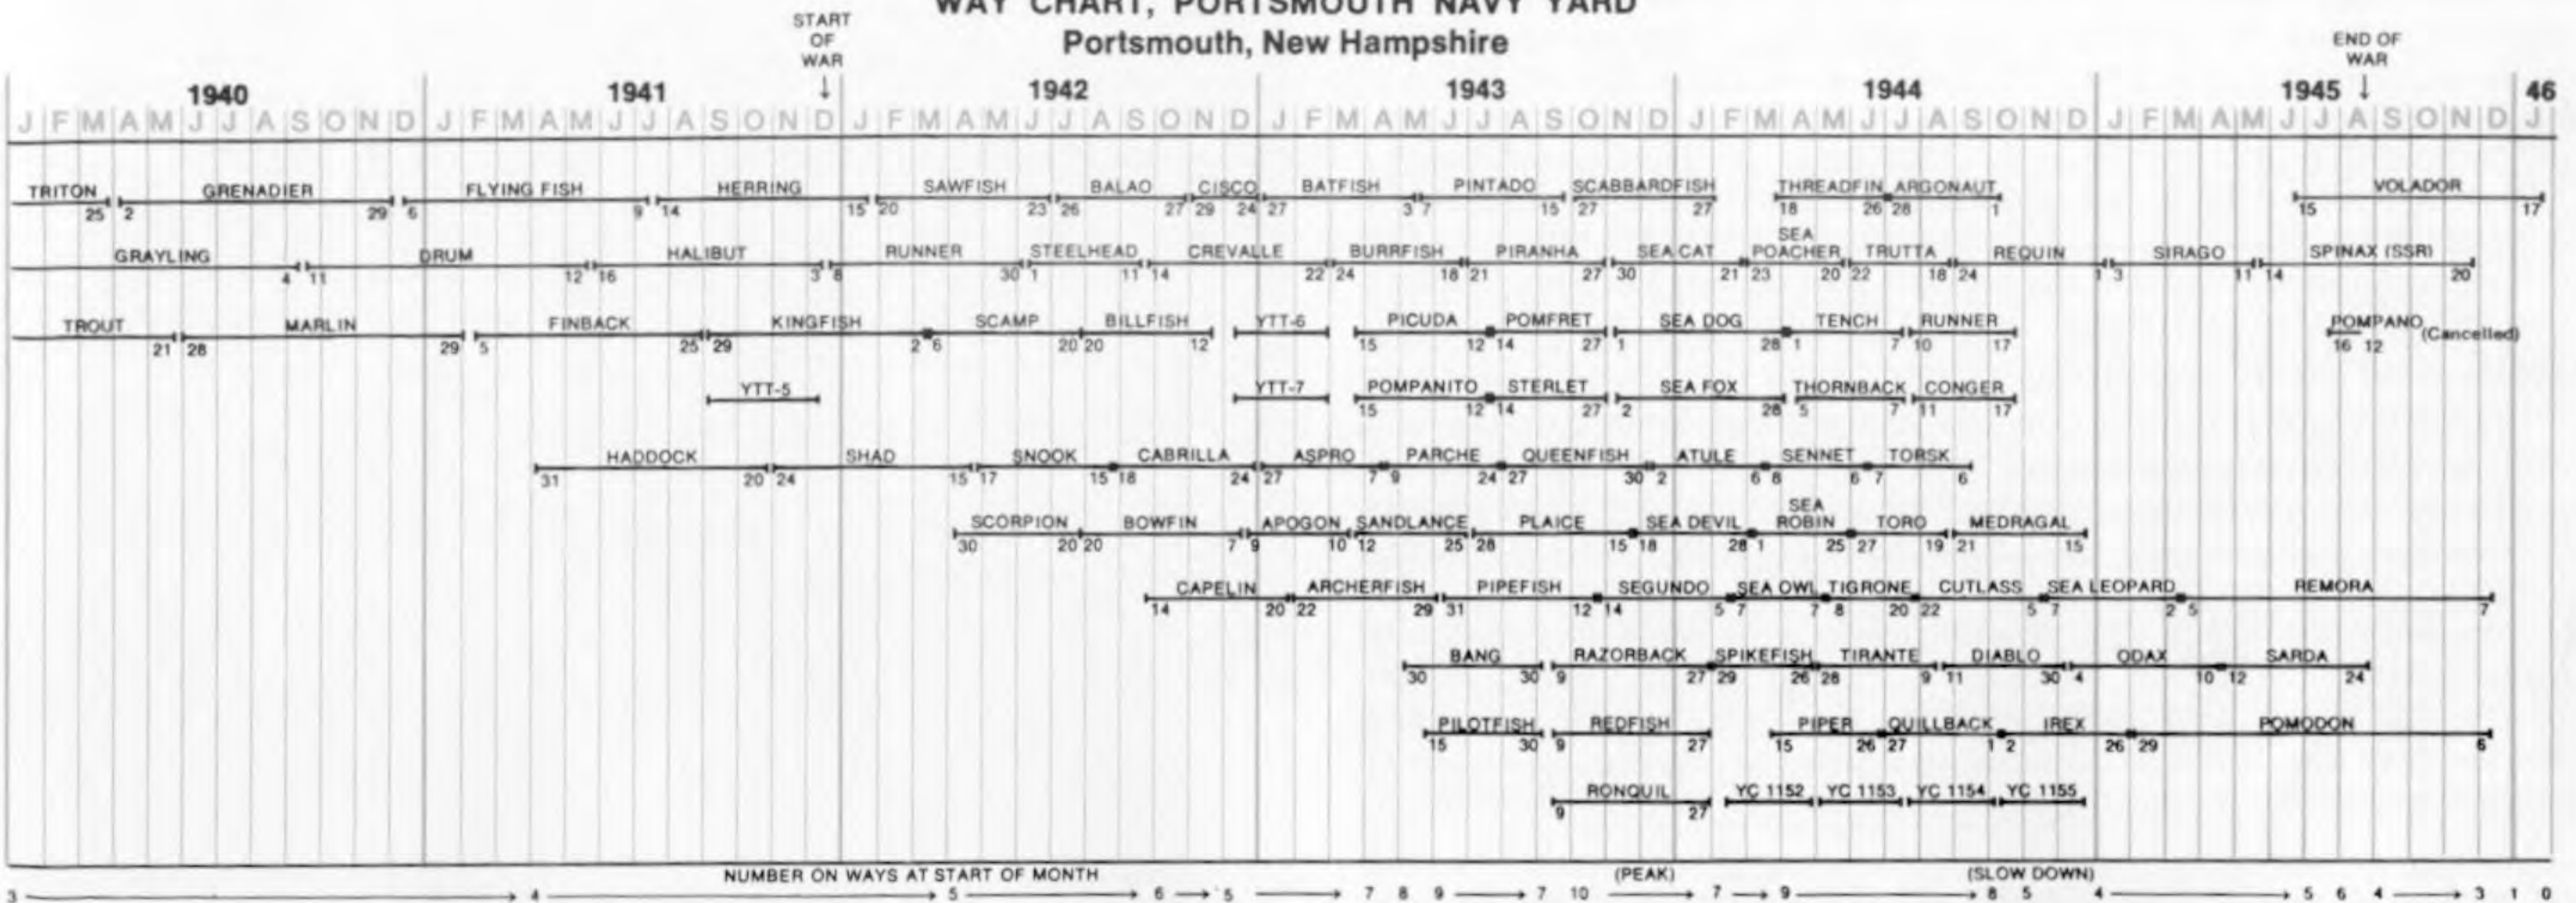
WAY CHART, PORTSMOUTH NAVY YARD Portsmouth, New Hampshire

LINES REPRESENT INTERVAL ON WAYS FROM KEEL LAYING TO LAUNCHING
 YTTs ARE 165 x 55 TORPEDO TESTING BARGES, NON SELF-PROPELLED, INTRODUCED INTO THE HIGH PRIORITY SUBMARINE PROGRAM BECAUSE OF THE URGENT NEED TO IMPROVE U.S. TORPEDOES
 CANCELLED: 3-27-45—SS548-550; 8-12-45: SS491-515; SUSPENDED: 8-12-45—SS490 (VOLADOR)

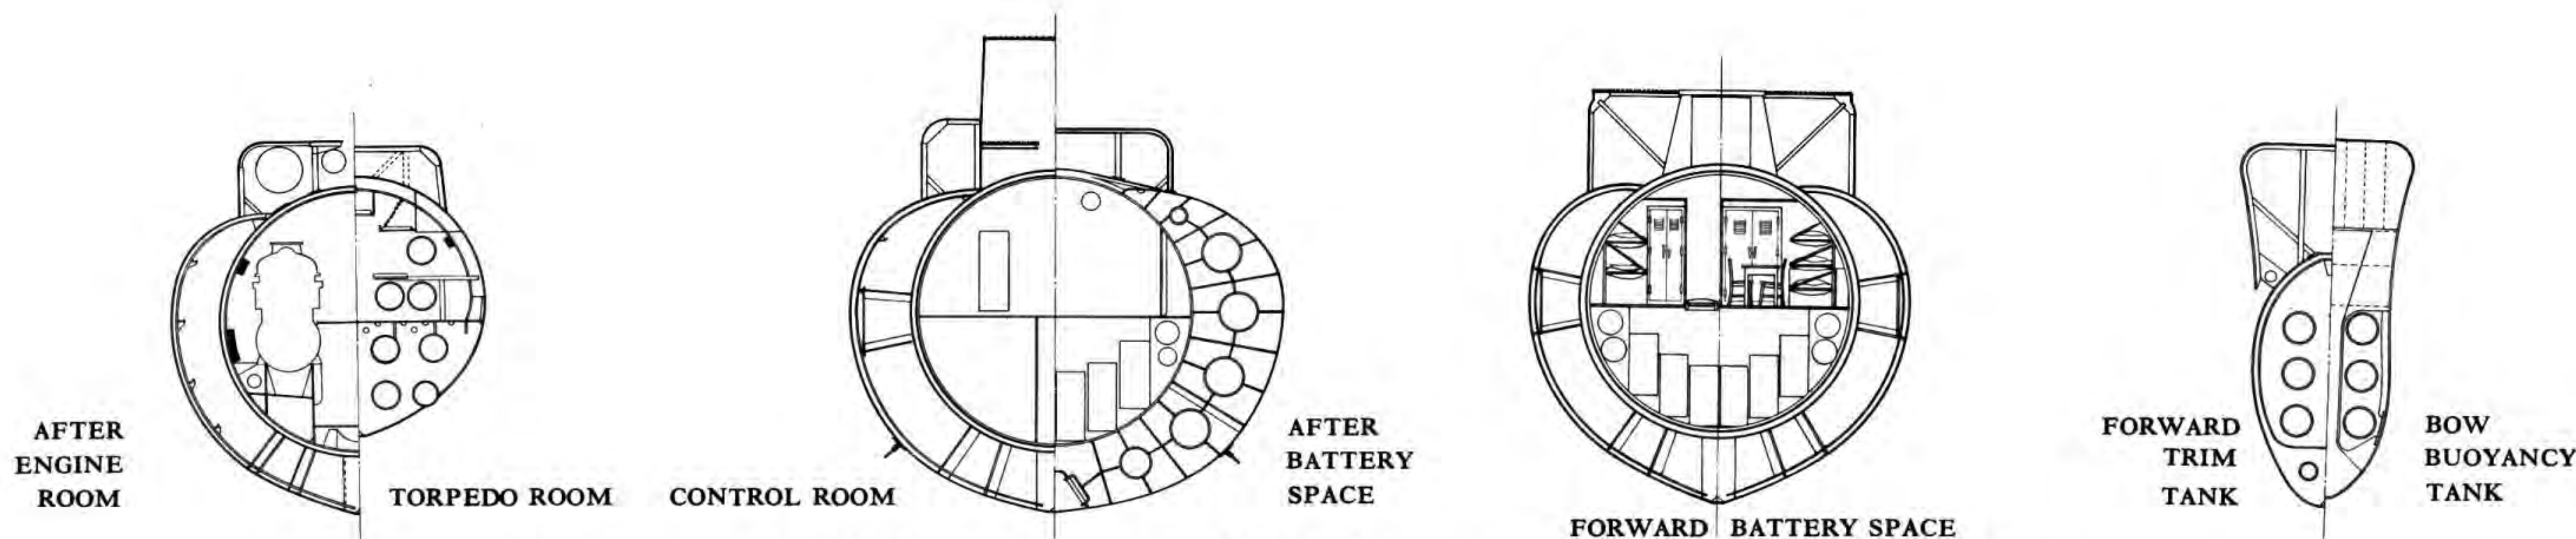
Typical sections of SS285-class boats. For further details and compartmentation, see pages 14, 15, 18 and 19.

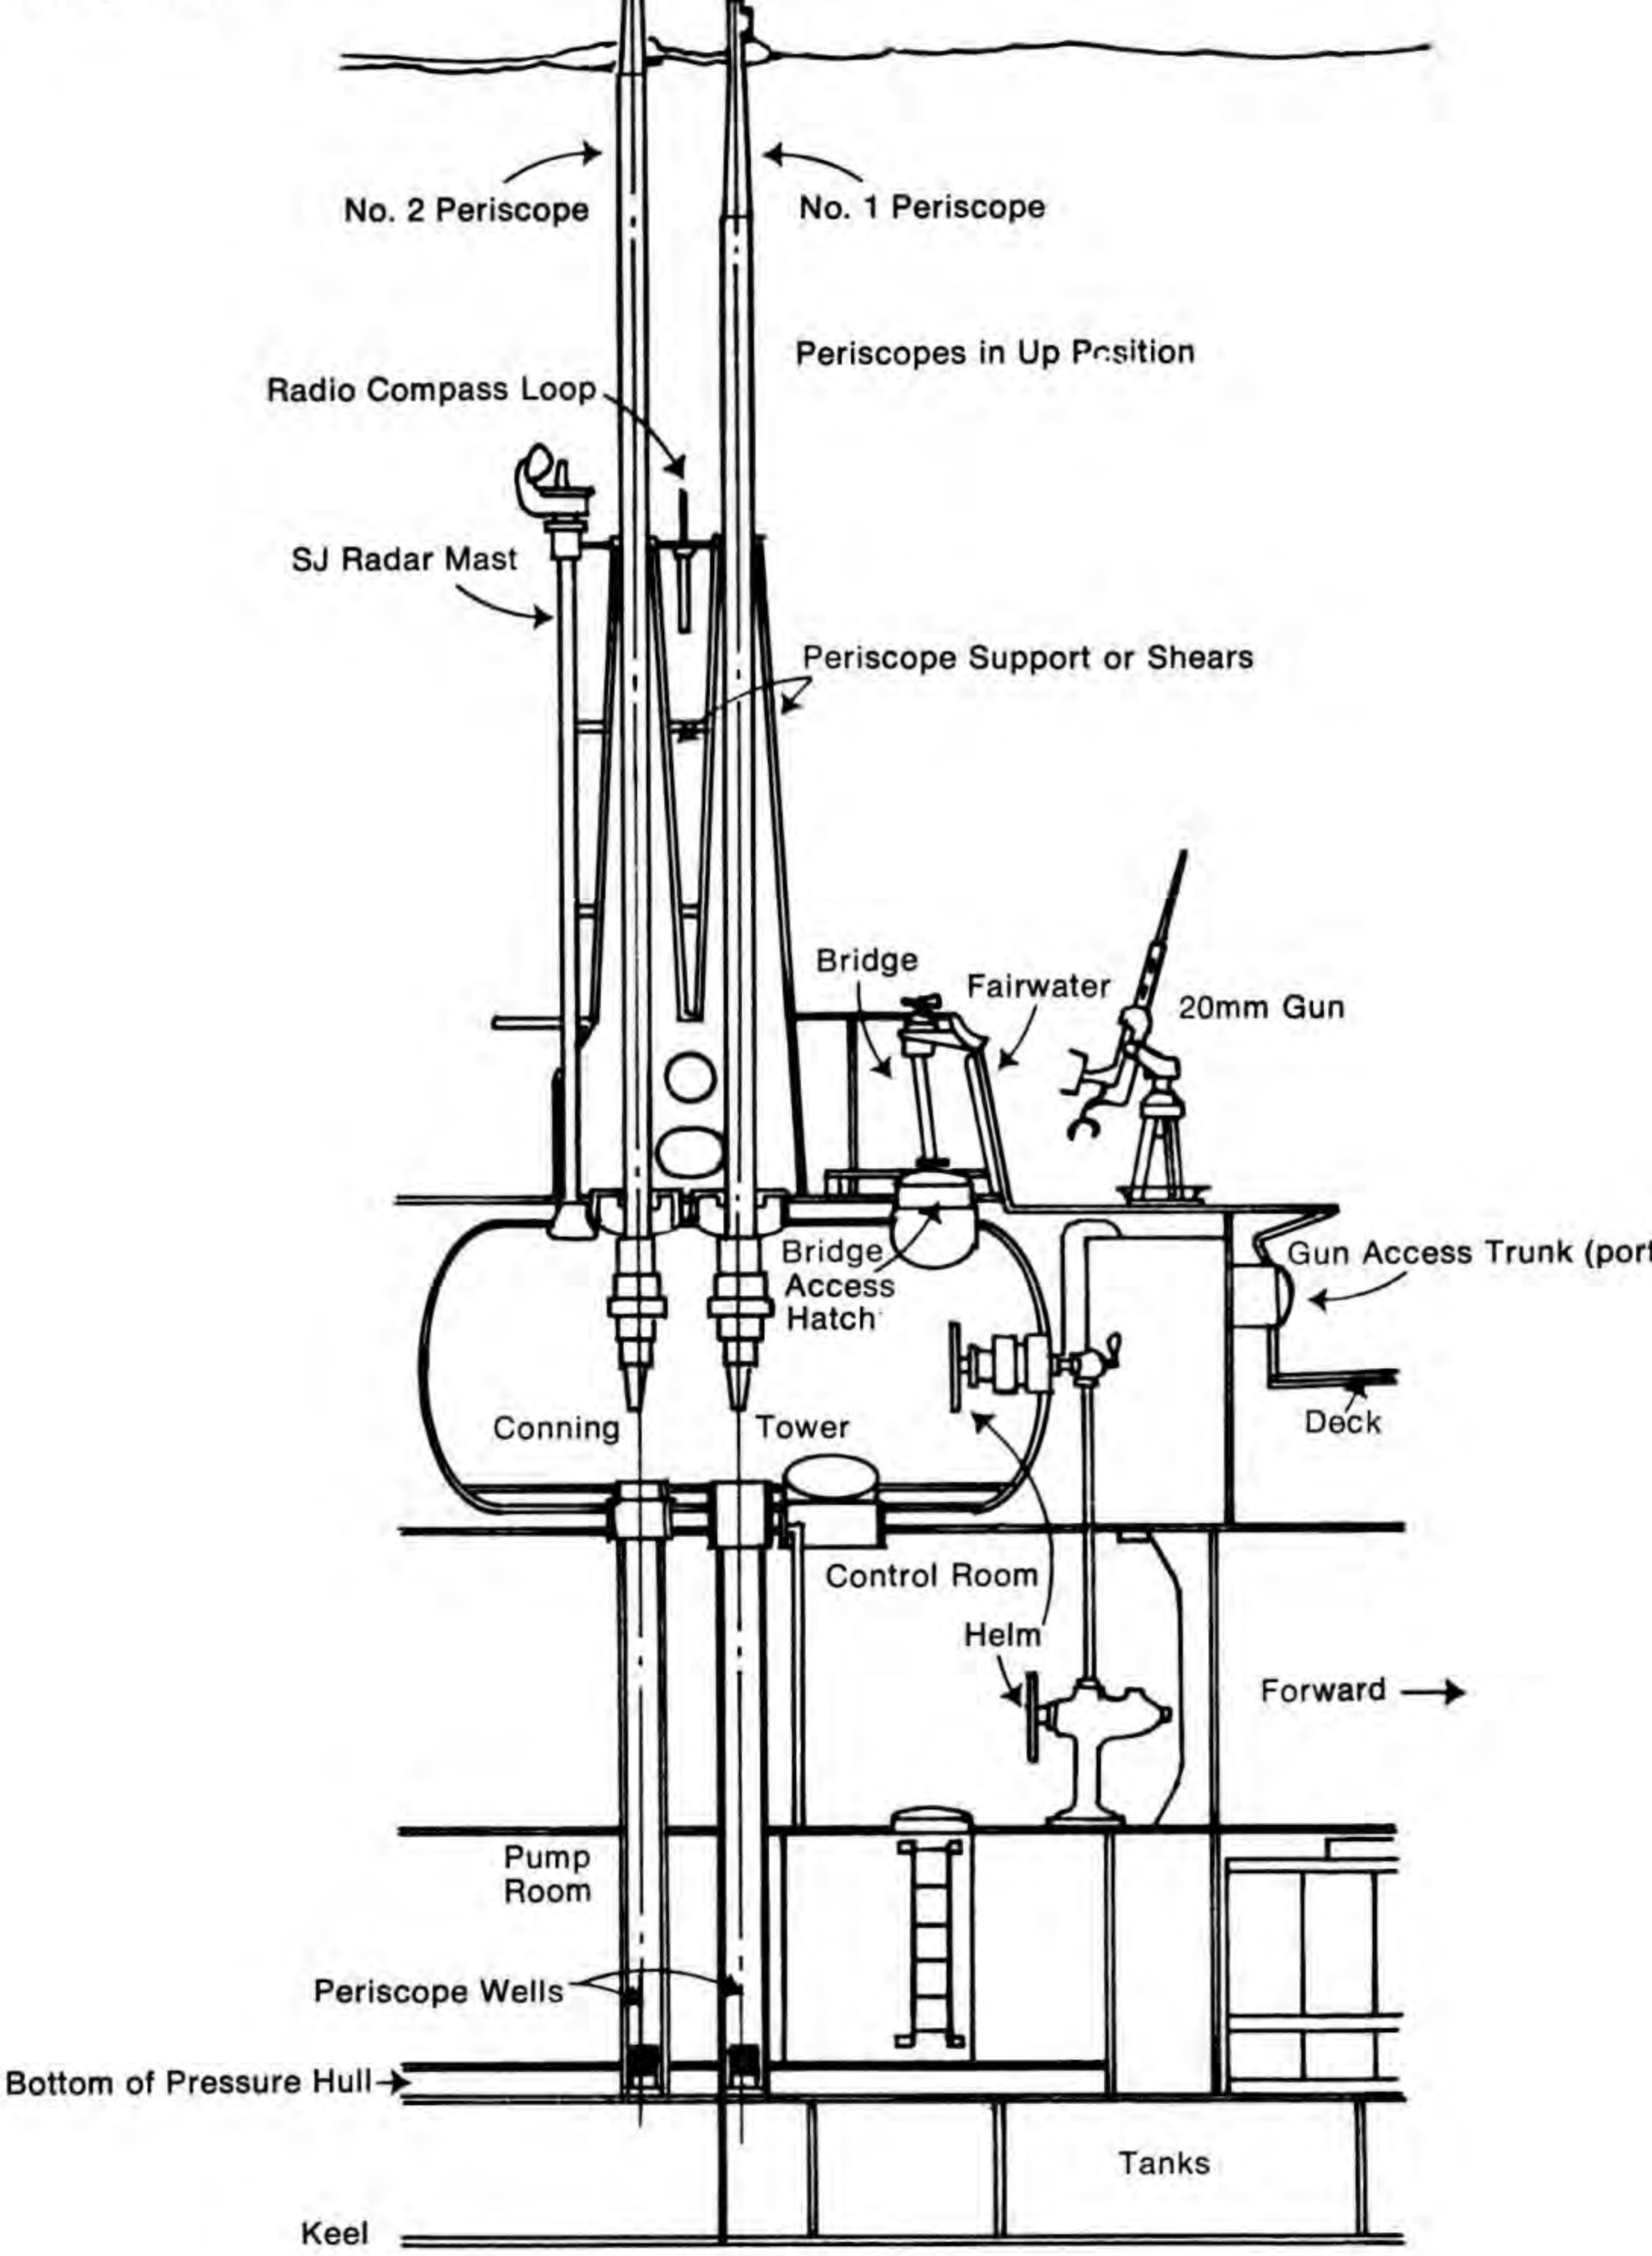
Partial inboard profile at periscope depth showing periscope arrangement.

the control room to the pump room below. These wells were omitted in the conning tower. The periscope eyepiece was about four feet, nine inches above deck level in the conning tower when the periscope was fully raised.

The periscope eyepiece had to be placed as high as possible in the boat, in order to keep the hull and fairwater submerged while running at periscope depth. This requirement made the conning tower a desired feature of submarine design.

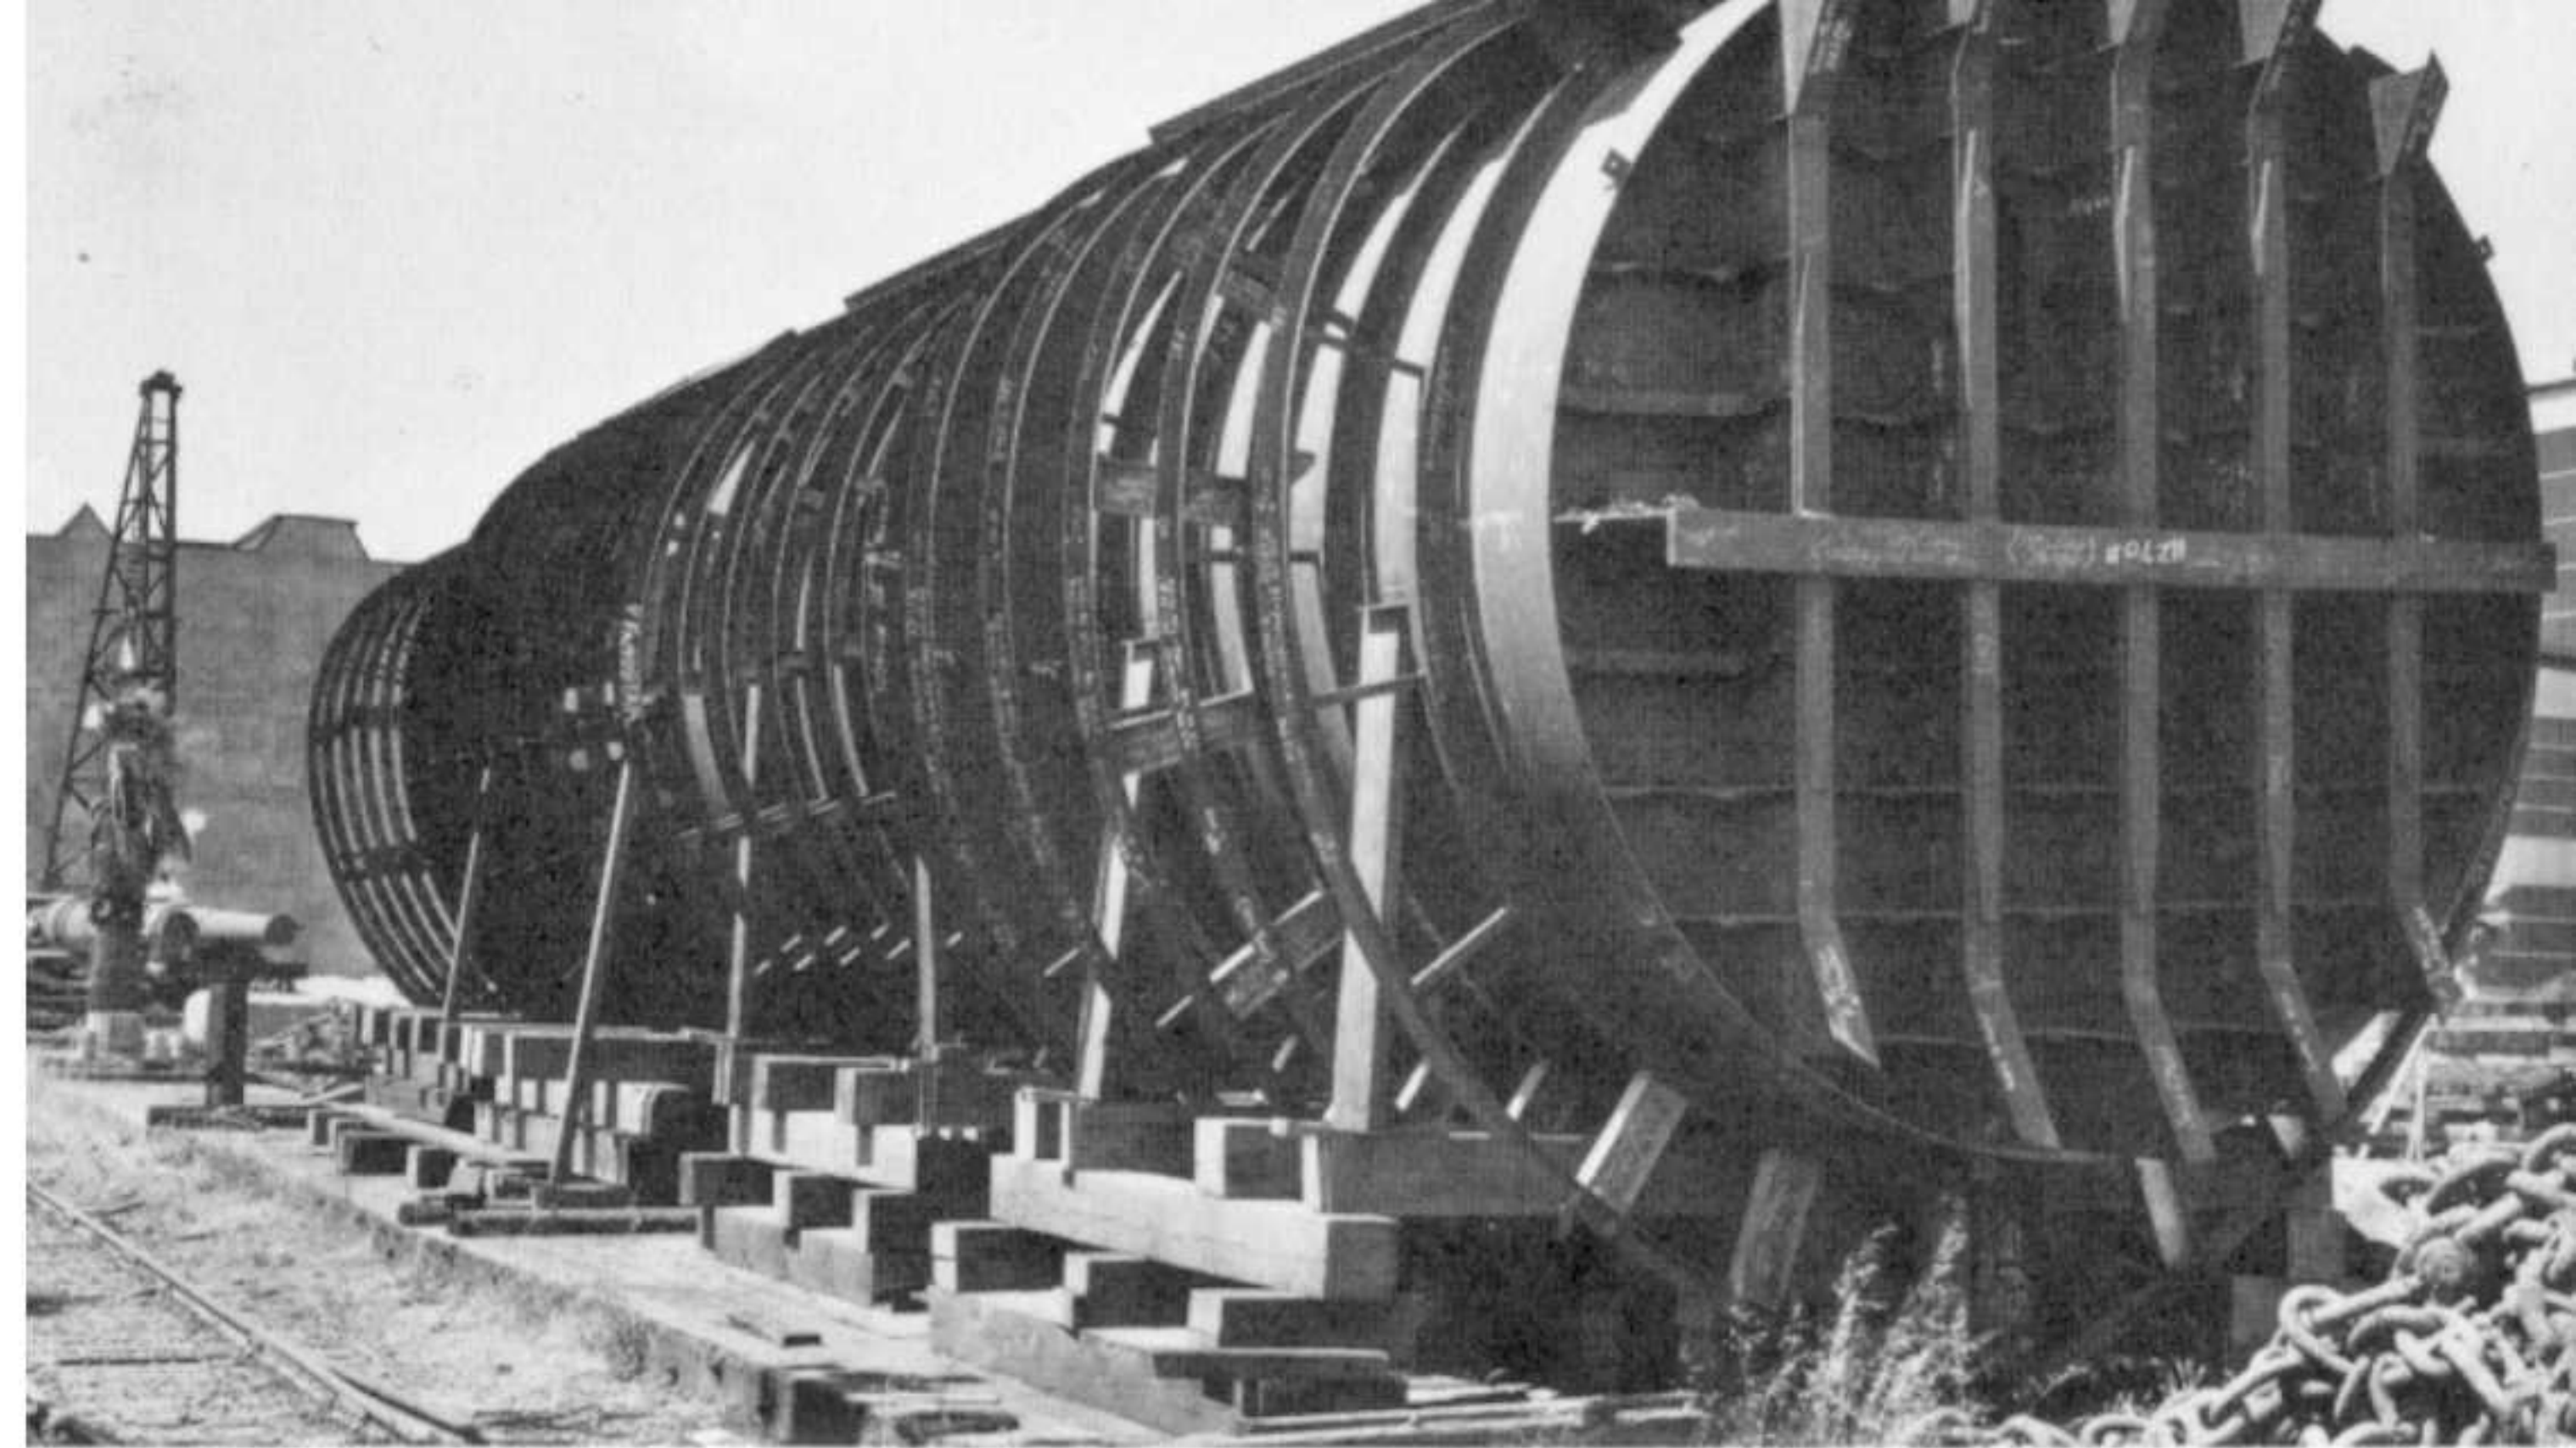
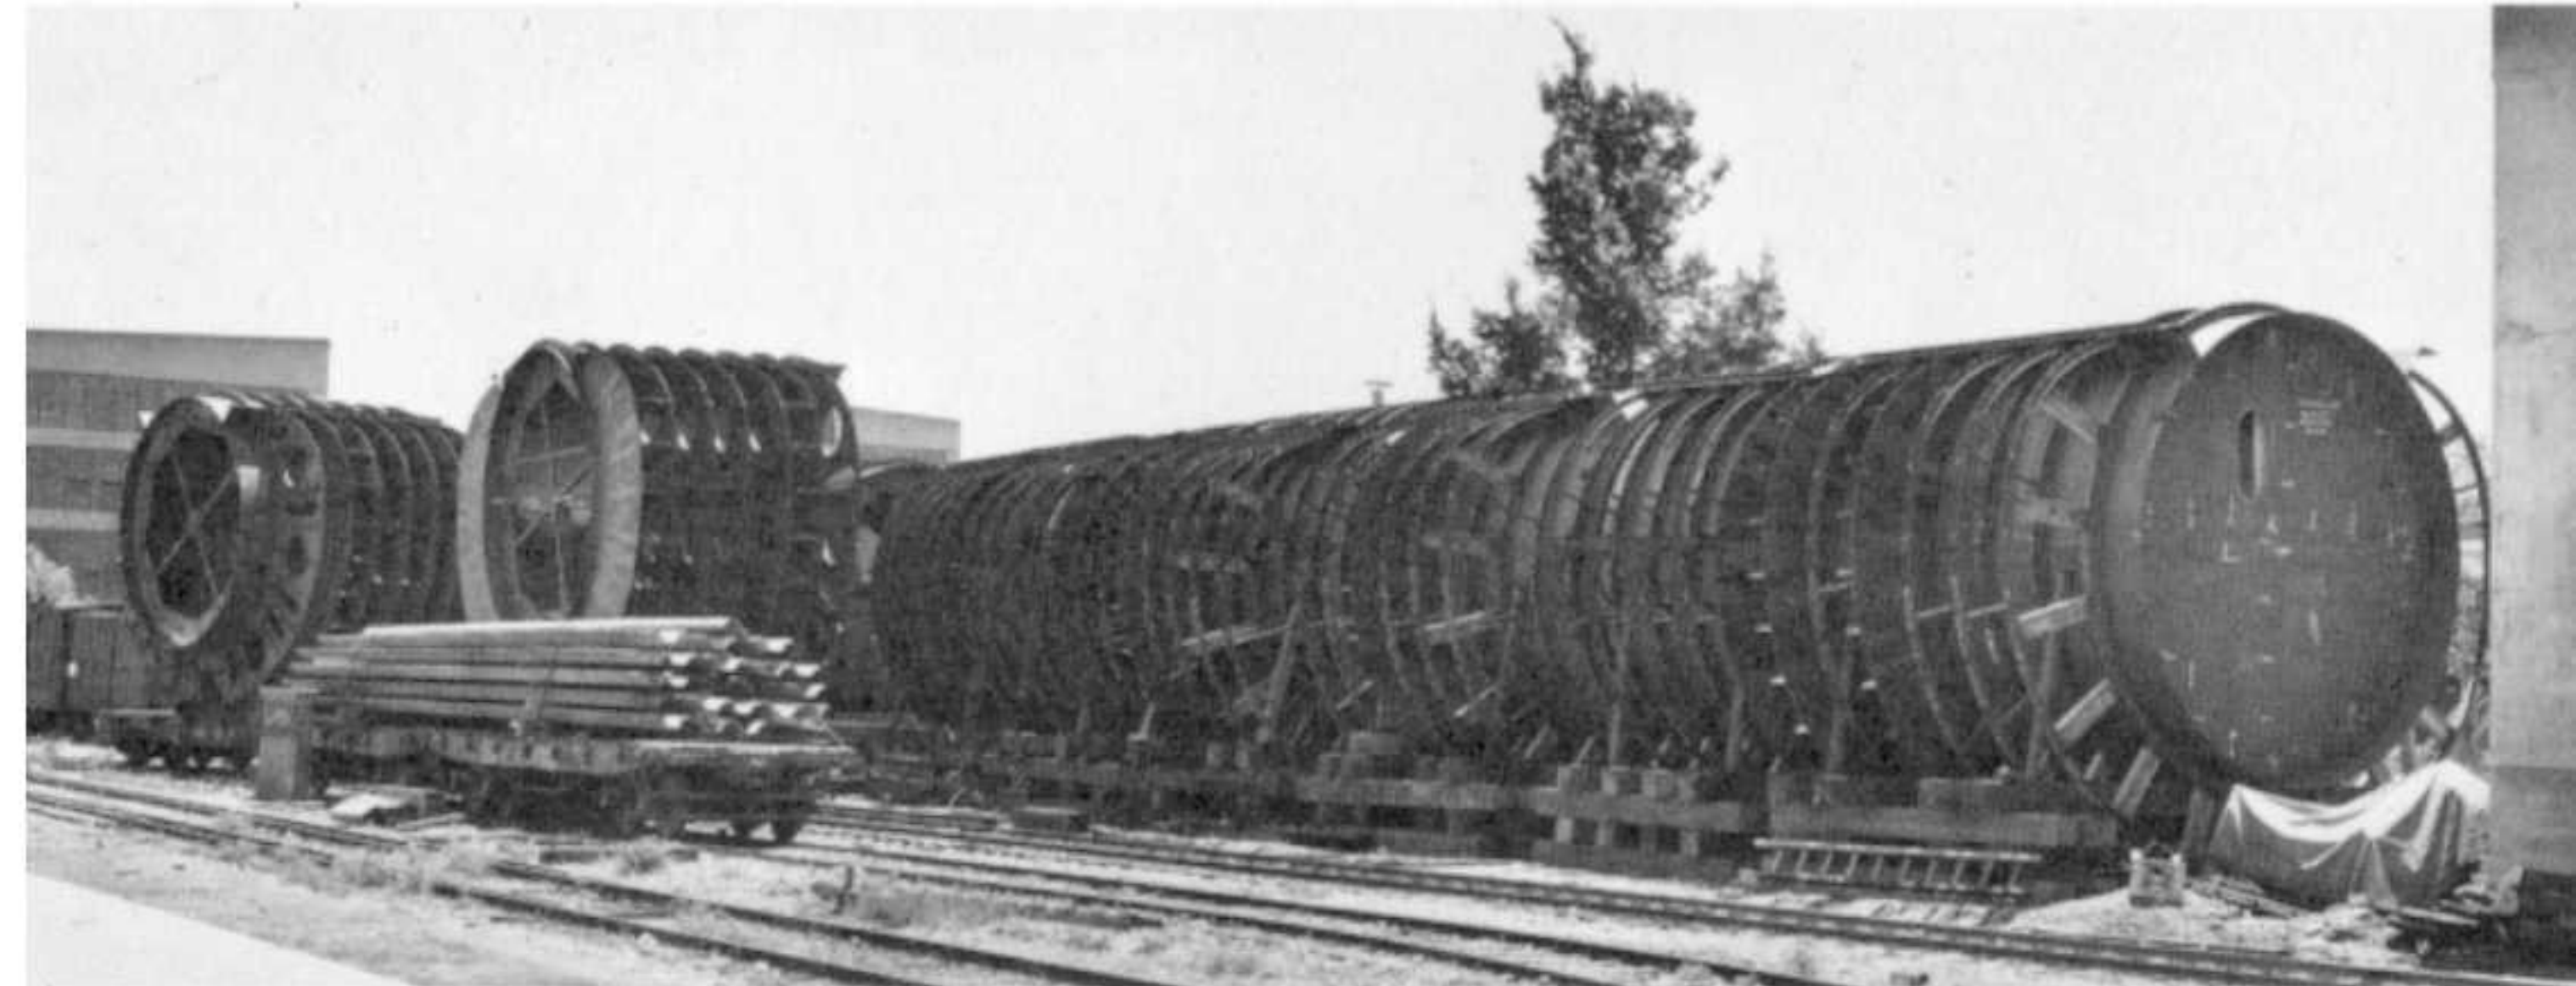
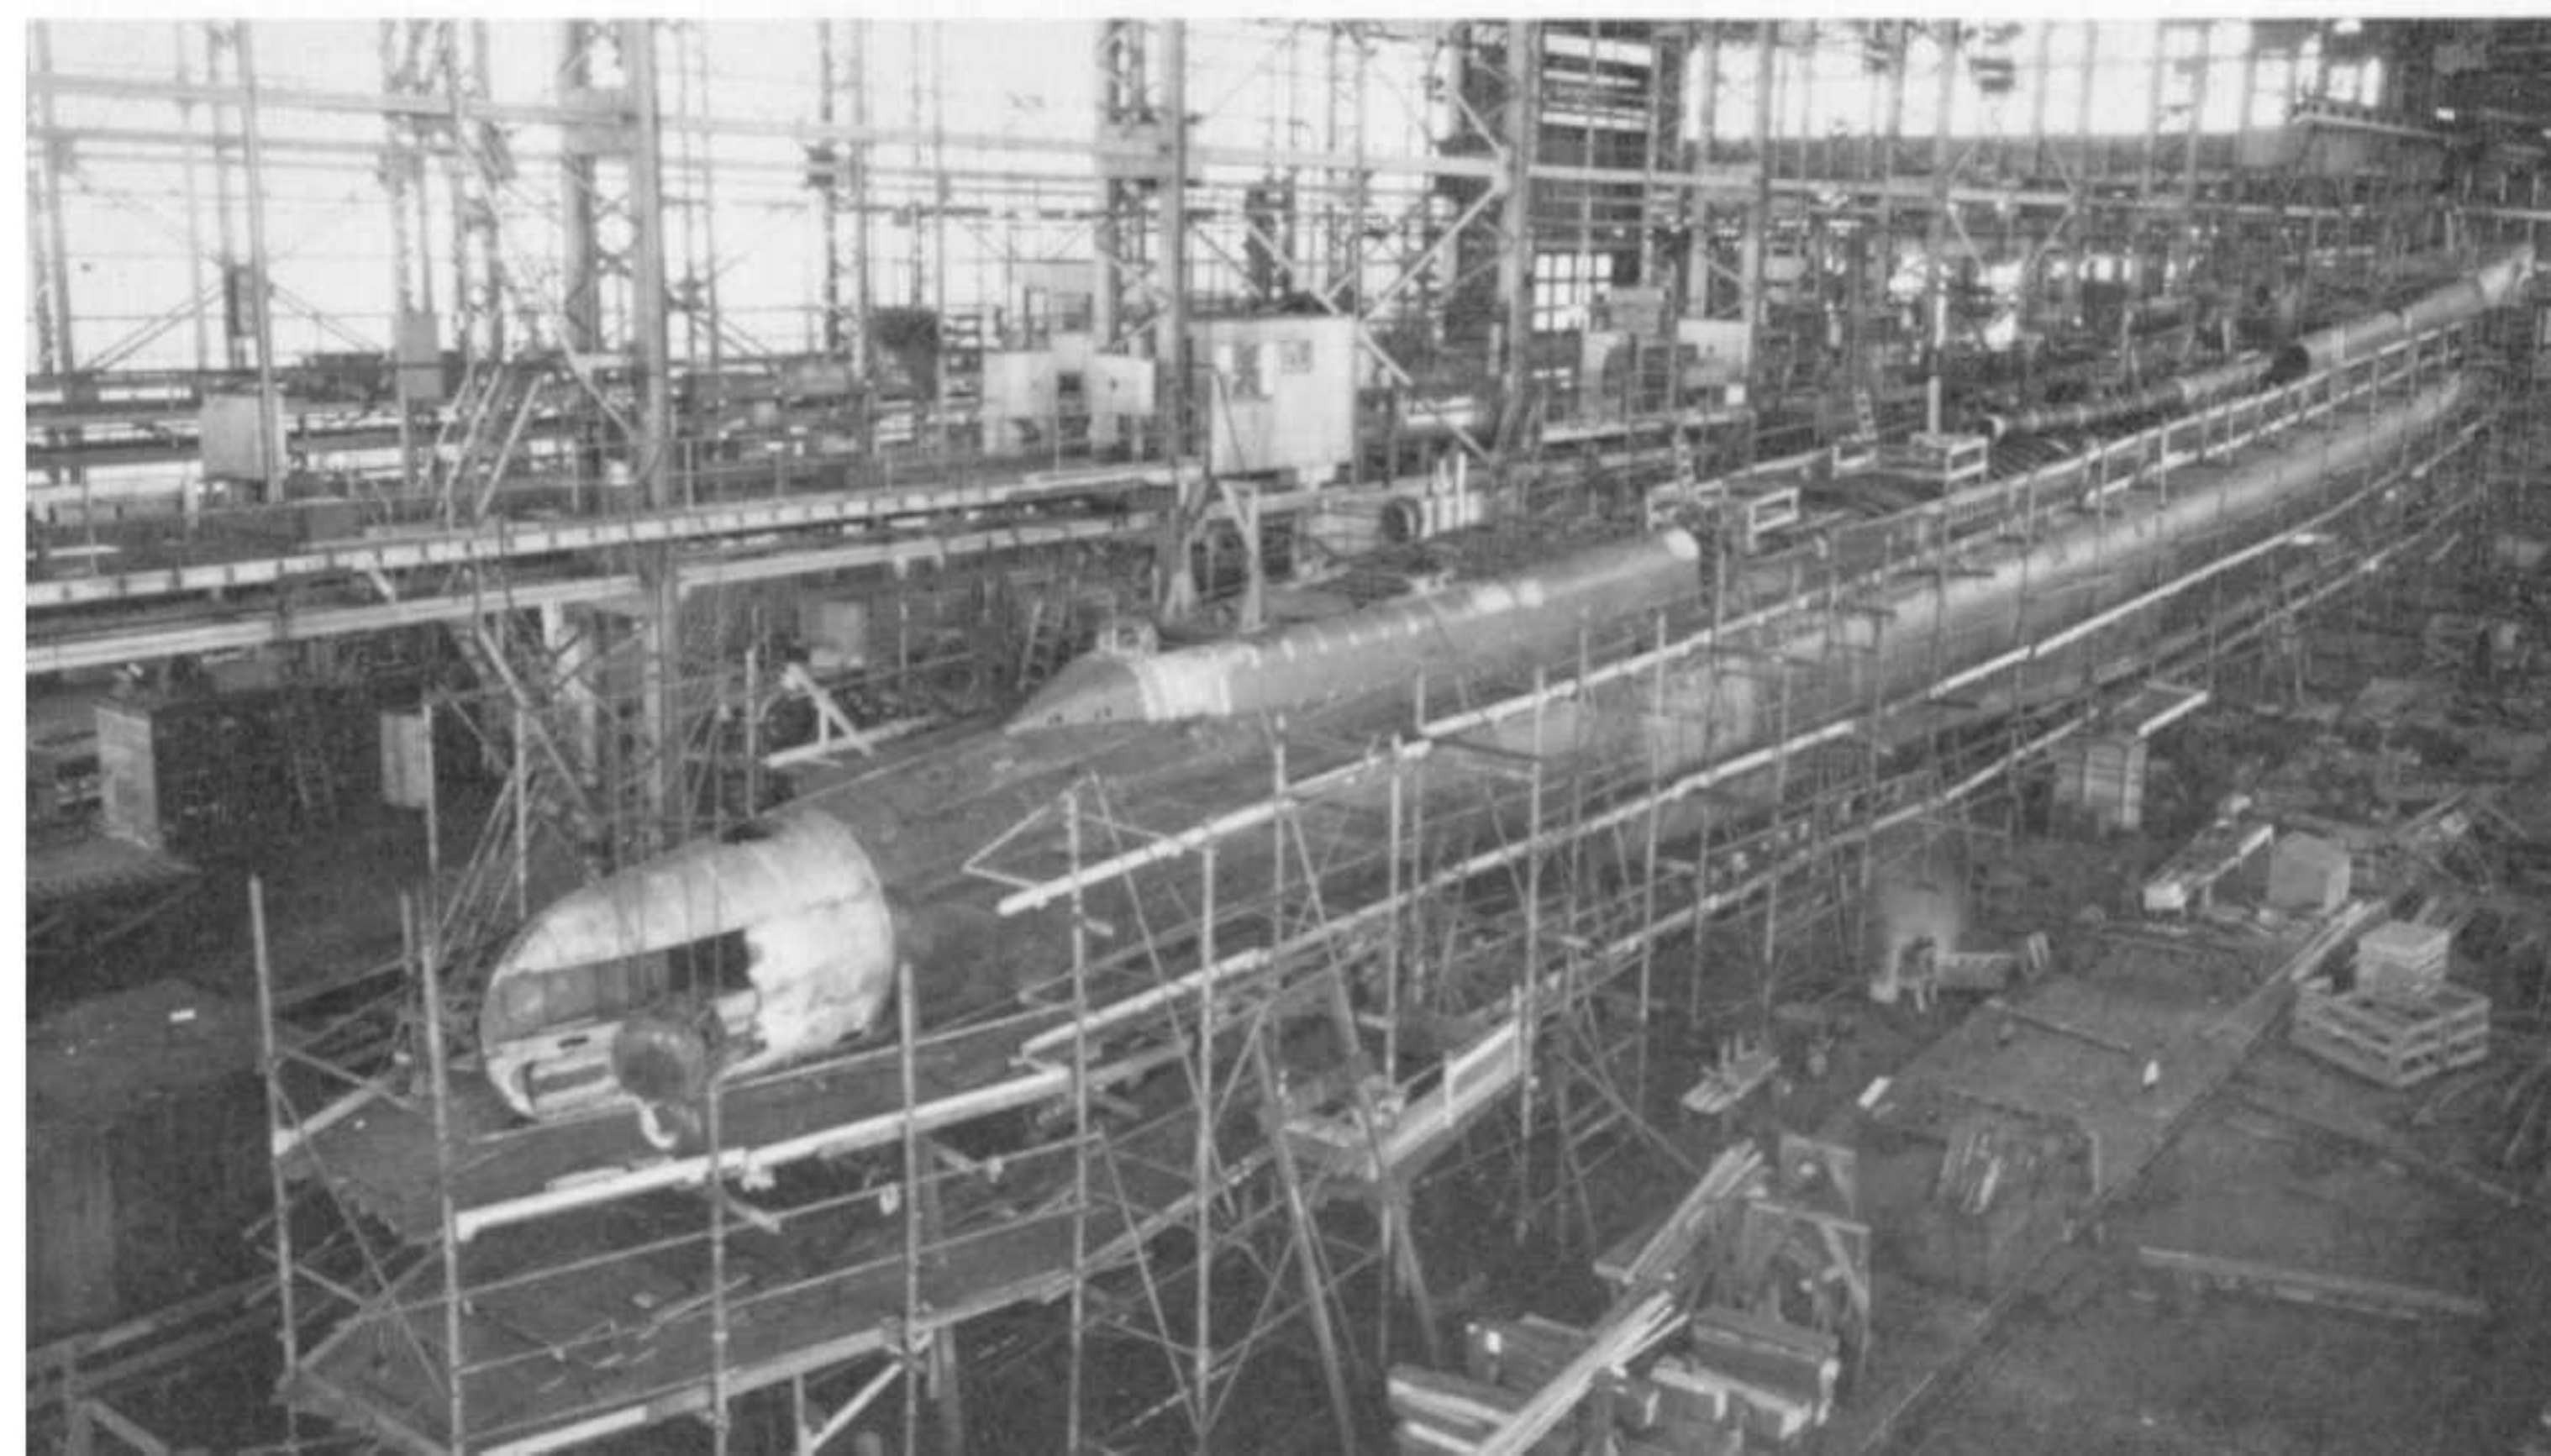
(Top and Center) Inner hull assemblies for USS Wahoo (SS238) stored outside fabricating shop at the Mare Island Navy Yard, 24 June 1941, awaiting erection and installation on building ways. Method of forming pressure hull and framing exterior tanks is clearly shown. (Bottom) USS Volador (SS490) on covered ways at the Portsmouth Navy Yard, 31 January 1946. Bowfin was built here.

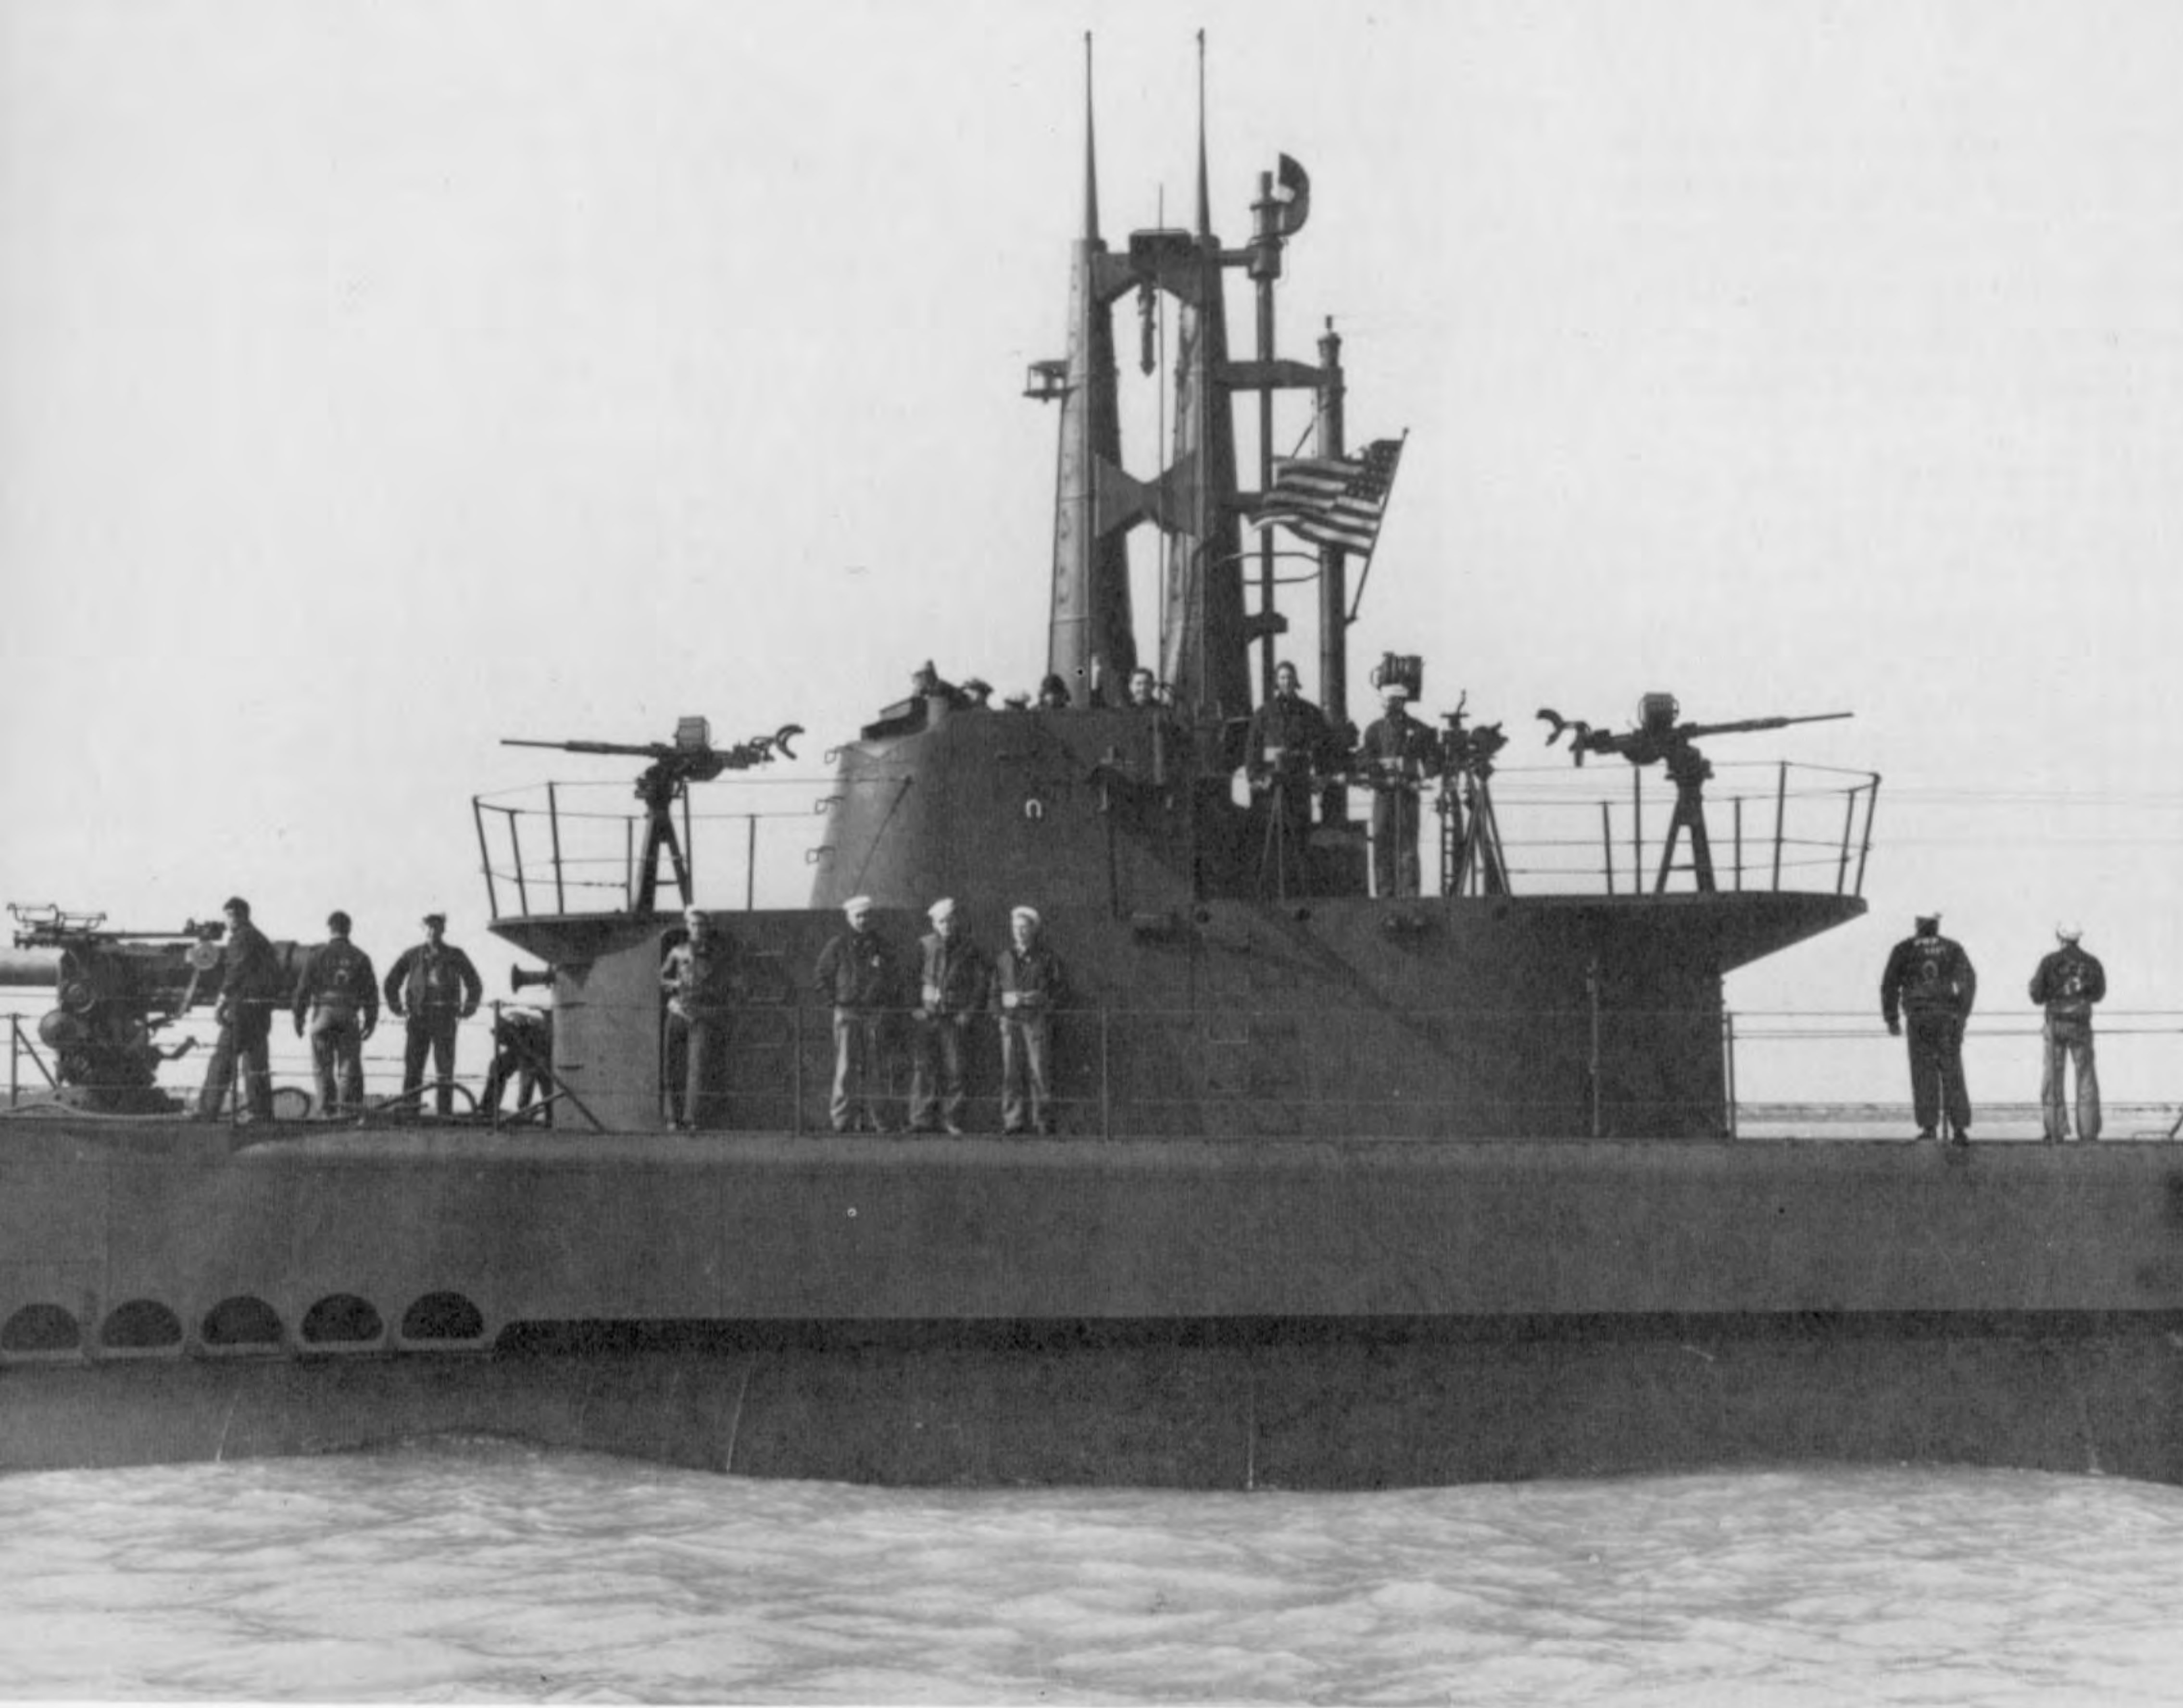
Close-up of USS Hardhead (SS365) showing port side of bridge in April 1944 configuration.
