GENERAL DATA

USS BOWFIN (SS287)

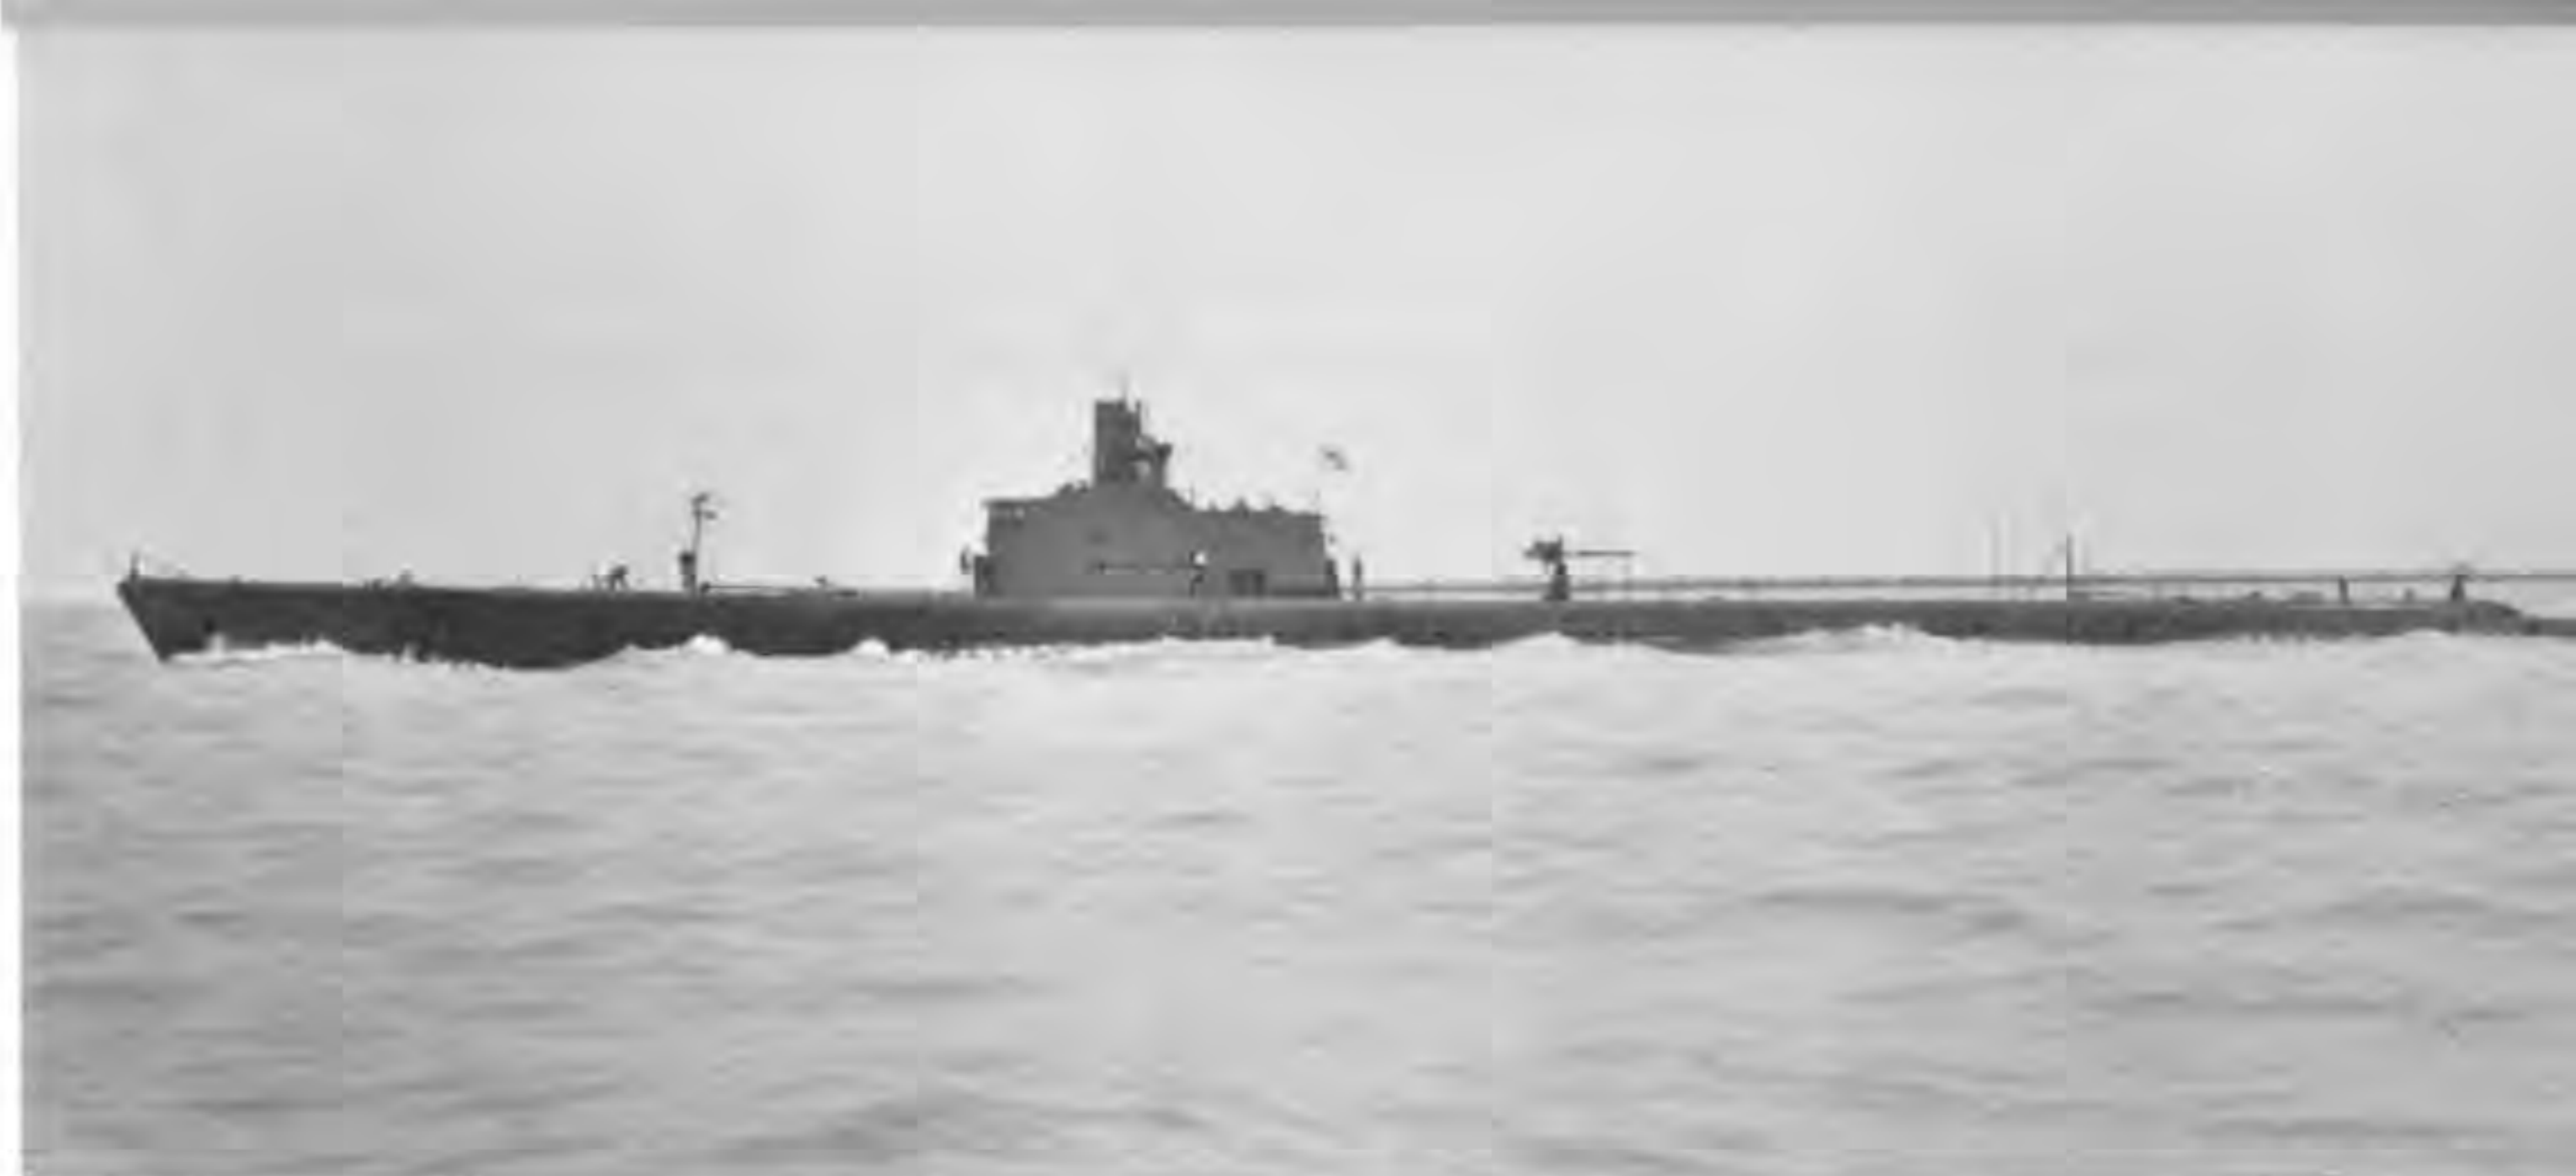
Original bridge design for early fleet-type boats is shown in this 6 April 1942 view of USS Trigger (SS237). Original 3"/50 deck gun proved too light for surface targets.

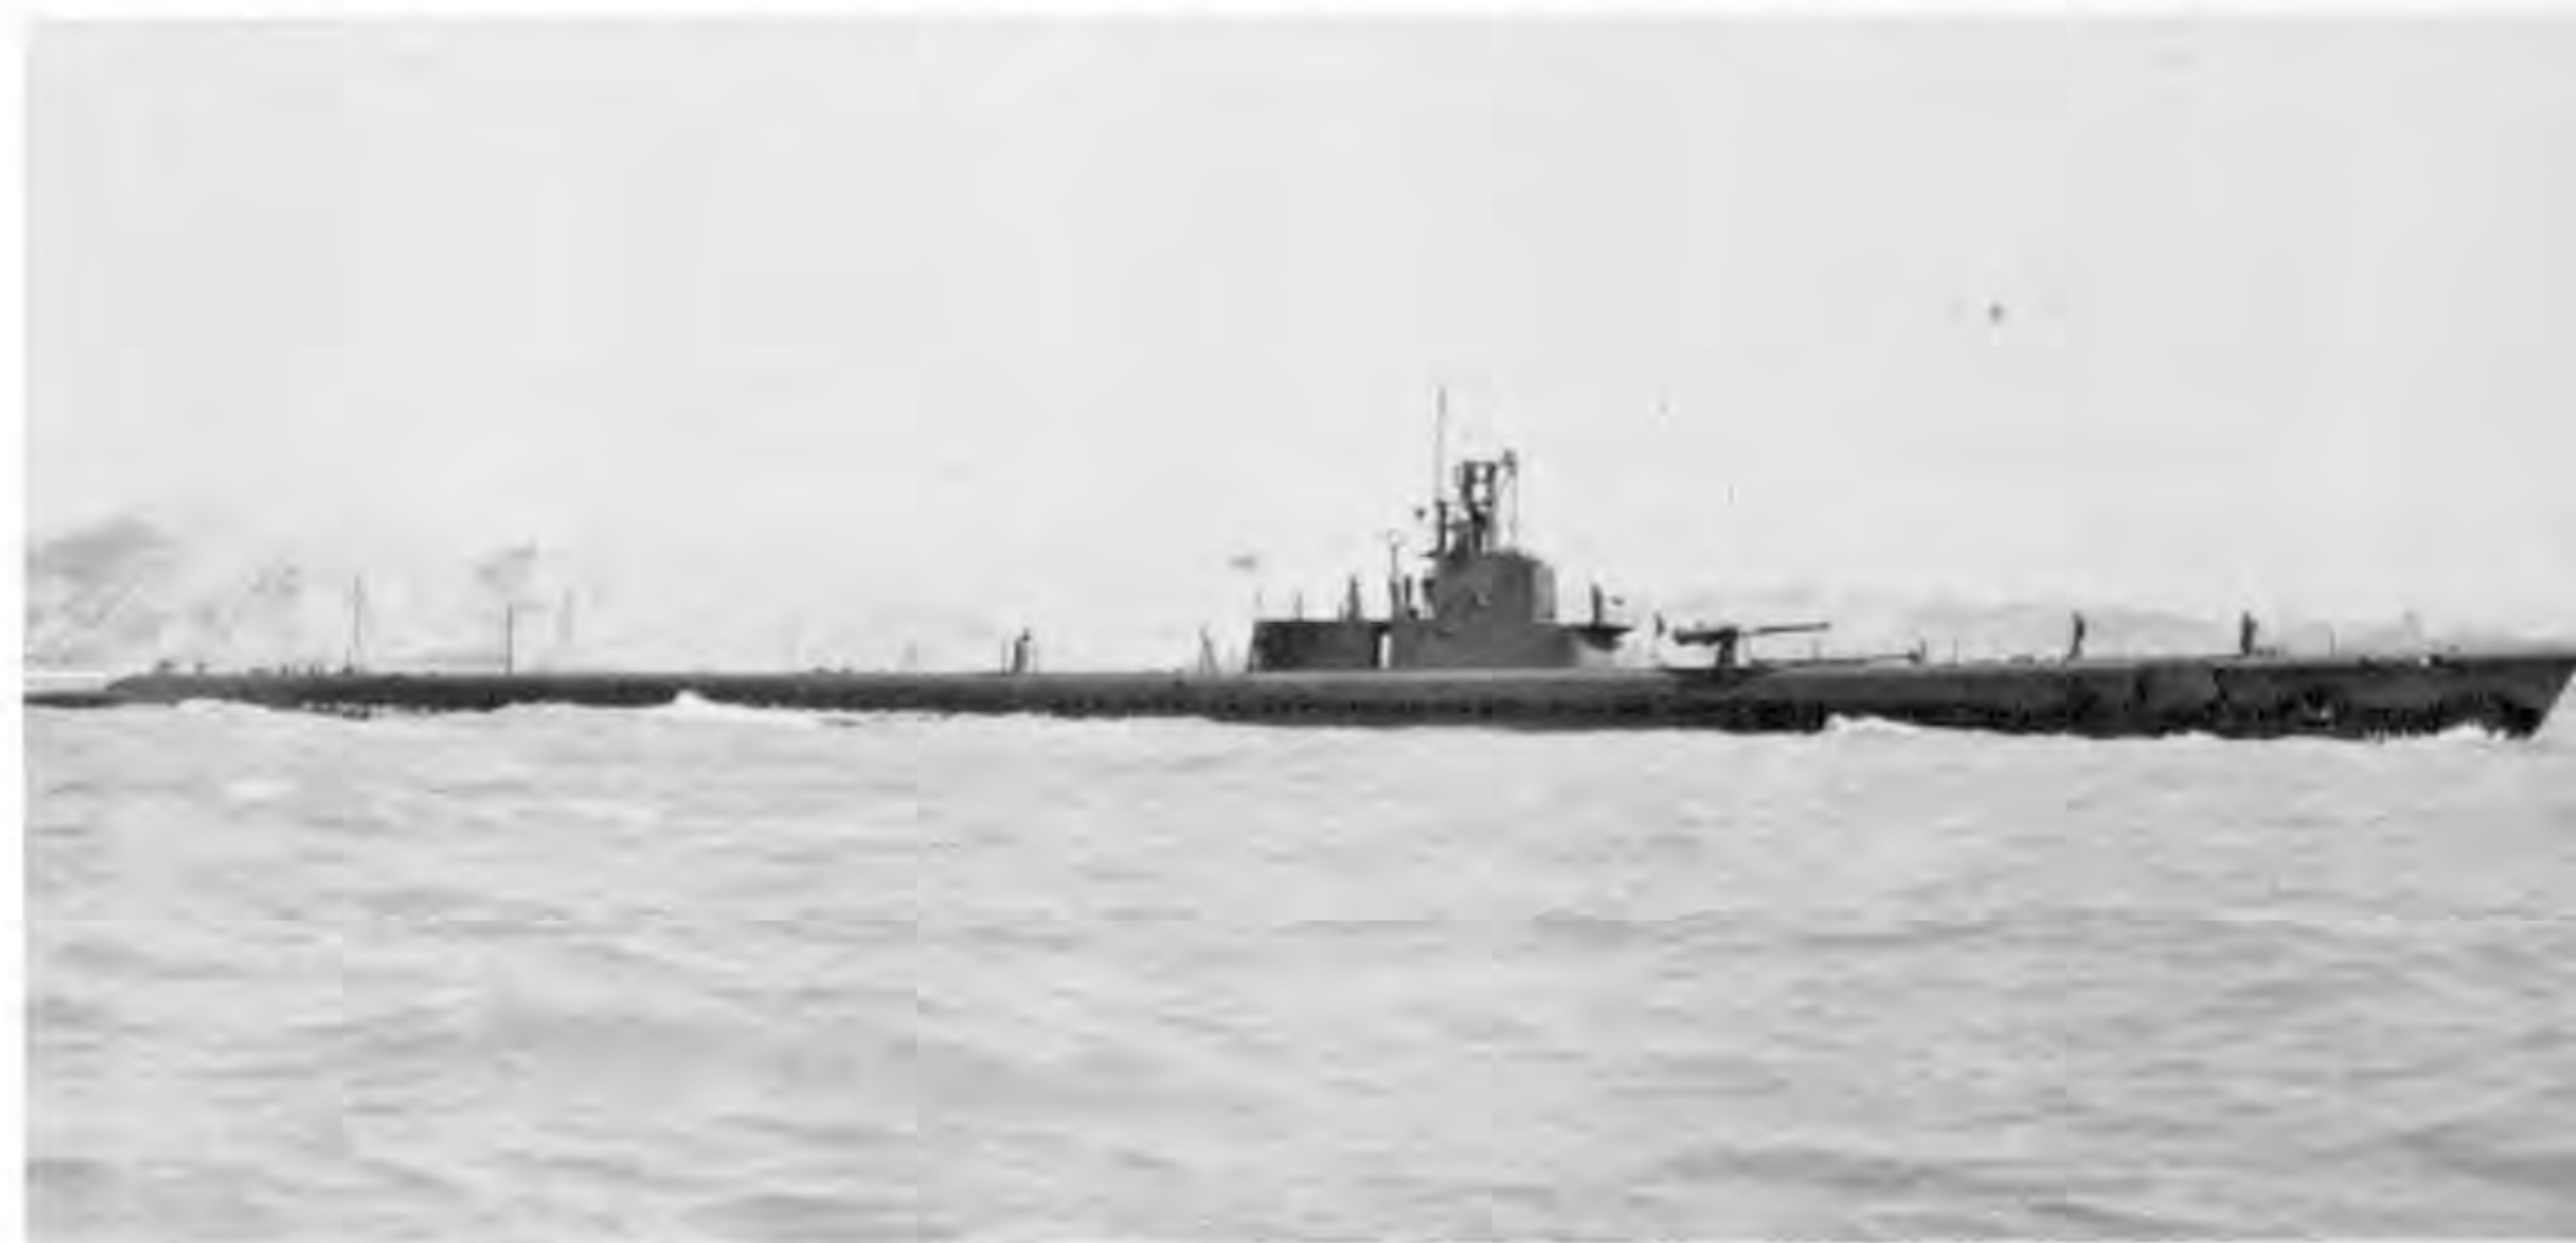
(Above) This view of USS Wahoo (SS238) taken 14 July 1943 shows the first major bridge alteration given to the early fleet-type submarines. A heavier 4"/50 deck gun has been mounted forward and a 20mm has been mounted on the forward and aft bridge platforms (barrels are removed). (Below) Most fleet-type boats finished the war outfitted similar to this 20 July 1945 shot of USS Mingo (SS261), mounting a 5"/25 aft, 40mm on the bridge platforms and in many boats a 20mm was placed over the main gun foundation forward.

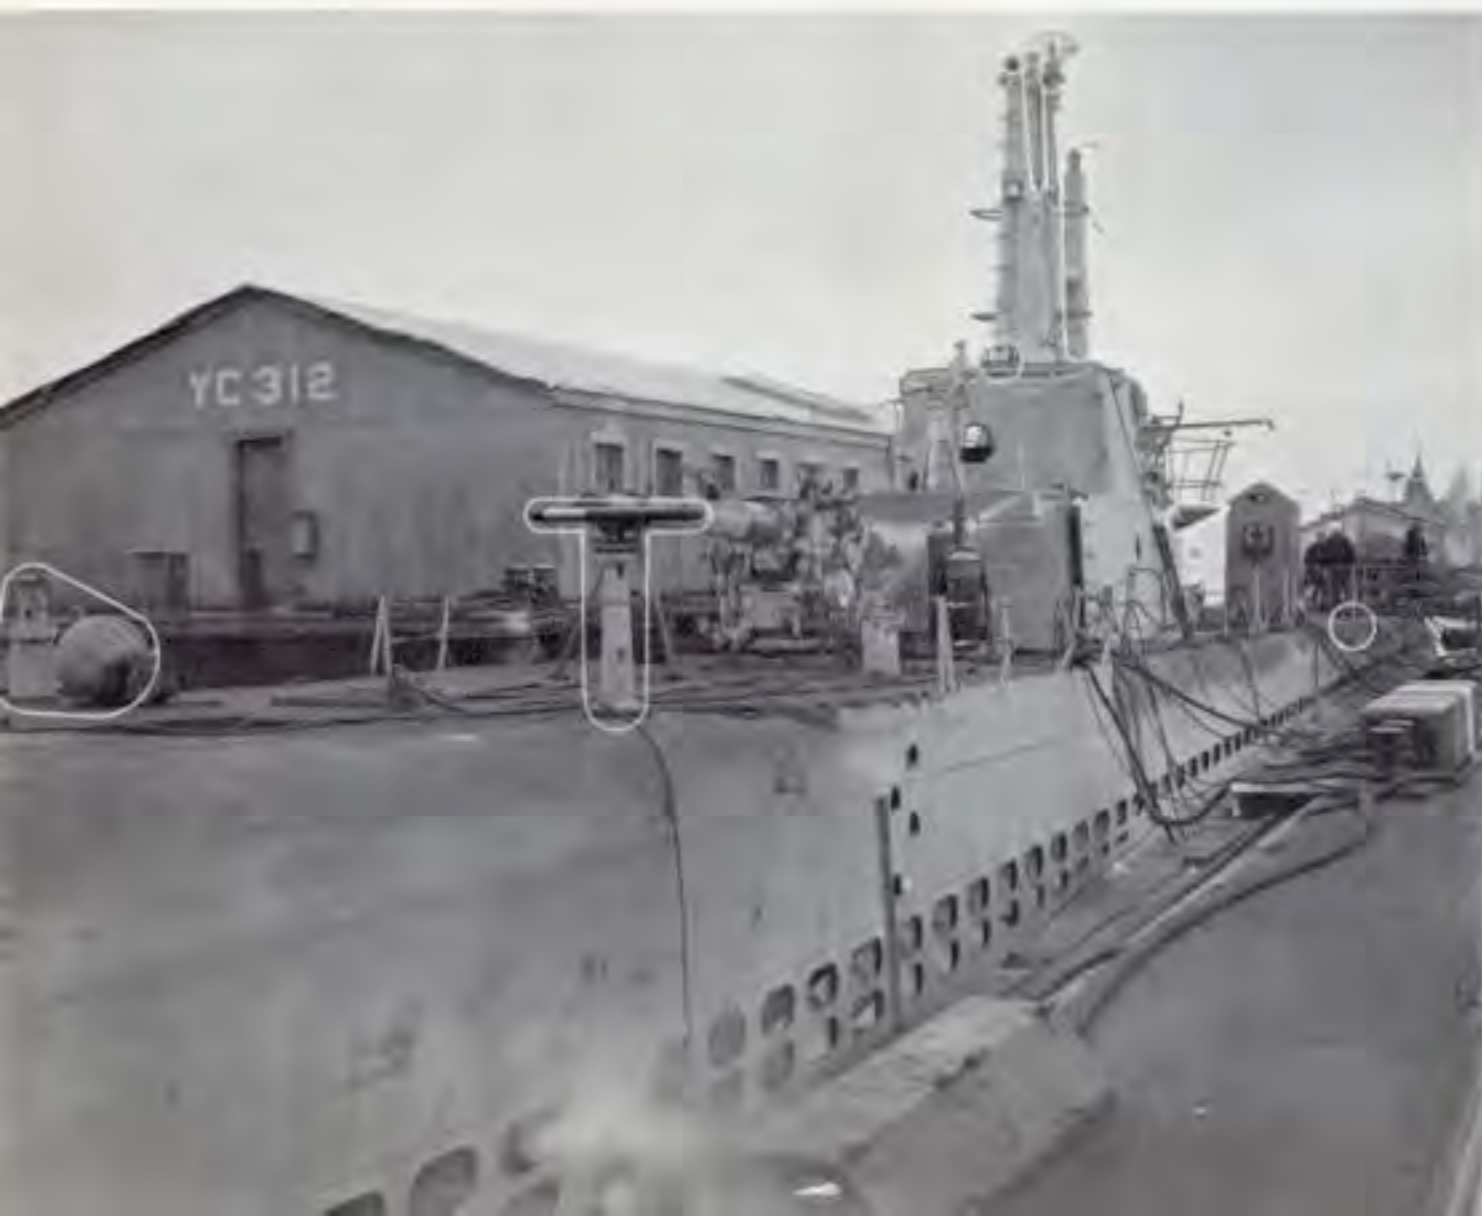
(Left) These photos taken 28 November 1944 at Mare Island show alterations made to *Bowfin* during the overhaul between her 6th and 7th War Patrols.

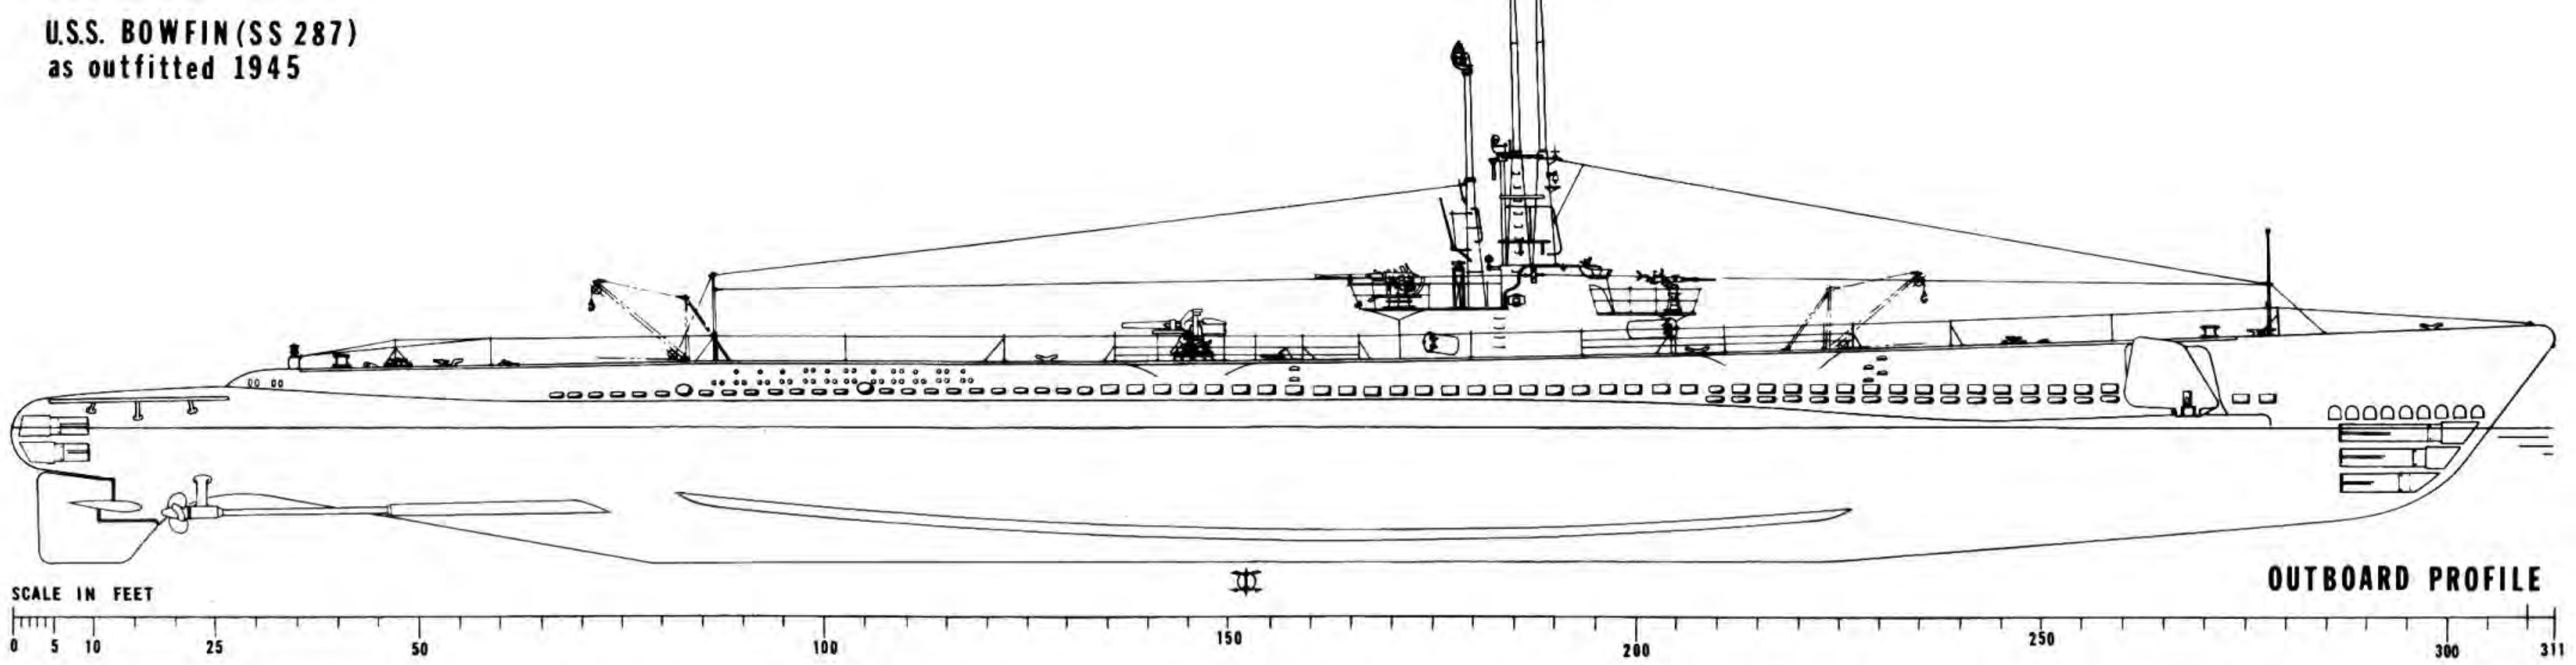
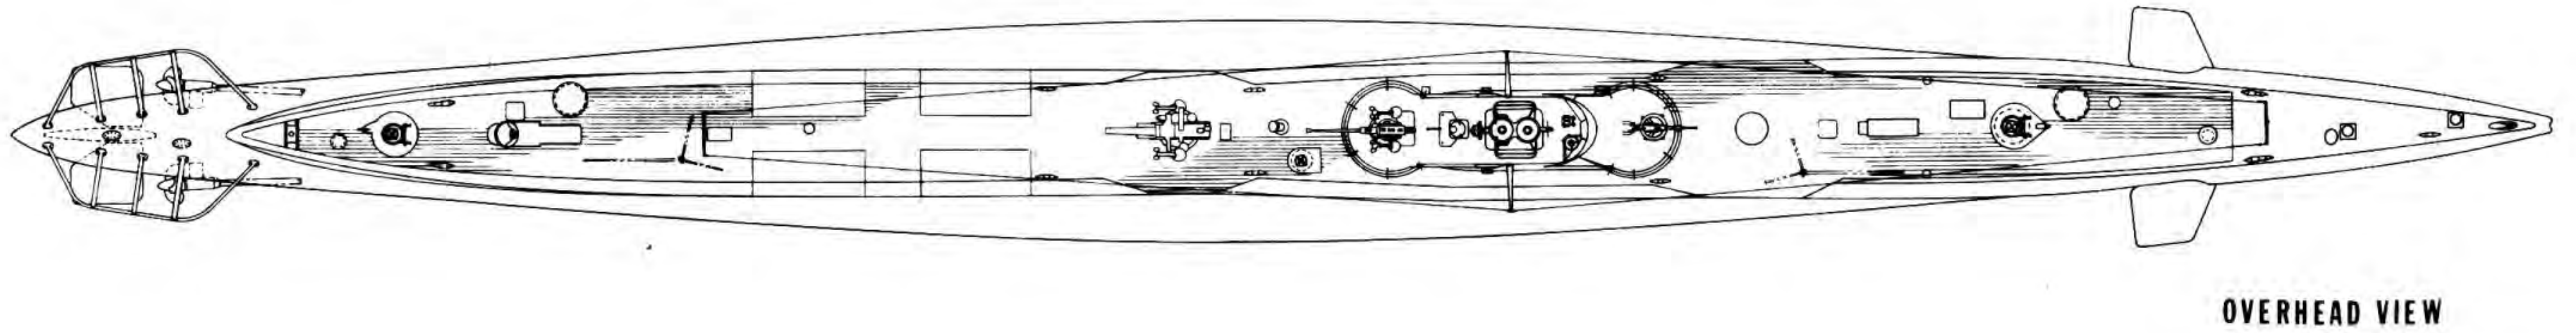
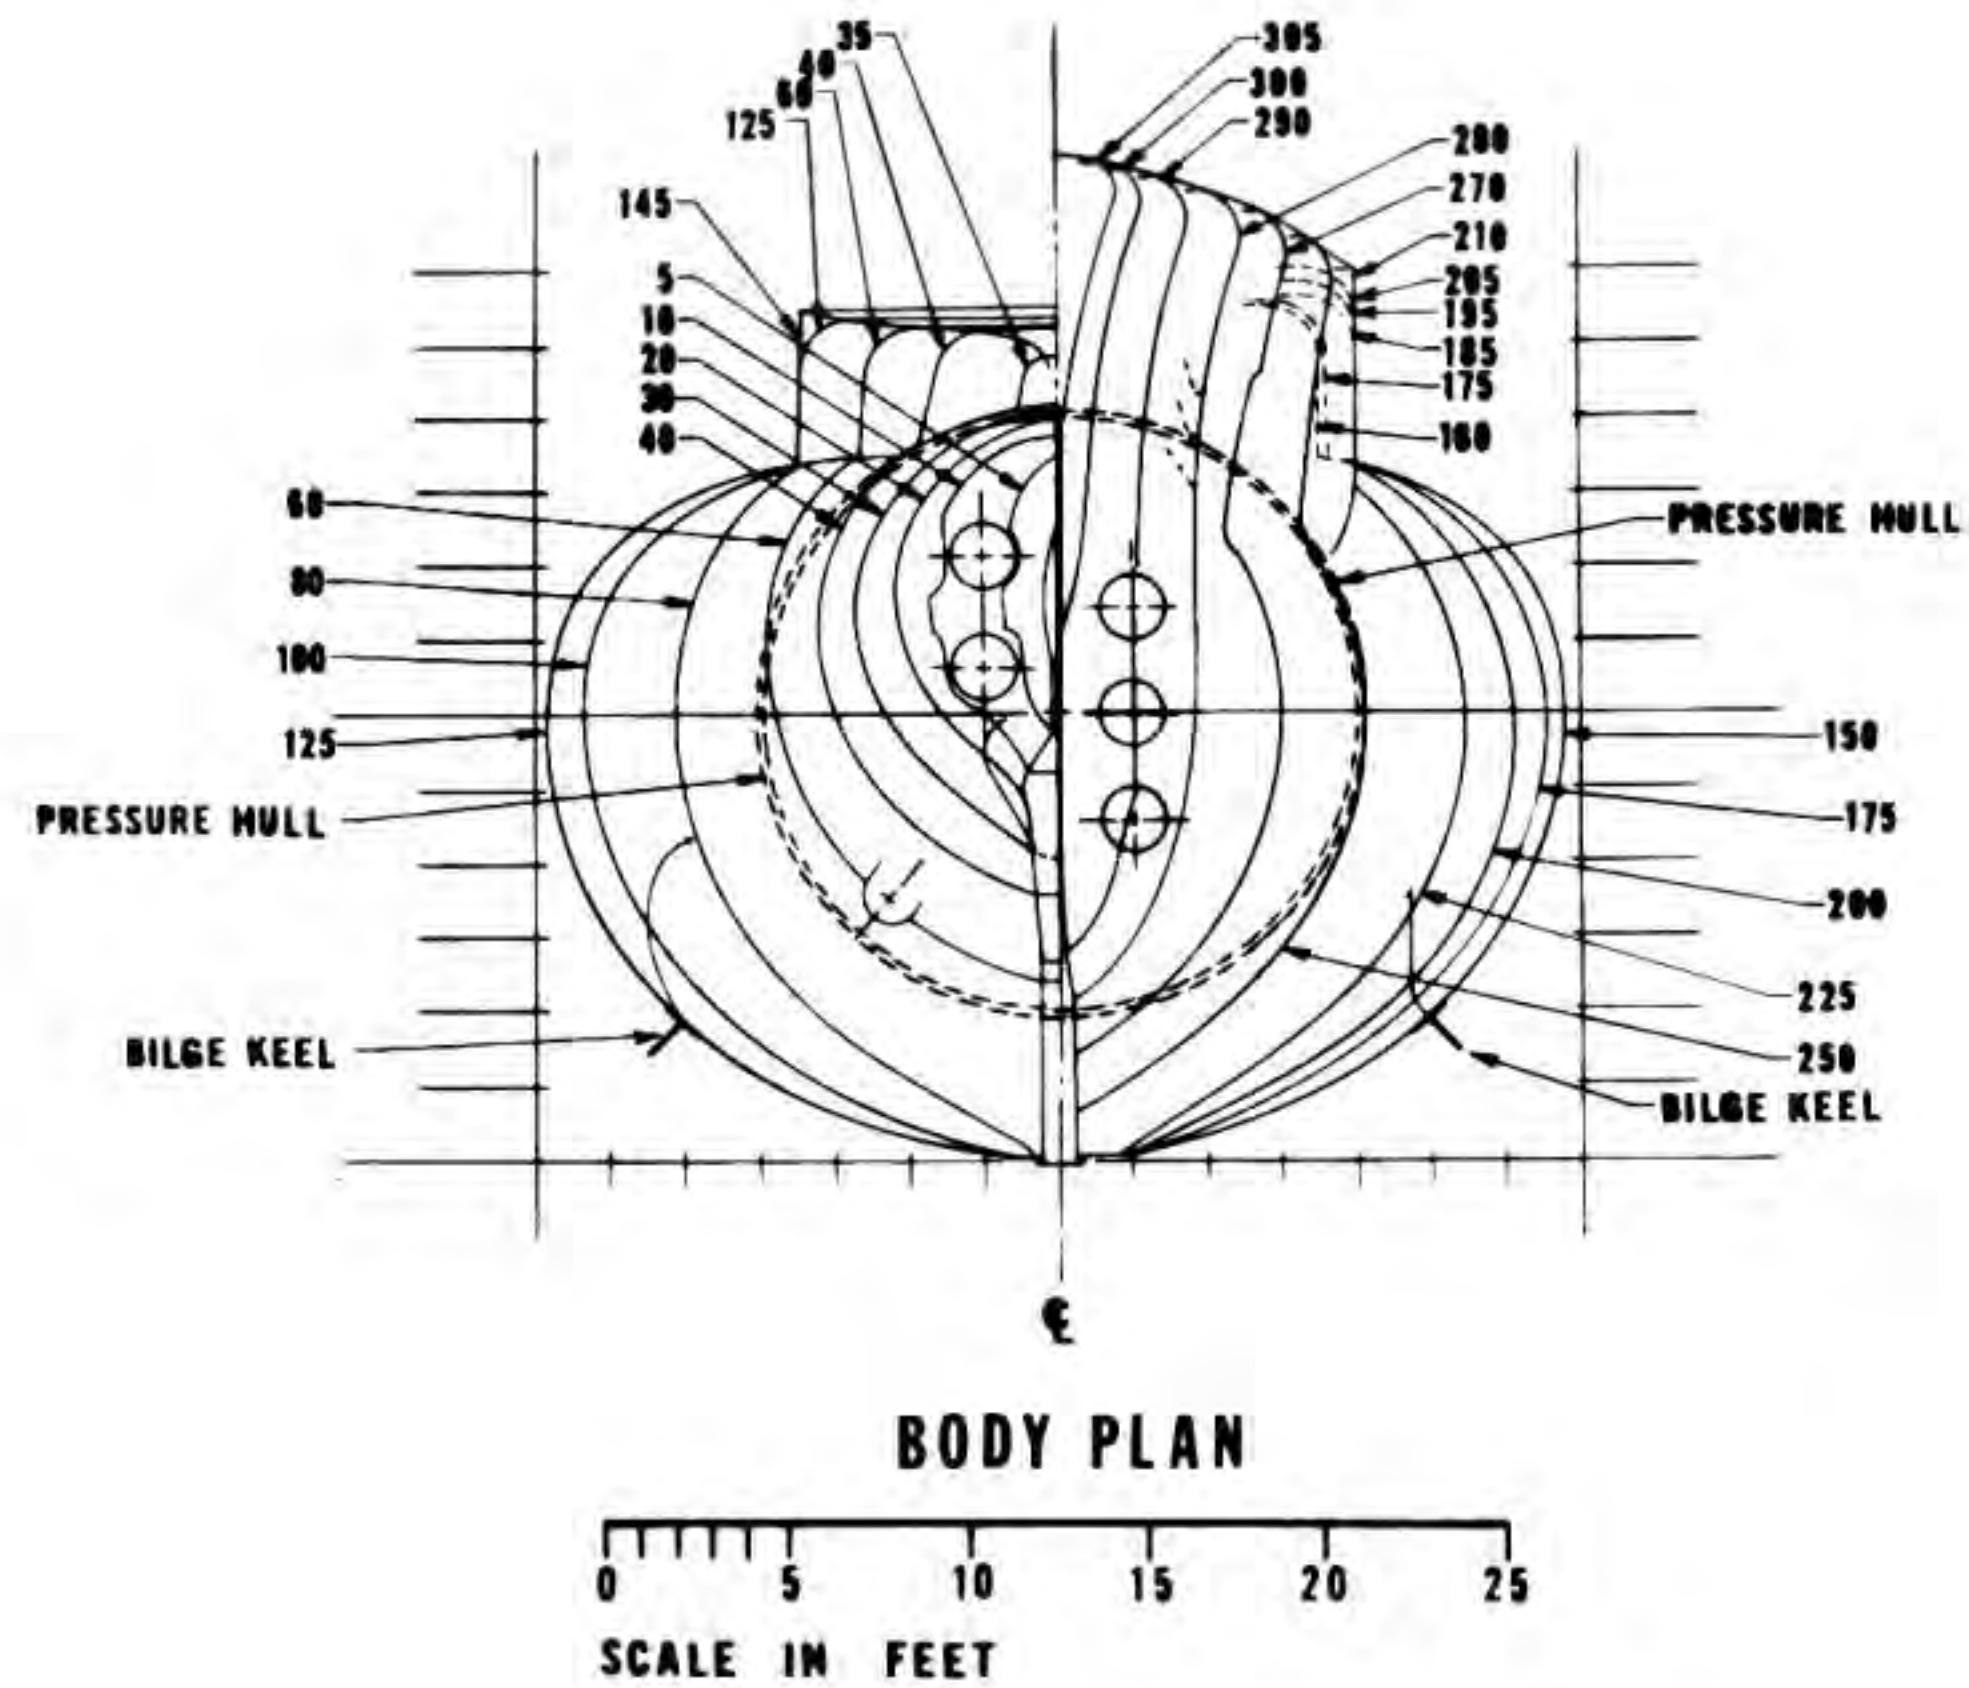
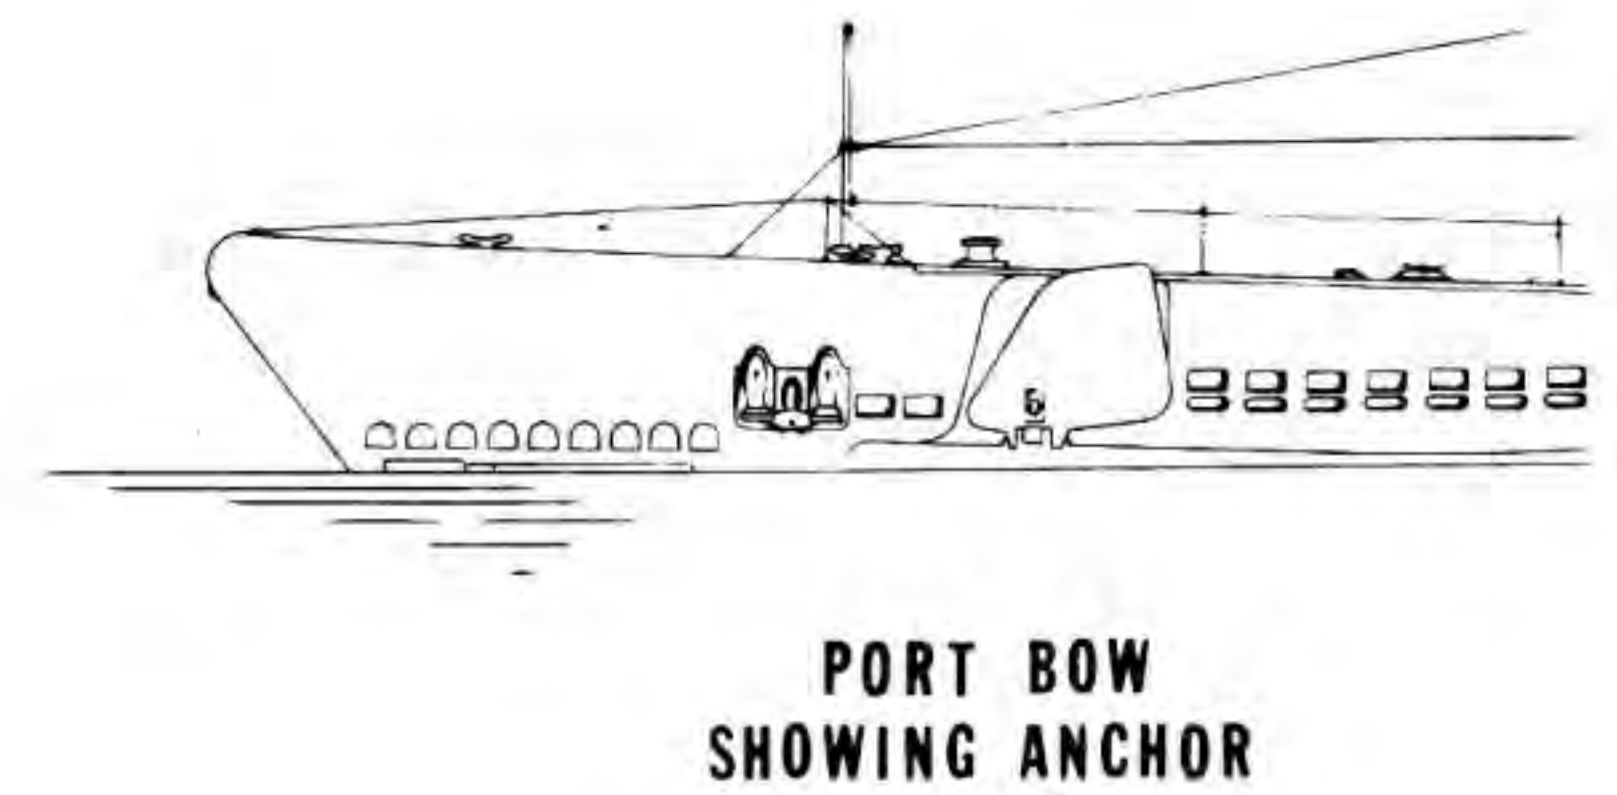
U.S.S. BOWFIN (SS 287)
as outfitted 1945

Bowfin as outfitted during her overhaul at the Mare Island Navy Yard, November, 1944.

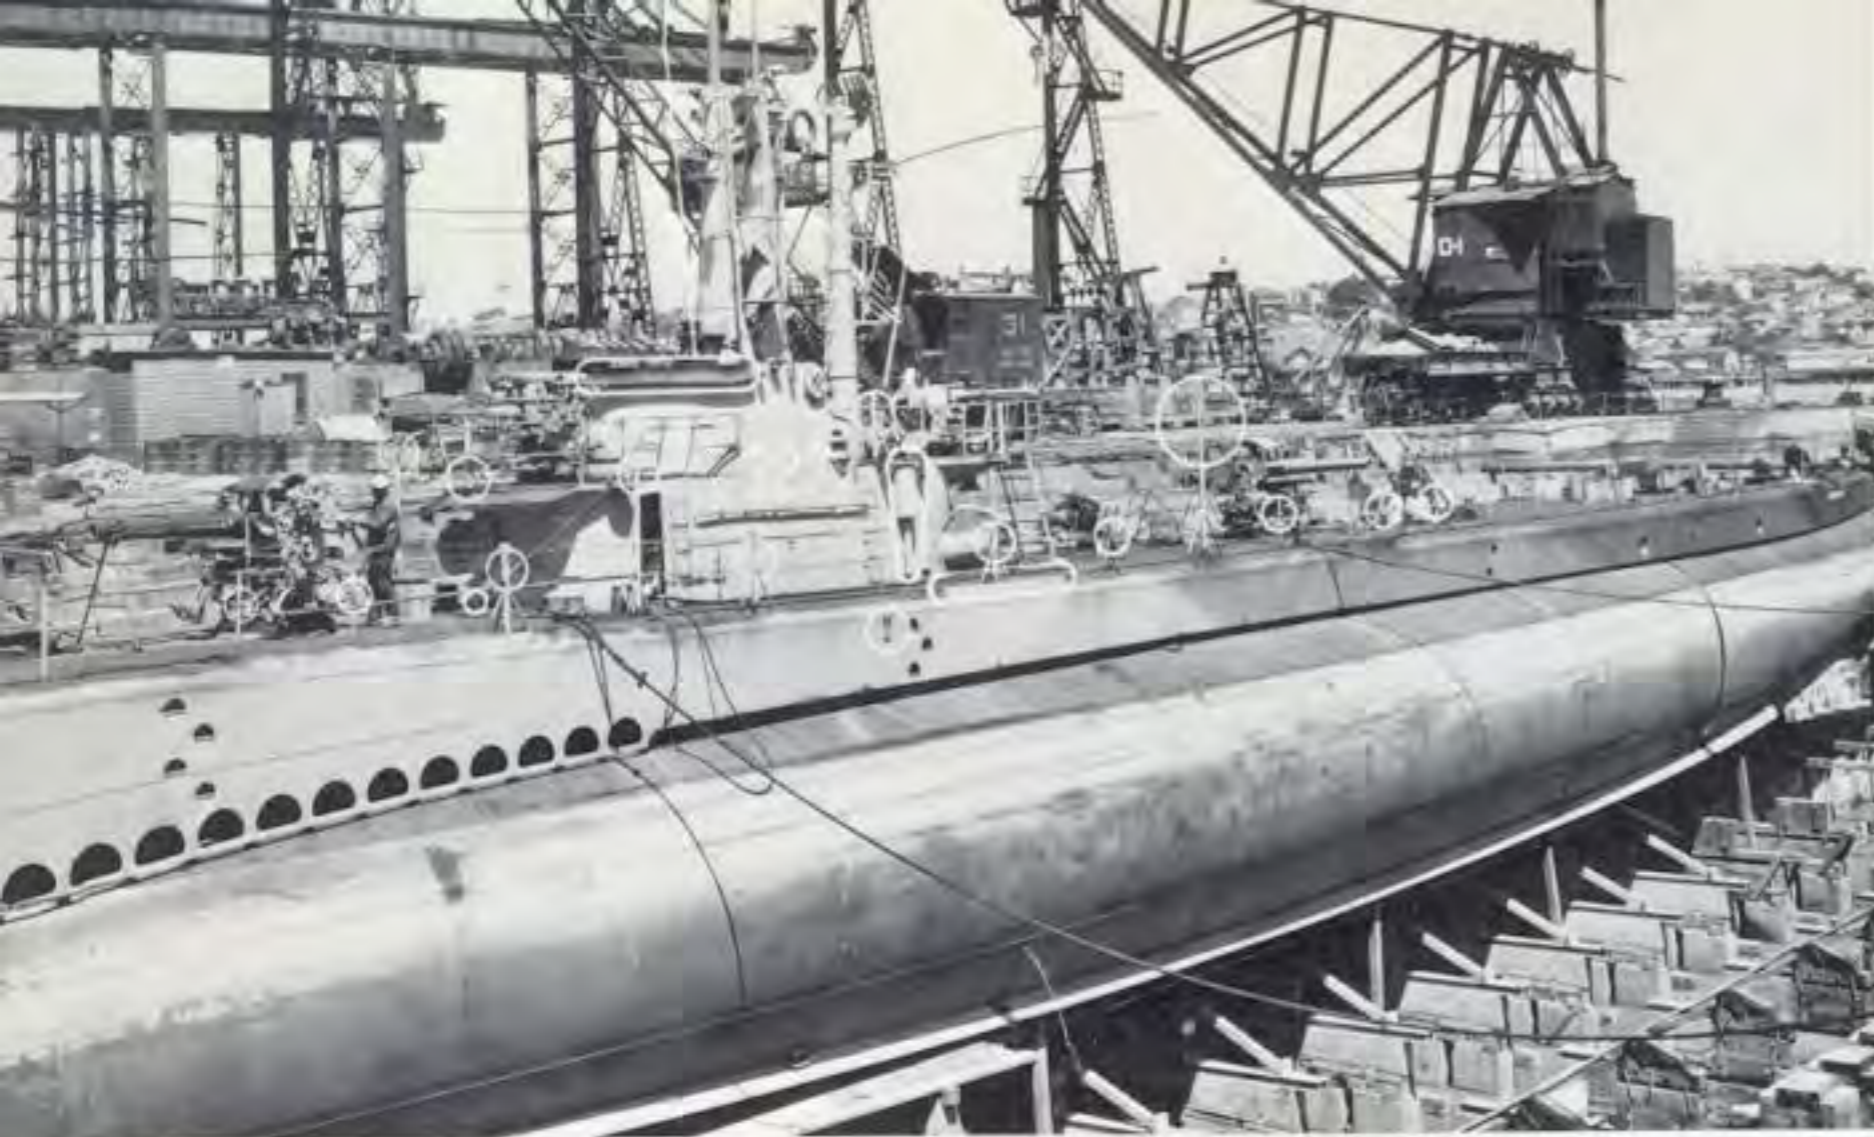
Built by Electric Boat Co., Boarfish displays the full length of her bilge keel and armament is the heaviest used on fleet type boats. Note the method of free flooding the superstructure and how it differs from the Portsmouth designed boats.

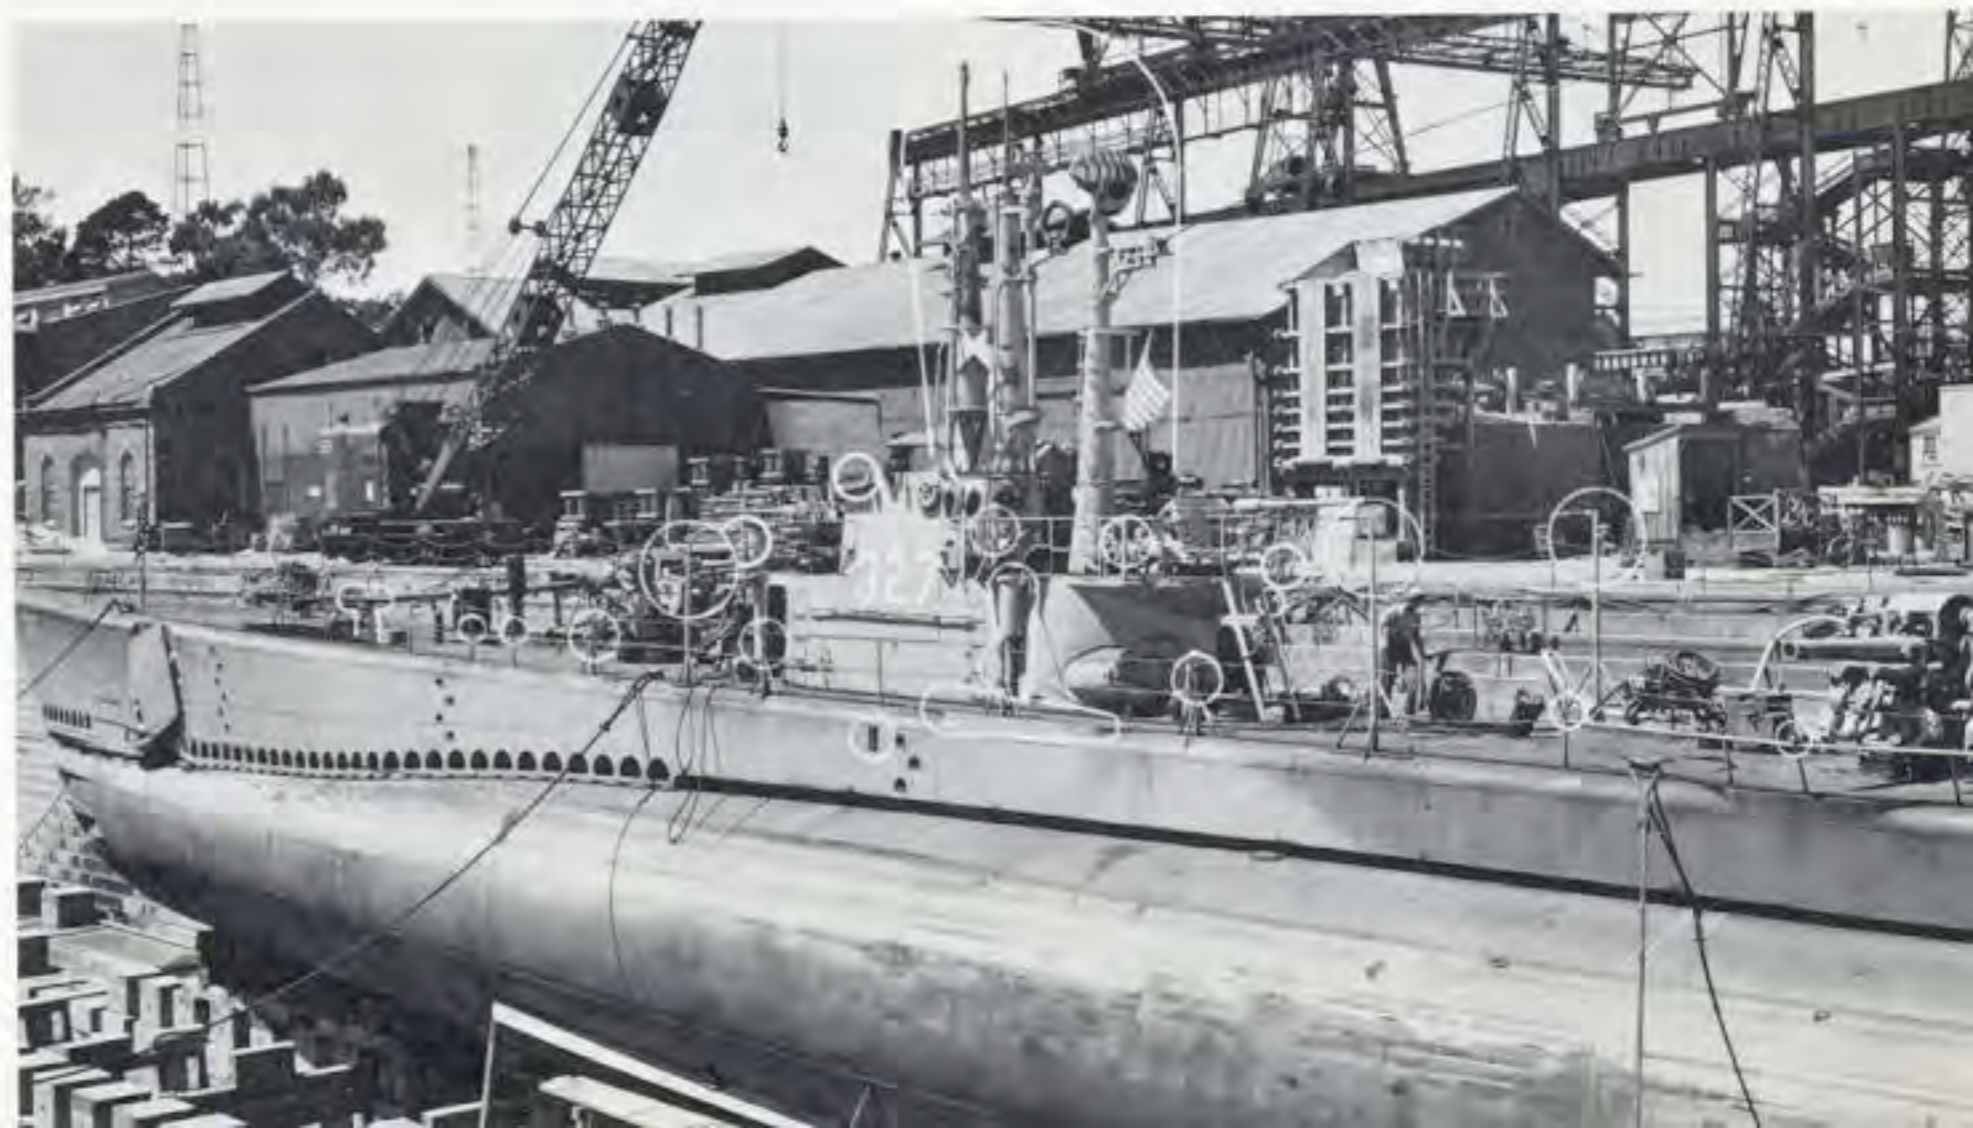
USS Boarfish [SS327] in drydock at Mare Island Naval Shipyard 19 August 1946. External features of the hull show clearly including the shutter doors for the forward torpedo tubes.
