GENERAL DATA

USS BOWFIN (SS287)

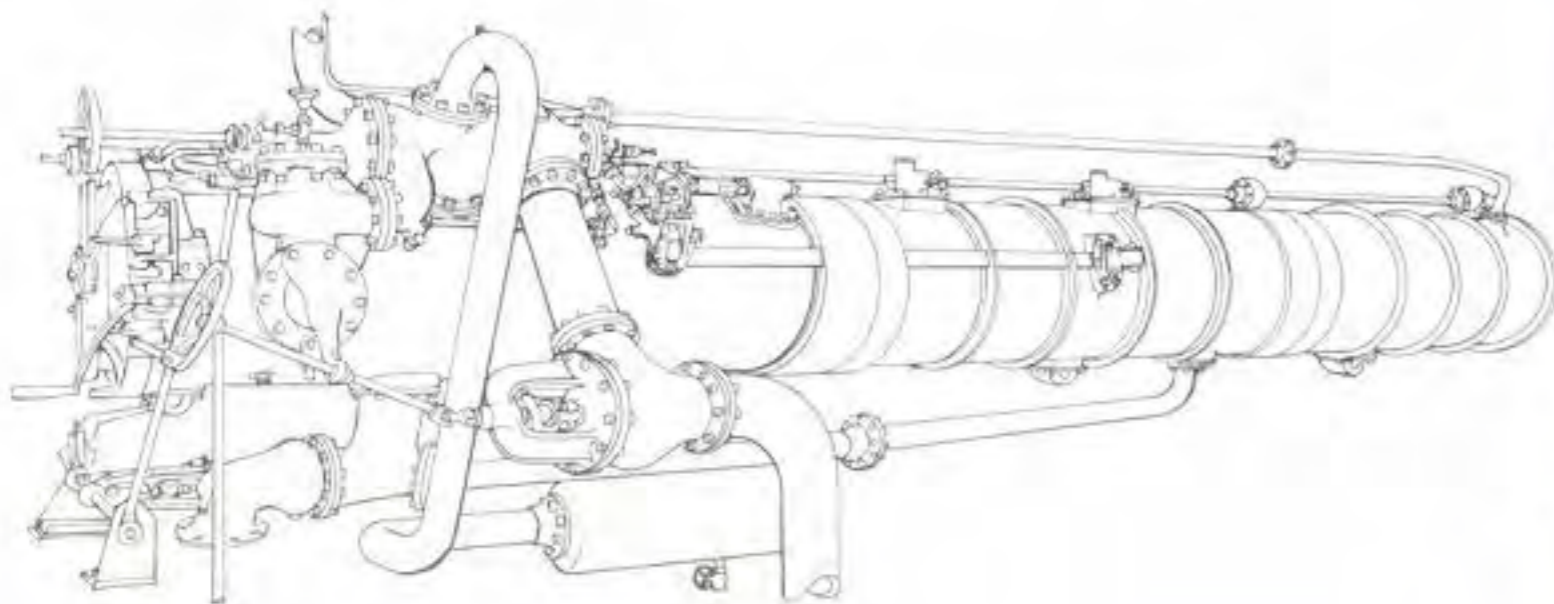
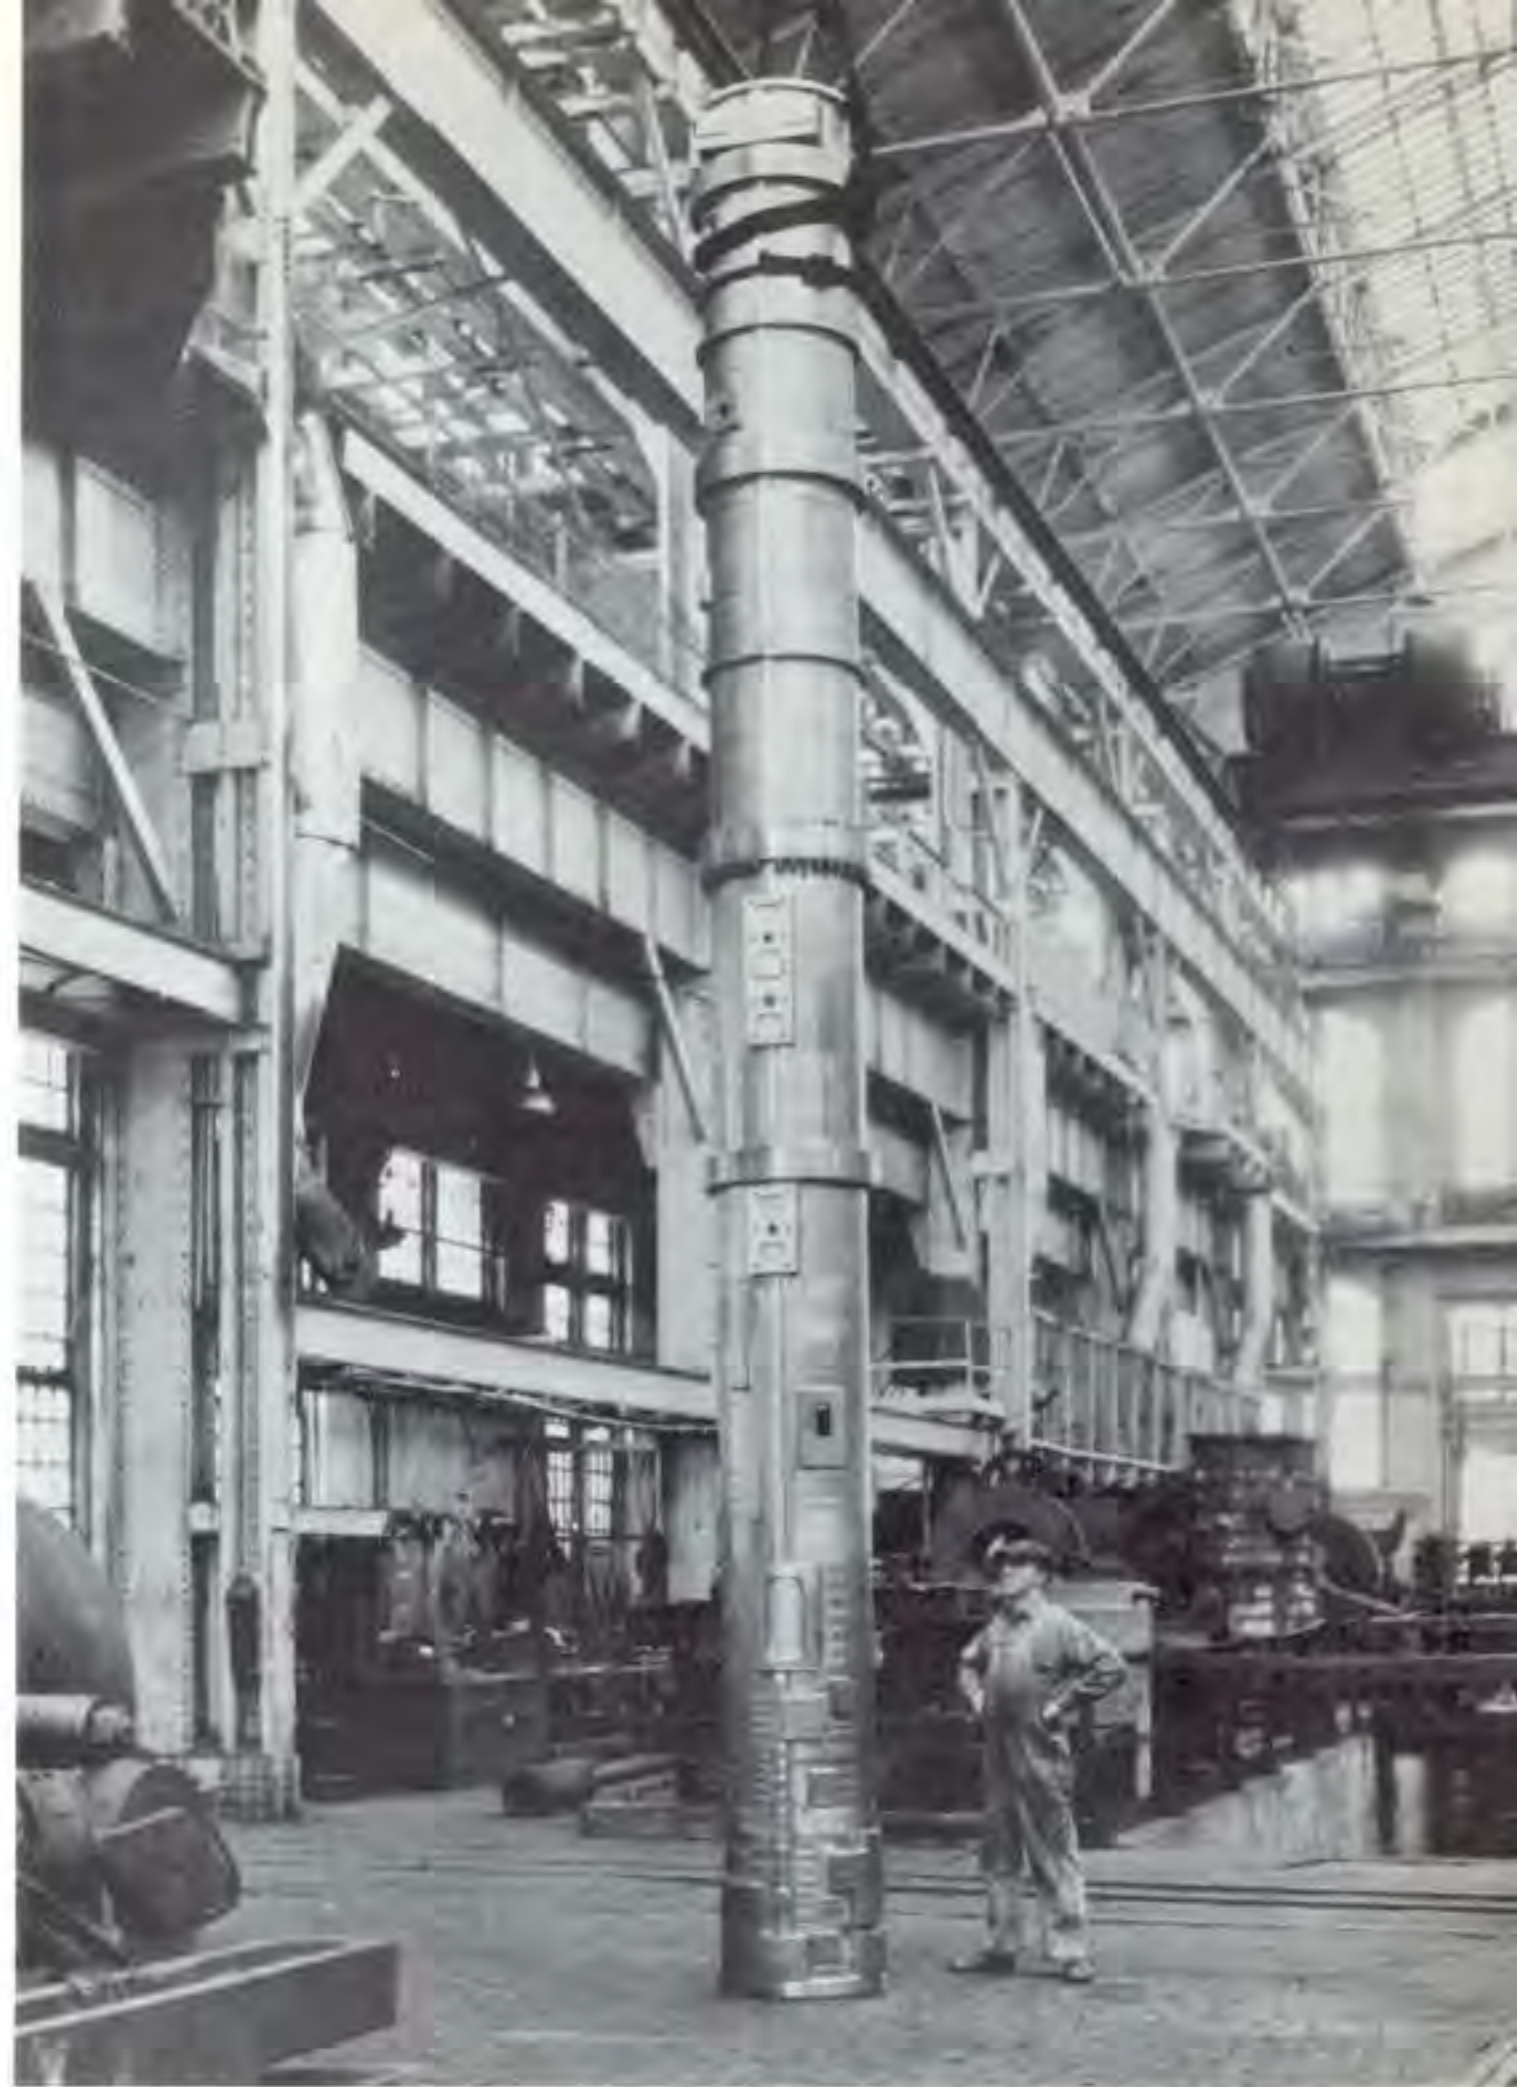
(Left) Perspective view of a 21" submerged torpedo tube (MK32-39). (Above) This corrosion-resisting steel torpedo tube was fabricated by the Midvale Steel Co. The massive size of a submarine torpedo tube is evident from the workman standing alongside.

Actually the operation of firing a torpedo is somewhat more complex. An interlock prevents the possibility of the breech and muzzle doors being open at the same time, thus when the breech is open for loading the muzzle doors must resist full sea pressure. After loading the tube the remaining volume of air is displaced with water from the WRT tank and vented into the submarine. Each tube is equipped with an equalizing line, which when vented to the sea, equalizes the pressure inside the tube with that of the sea water outside the boat. Now the muzzle door can be opened and the torpedo fired. The shot of compressed air which expels the torpedo from the tube is not large enough to fill the tube completely and is vented off inside the boat before it has a chance to escape and betray the position of the submarine. As the torpedo leaves the tube, outside sea water floods the cavity and assists in the venting off of the firing air. The muzzle door can now be closed. The water in the tube is drained to the WRT tank with the excess volume overflowing into the trim tank (each WRT tank had enough capacity to flood three tubes after they were loaded, and boats always began patrols with these tanks full). A torpedo had approximately neutral buoyancy, therefore, the weight of the boat before and after the firing of torpedoes remained the same.

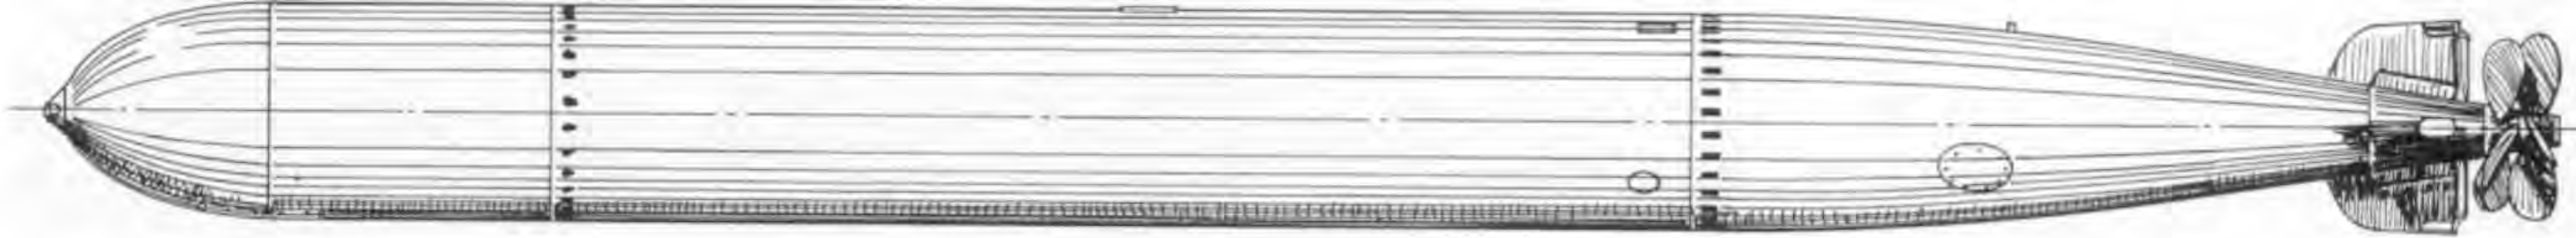
The MK14 Torpedo had four sections; warhead, air flask section, after body and tail. It measured 21" in diameter and 20 feet 6 inches overall length (see BALLISTIC DATA table for statistics).

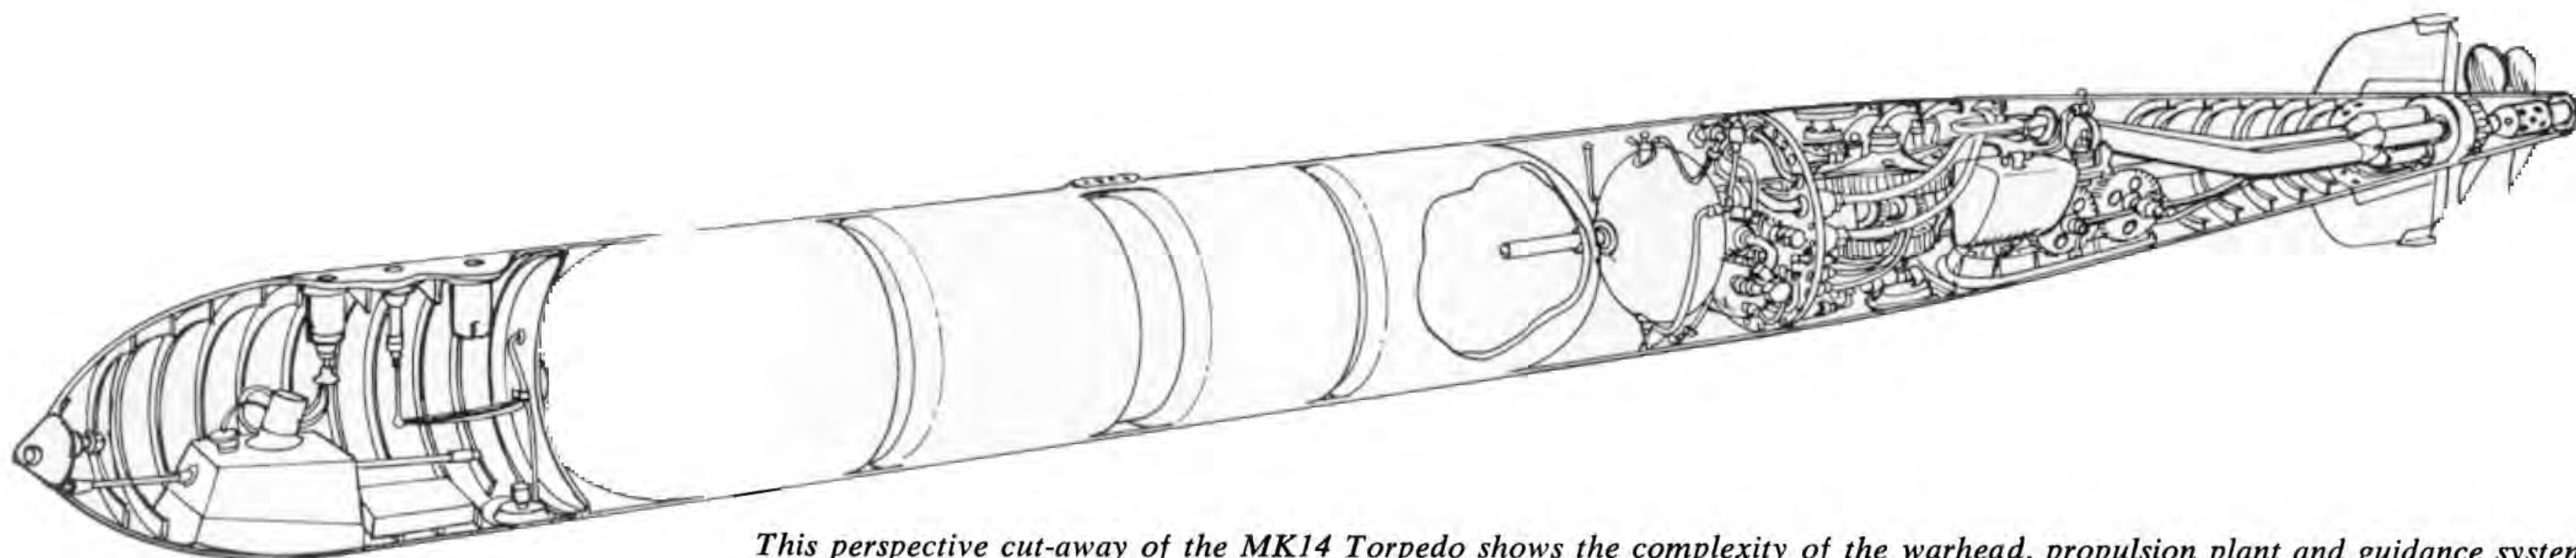
This perspective cut-away of the MK14 Torpedo shows the complexity of the warhead, propulsion plant and guidance system.

Basically, three torpedoes were used by U.S. submarines during World War II—the Mark 10, 14 and 18, of which the Mark 14 was the most widely used. Although some older models were converted early in the war, and a few new models were introduced near the end, none were used sufficiently to make realistic evaluations possible. (See BALLISTIC DATA table for torpedo data).

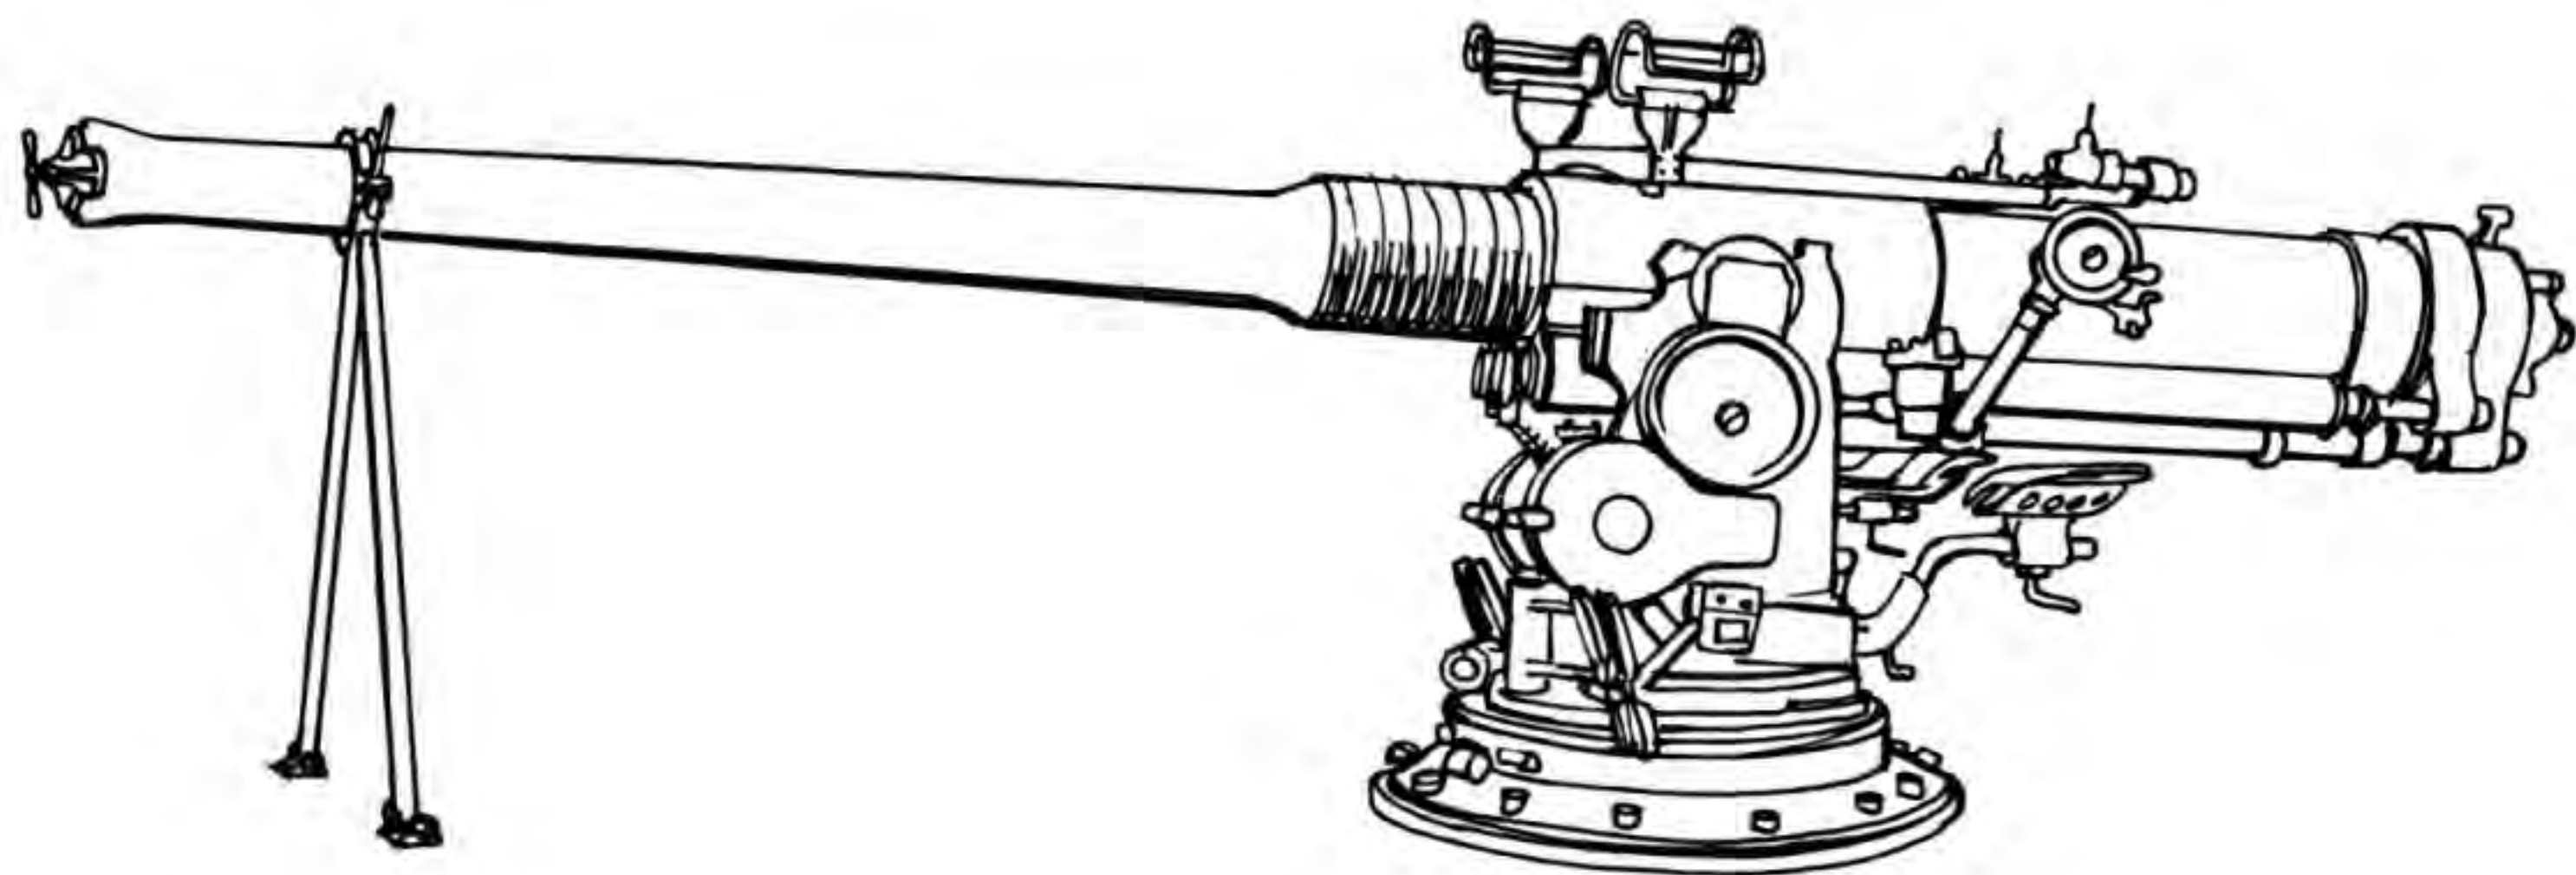
The 4"/50 cal. MK12 deck gun mount (see BALLISTIC DATA table for complete data).

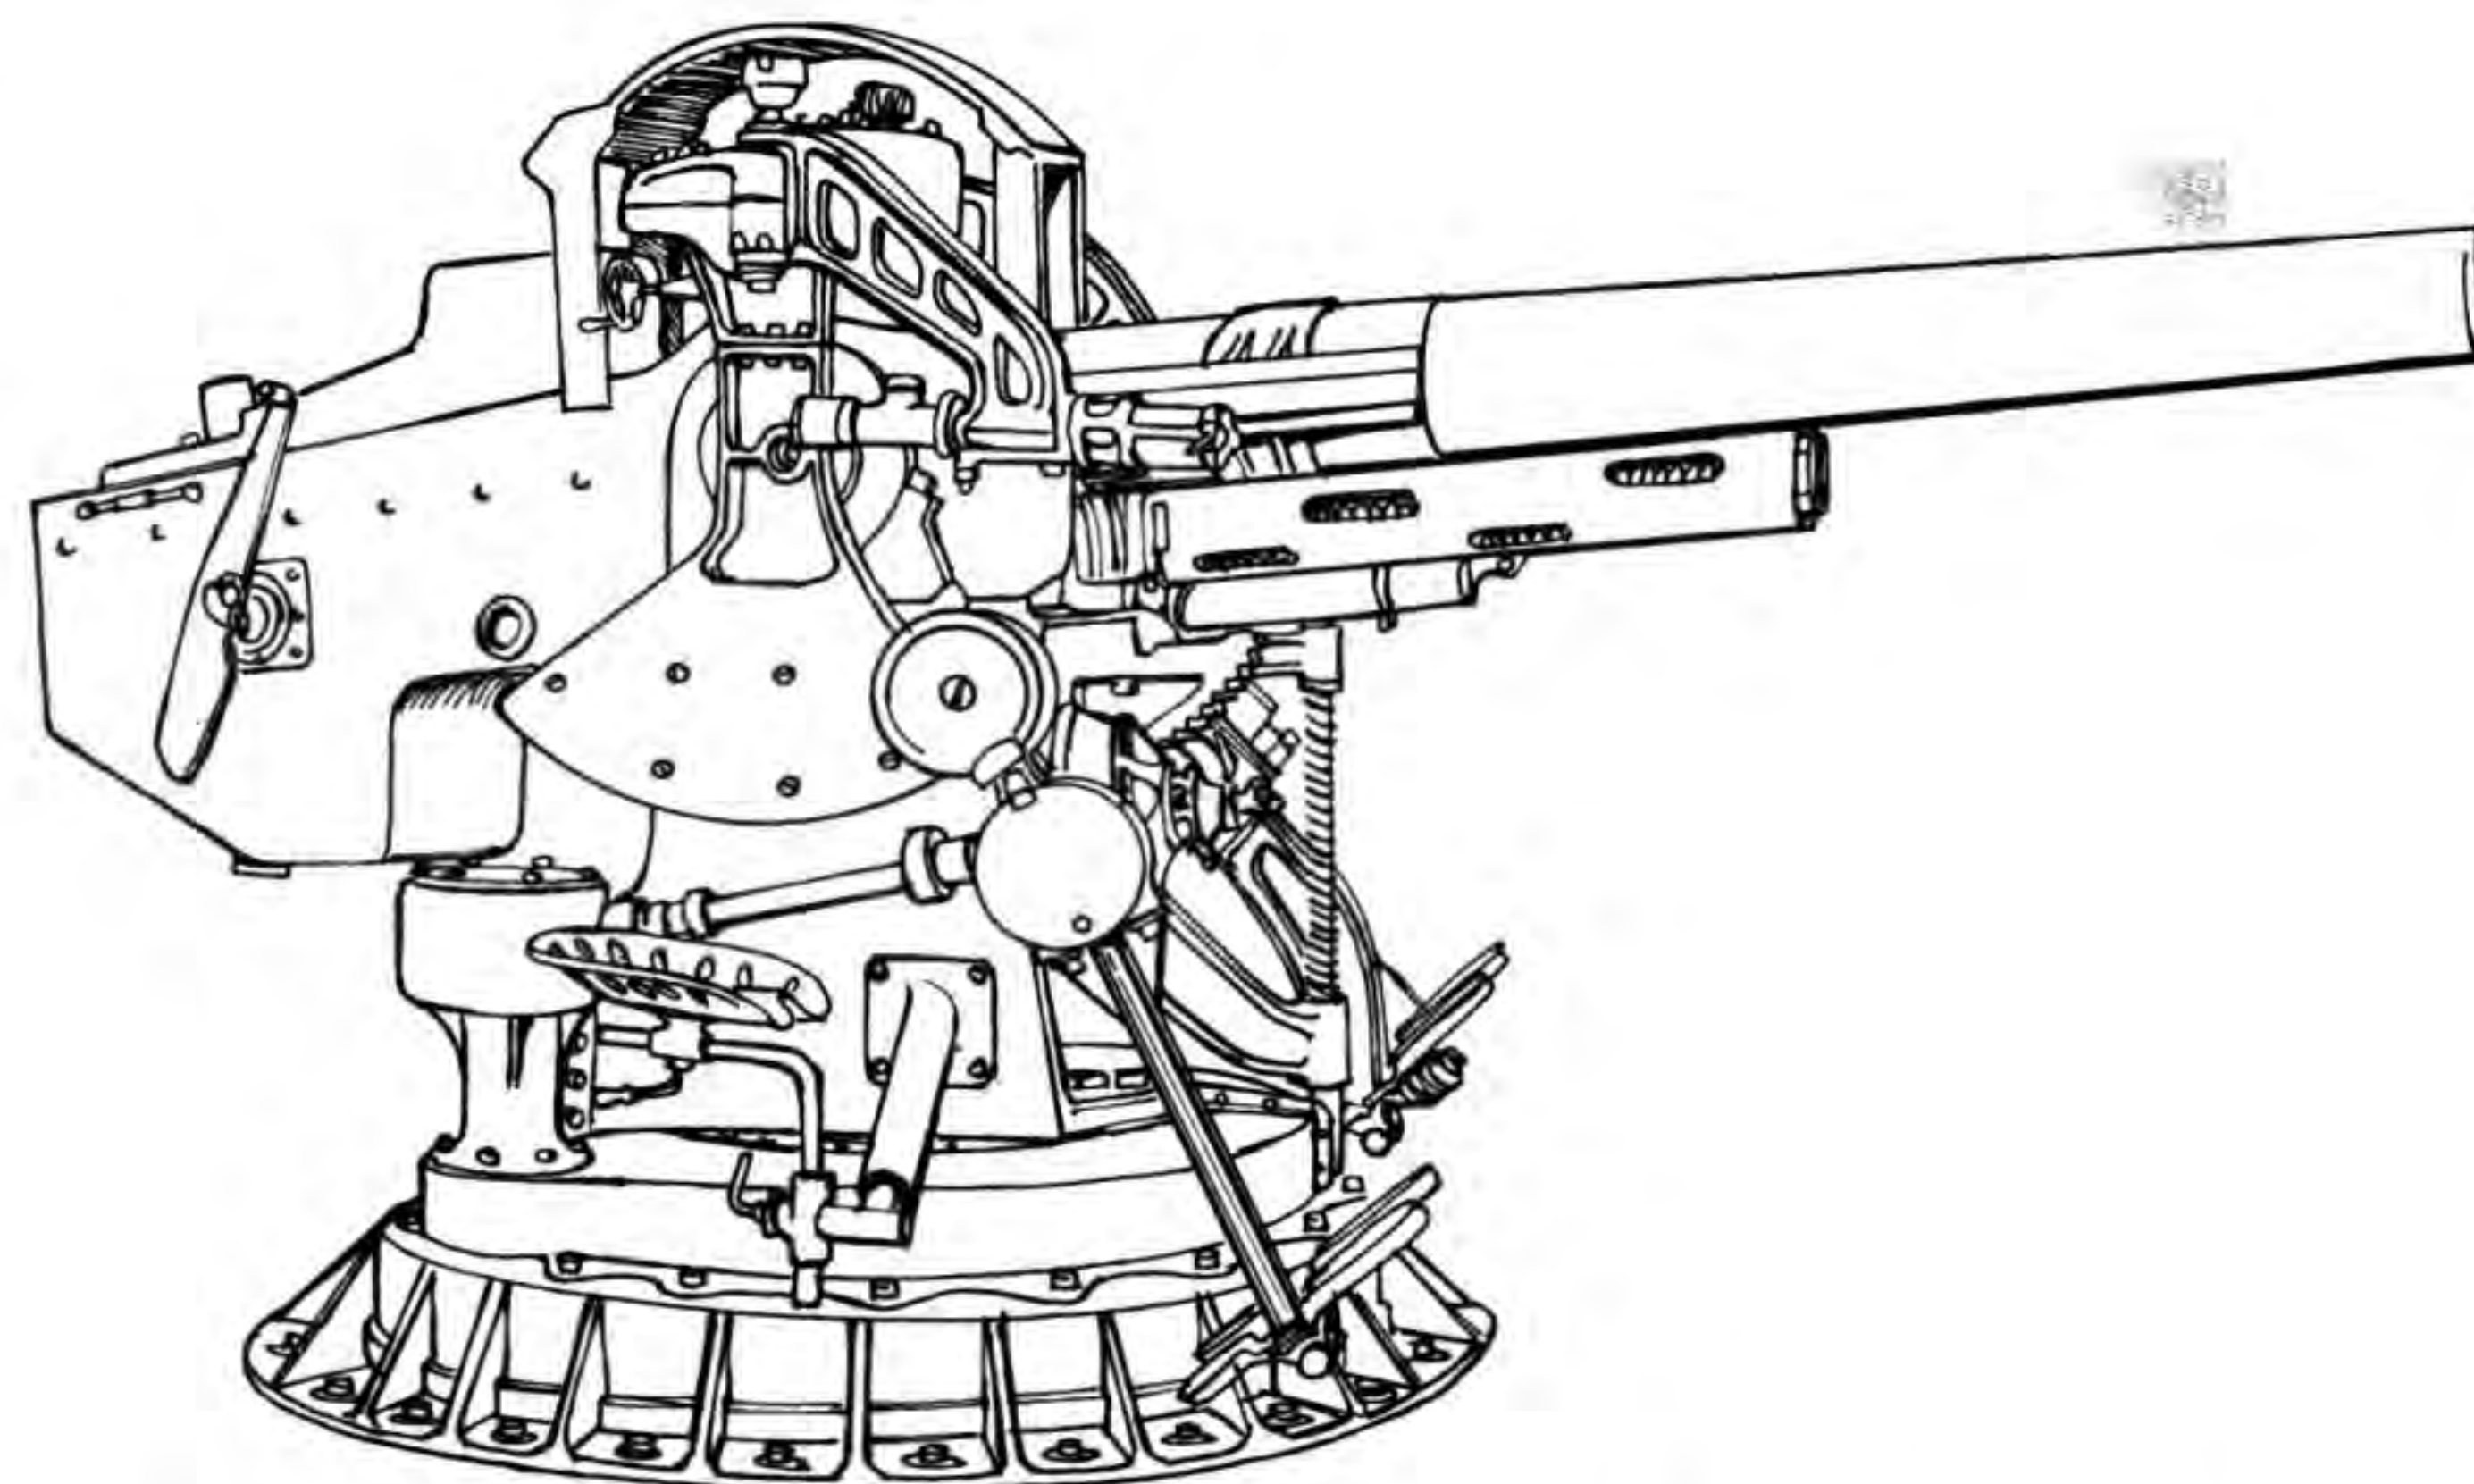
The 5"/25 cal. MK40 deck gun mount (see BALLISTIC DATA table for complete data).

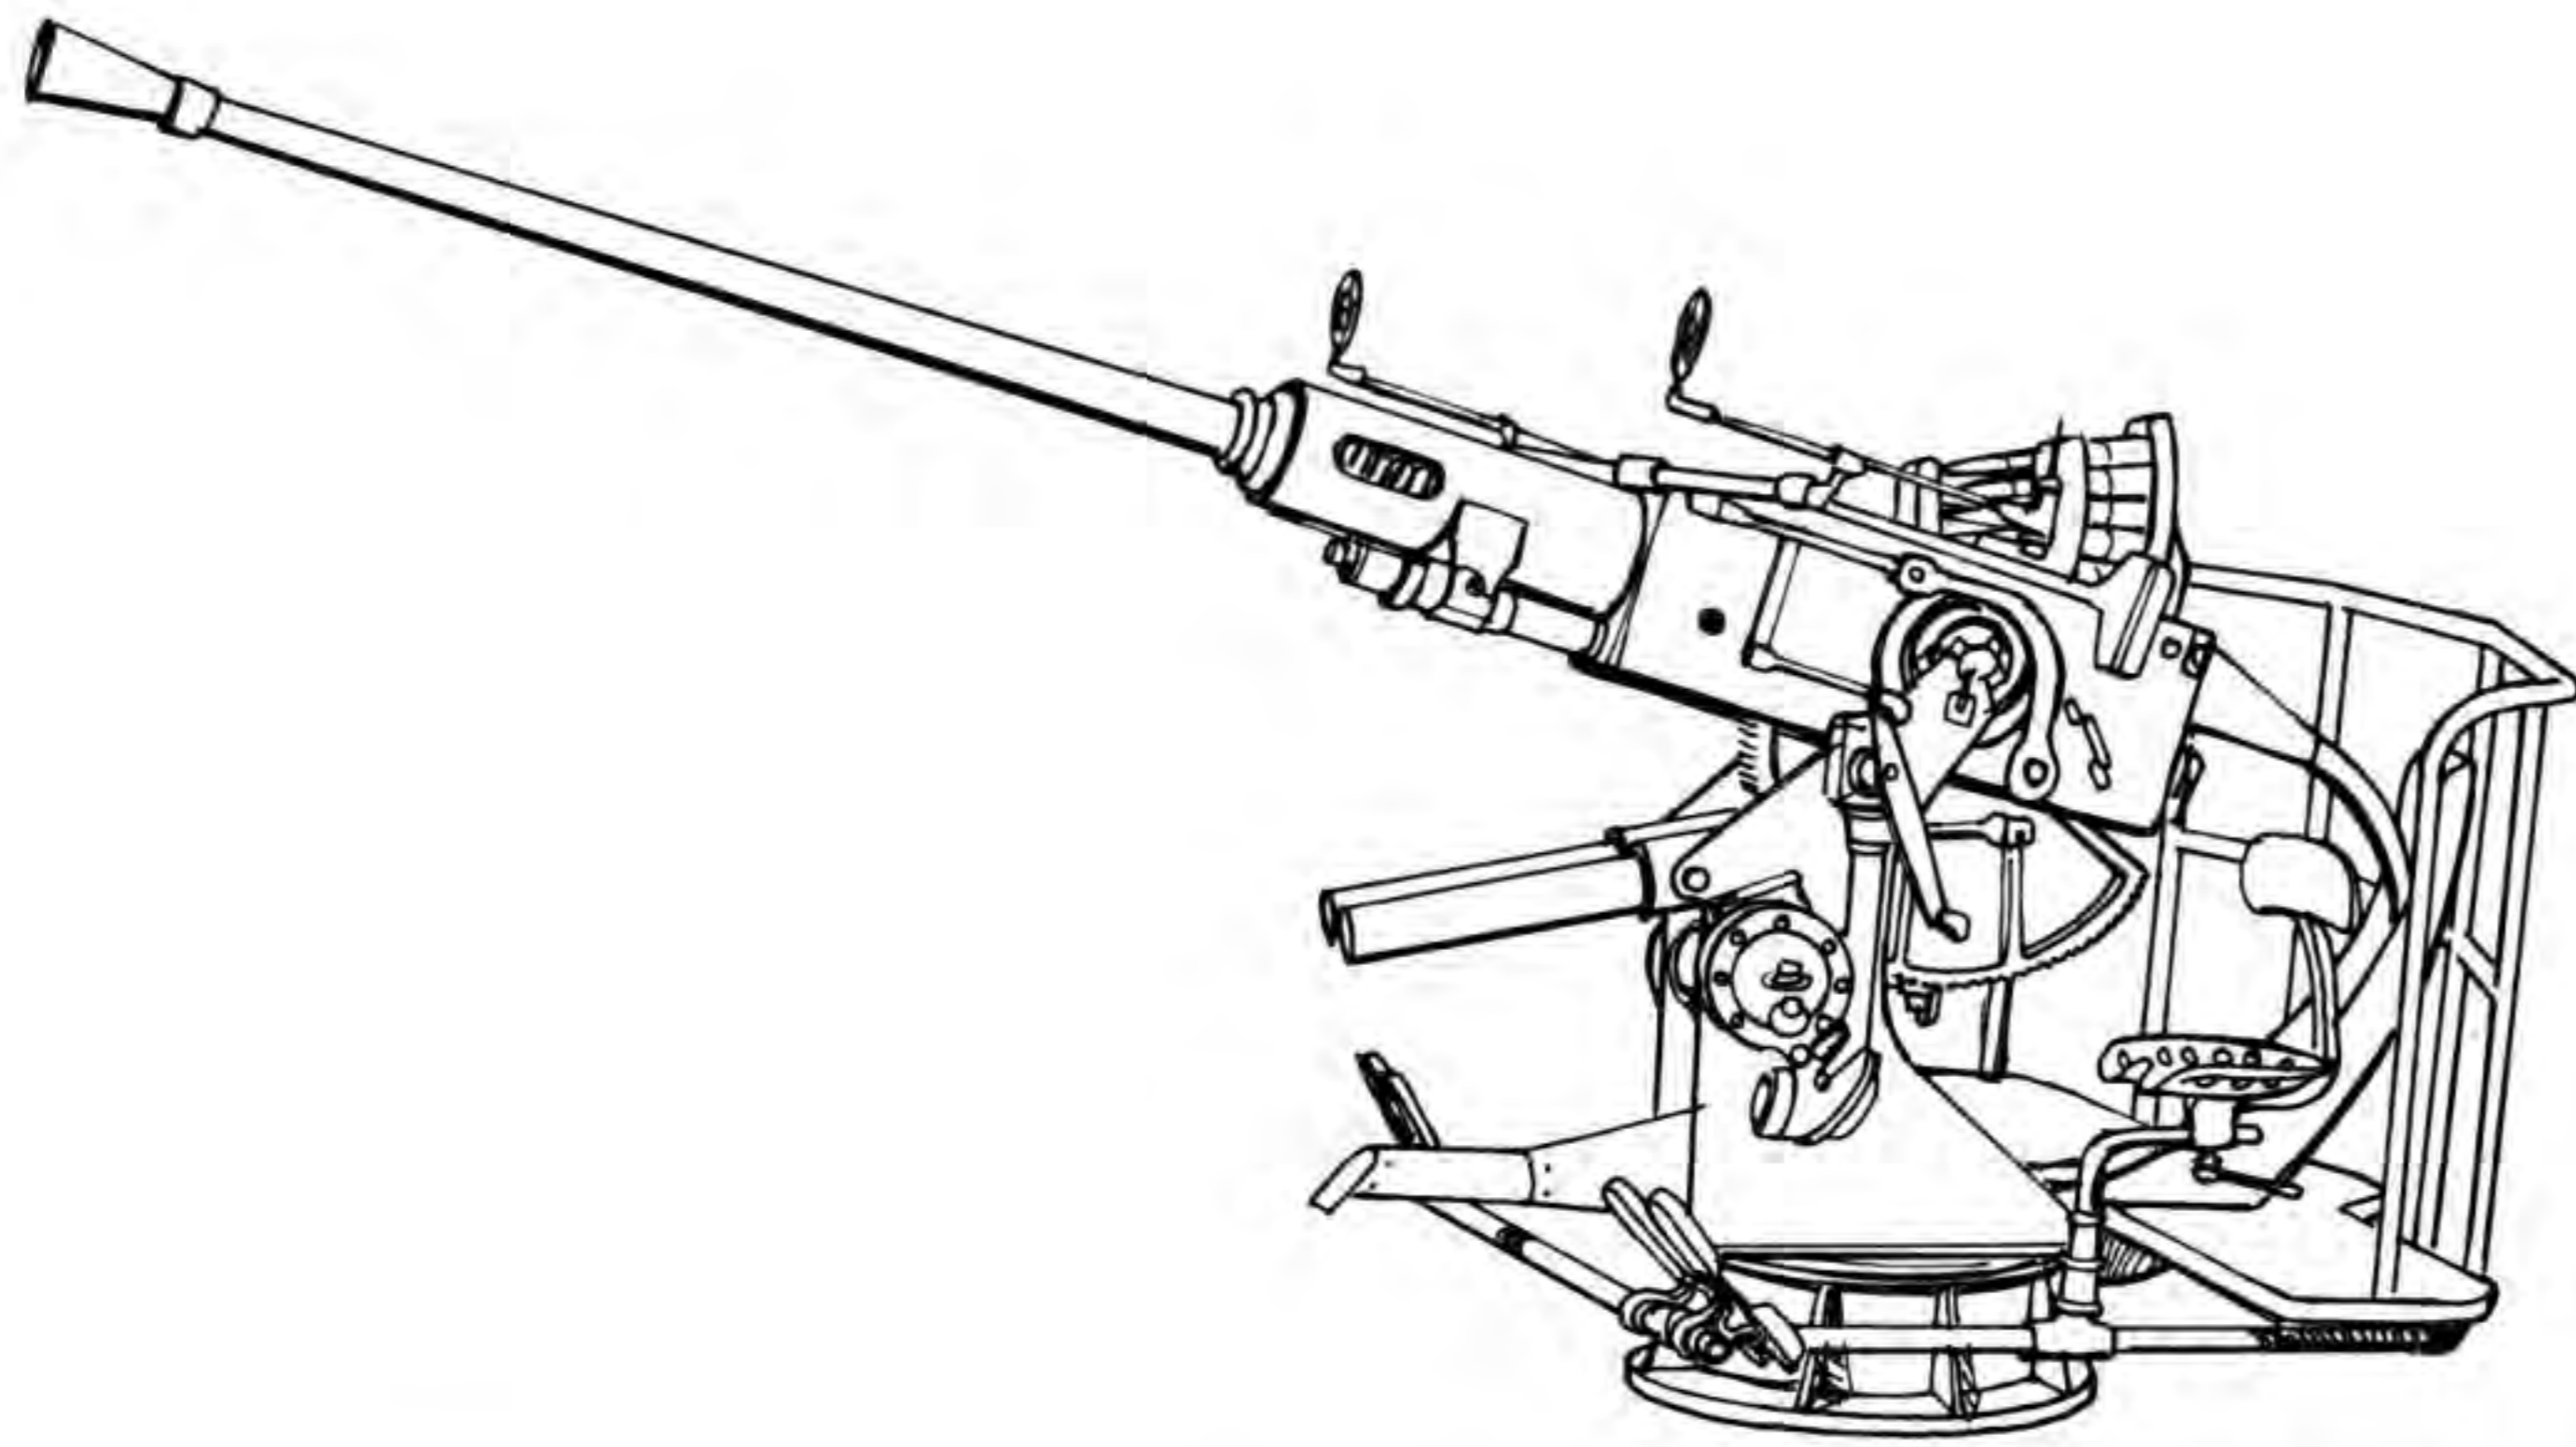
The 40mm MK3 machine gun mount (see BALLISTIC DATA table for complete data).

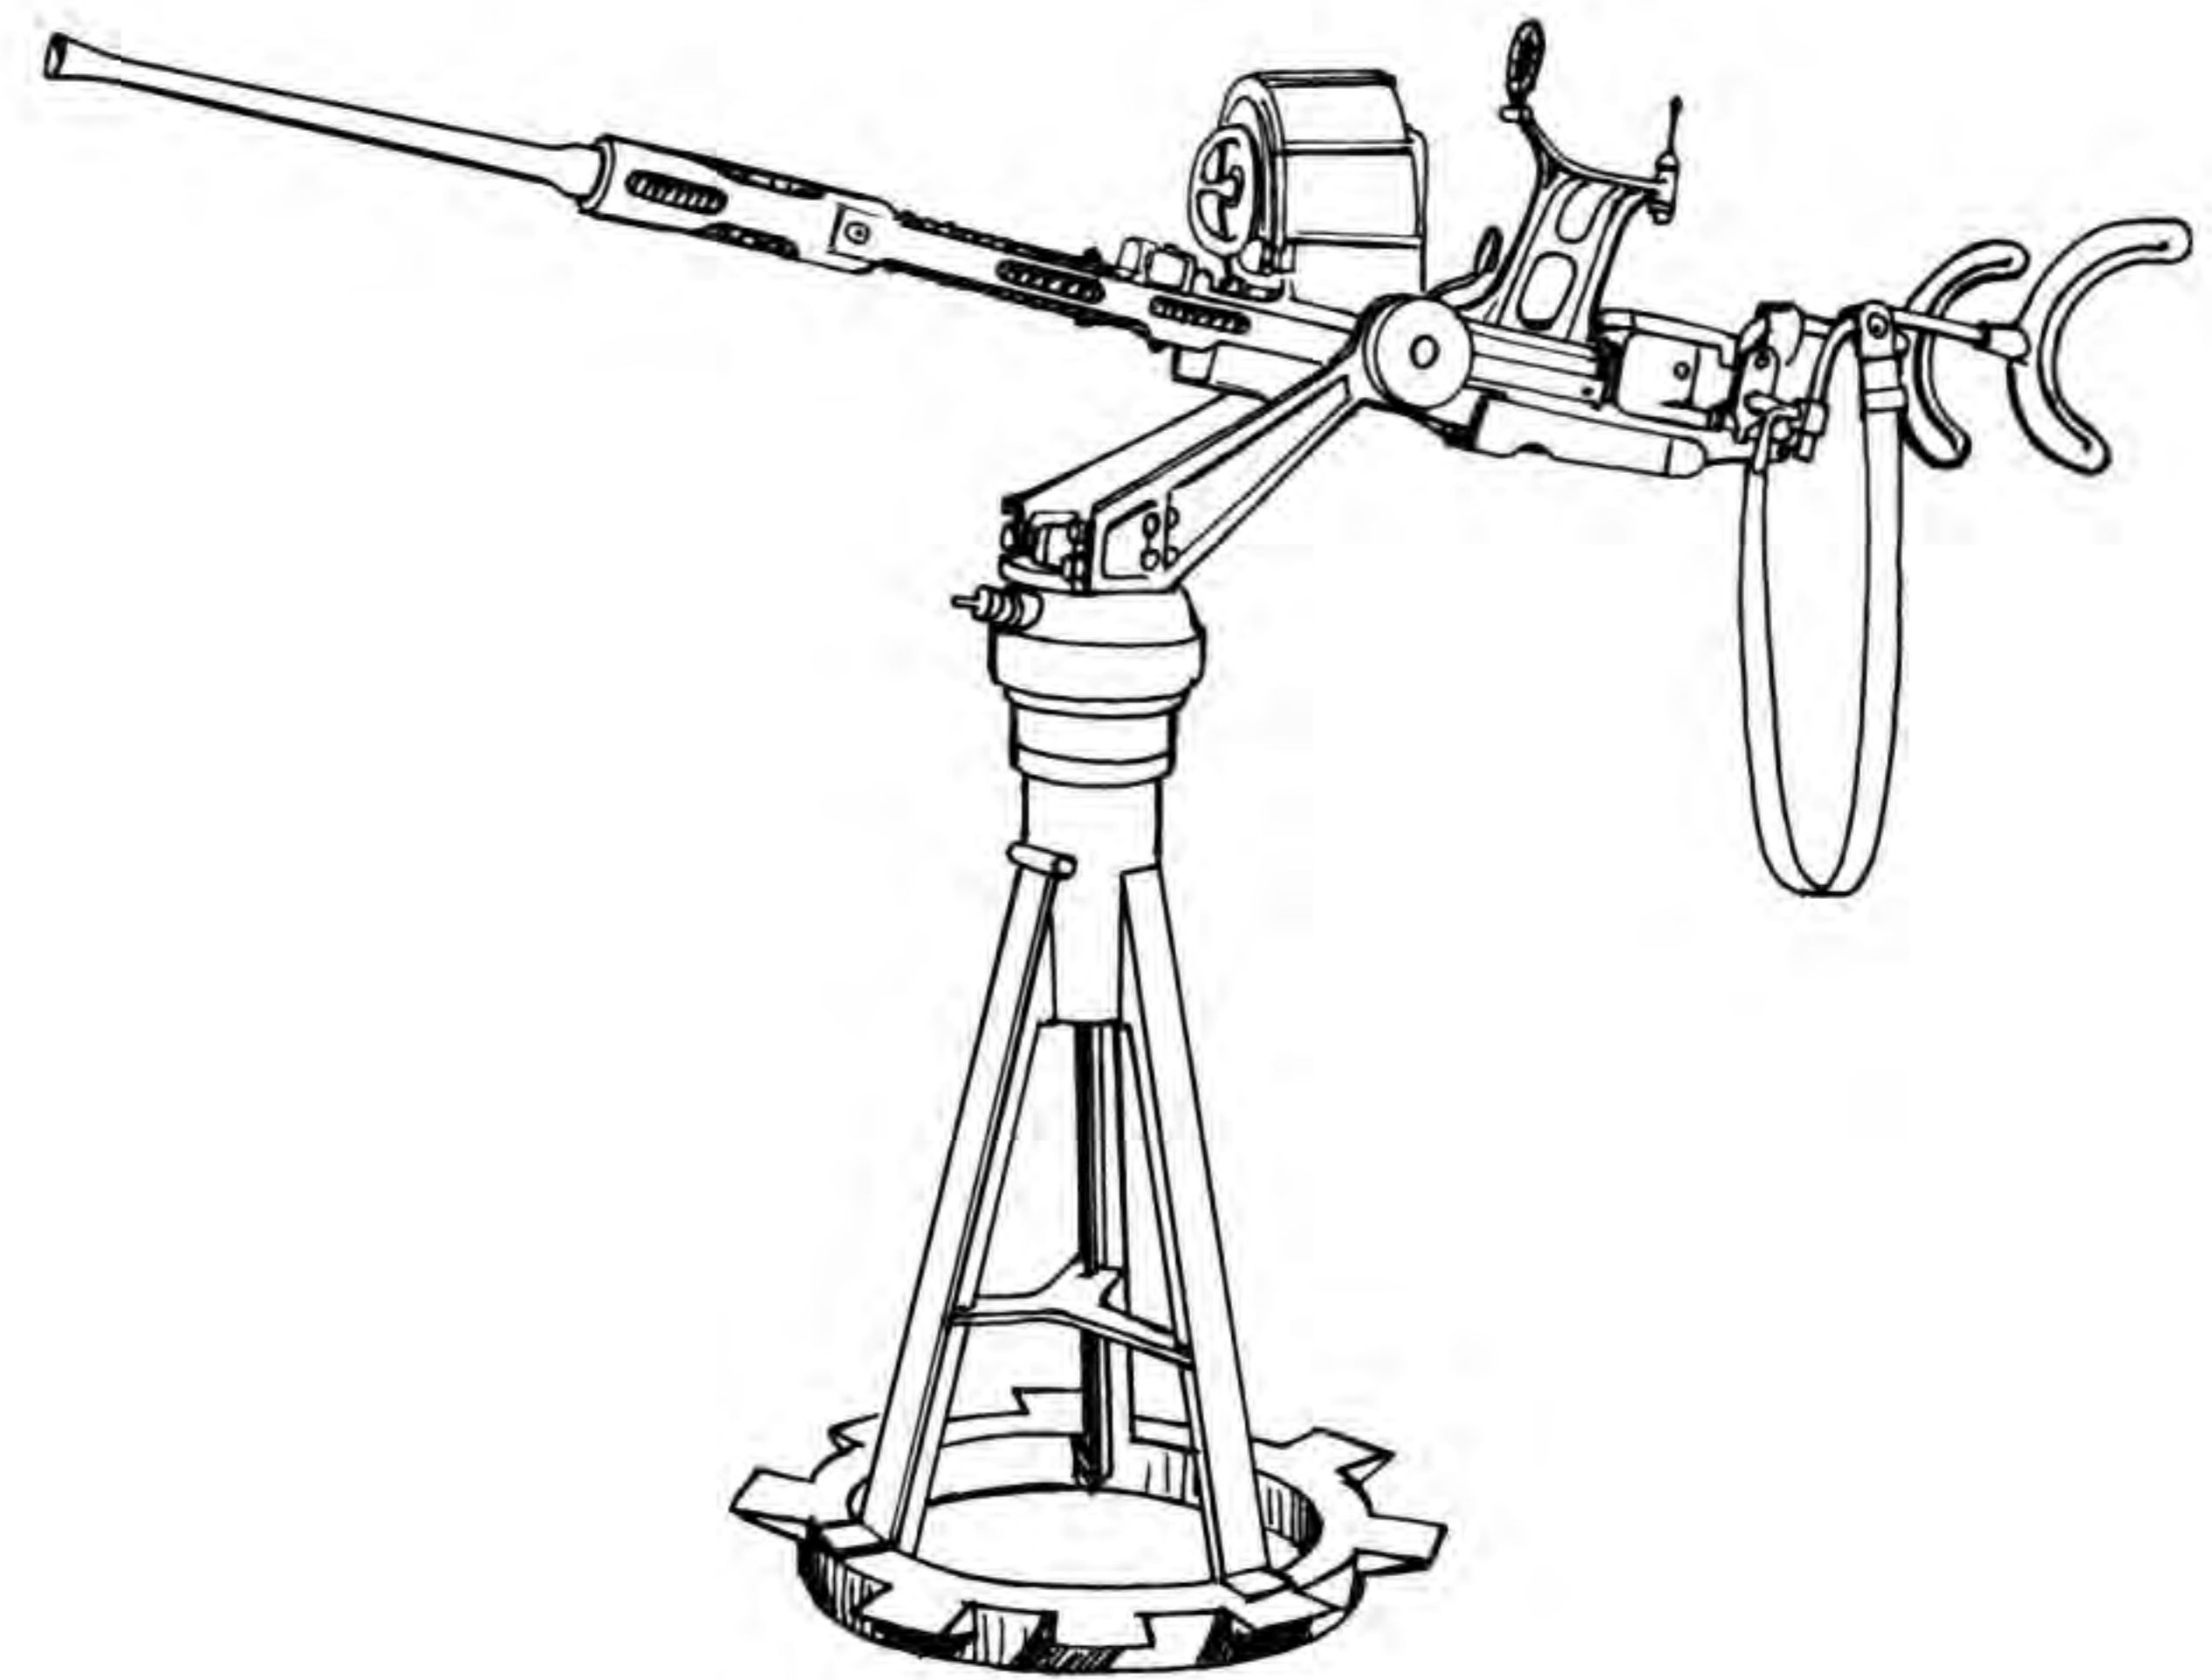
The 20mm MK10 machine gun mount (see BALLISTIC DATA table for complete data).

When first commissioned, *Bowfin* had two single 20mm Mark 5 mounts installed forward and aft on her bridge deck. The Mark 5s had a heavy cast pedestal base and were replaced during the November 1944 refit with a 20mm Mark 10 forward and a 40mm Mark 4 aft. The Mark 10 was an open pedestal tripod design saving over seven hundred pounds which
