GENERAL DATA

USS BOWFIN (SS287)

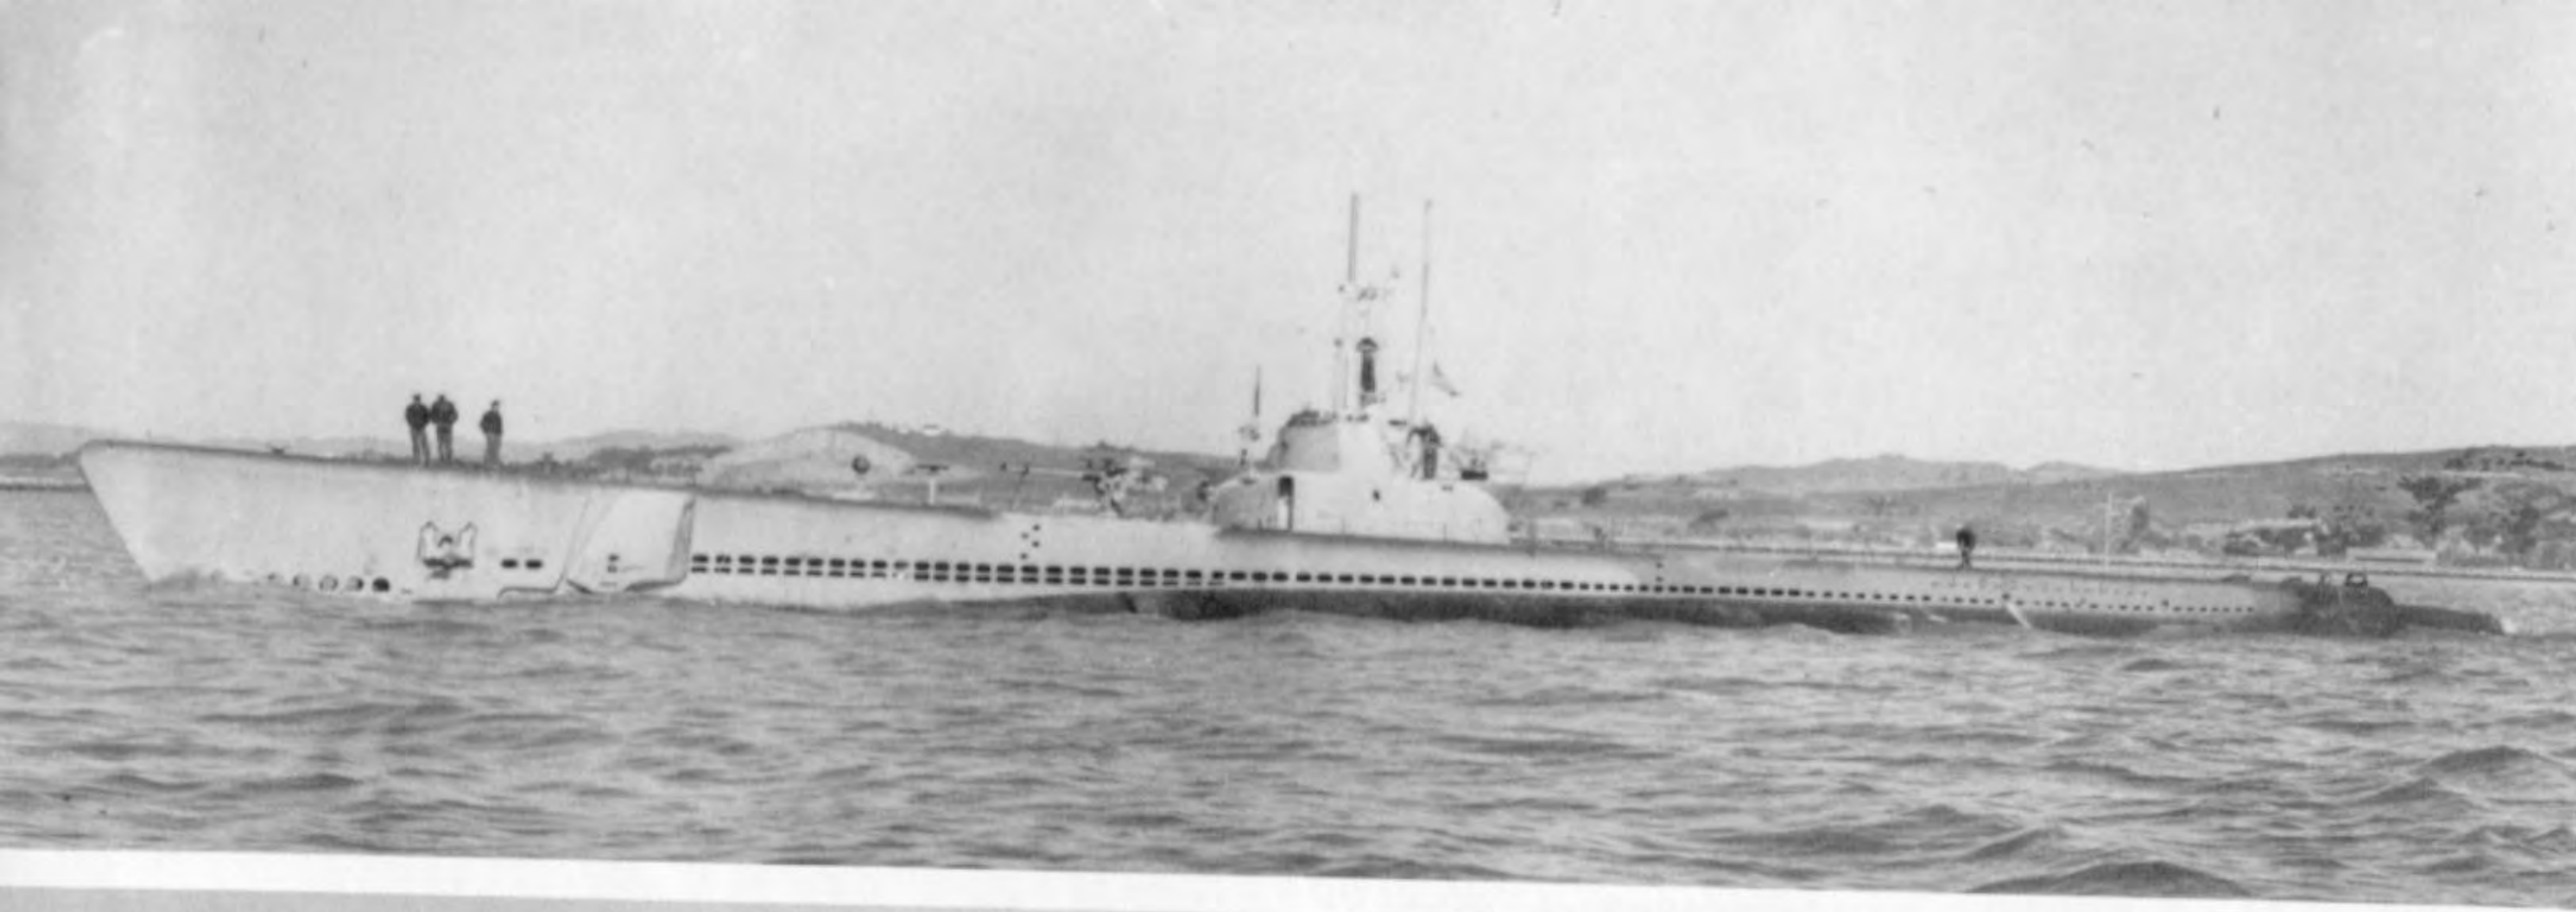
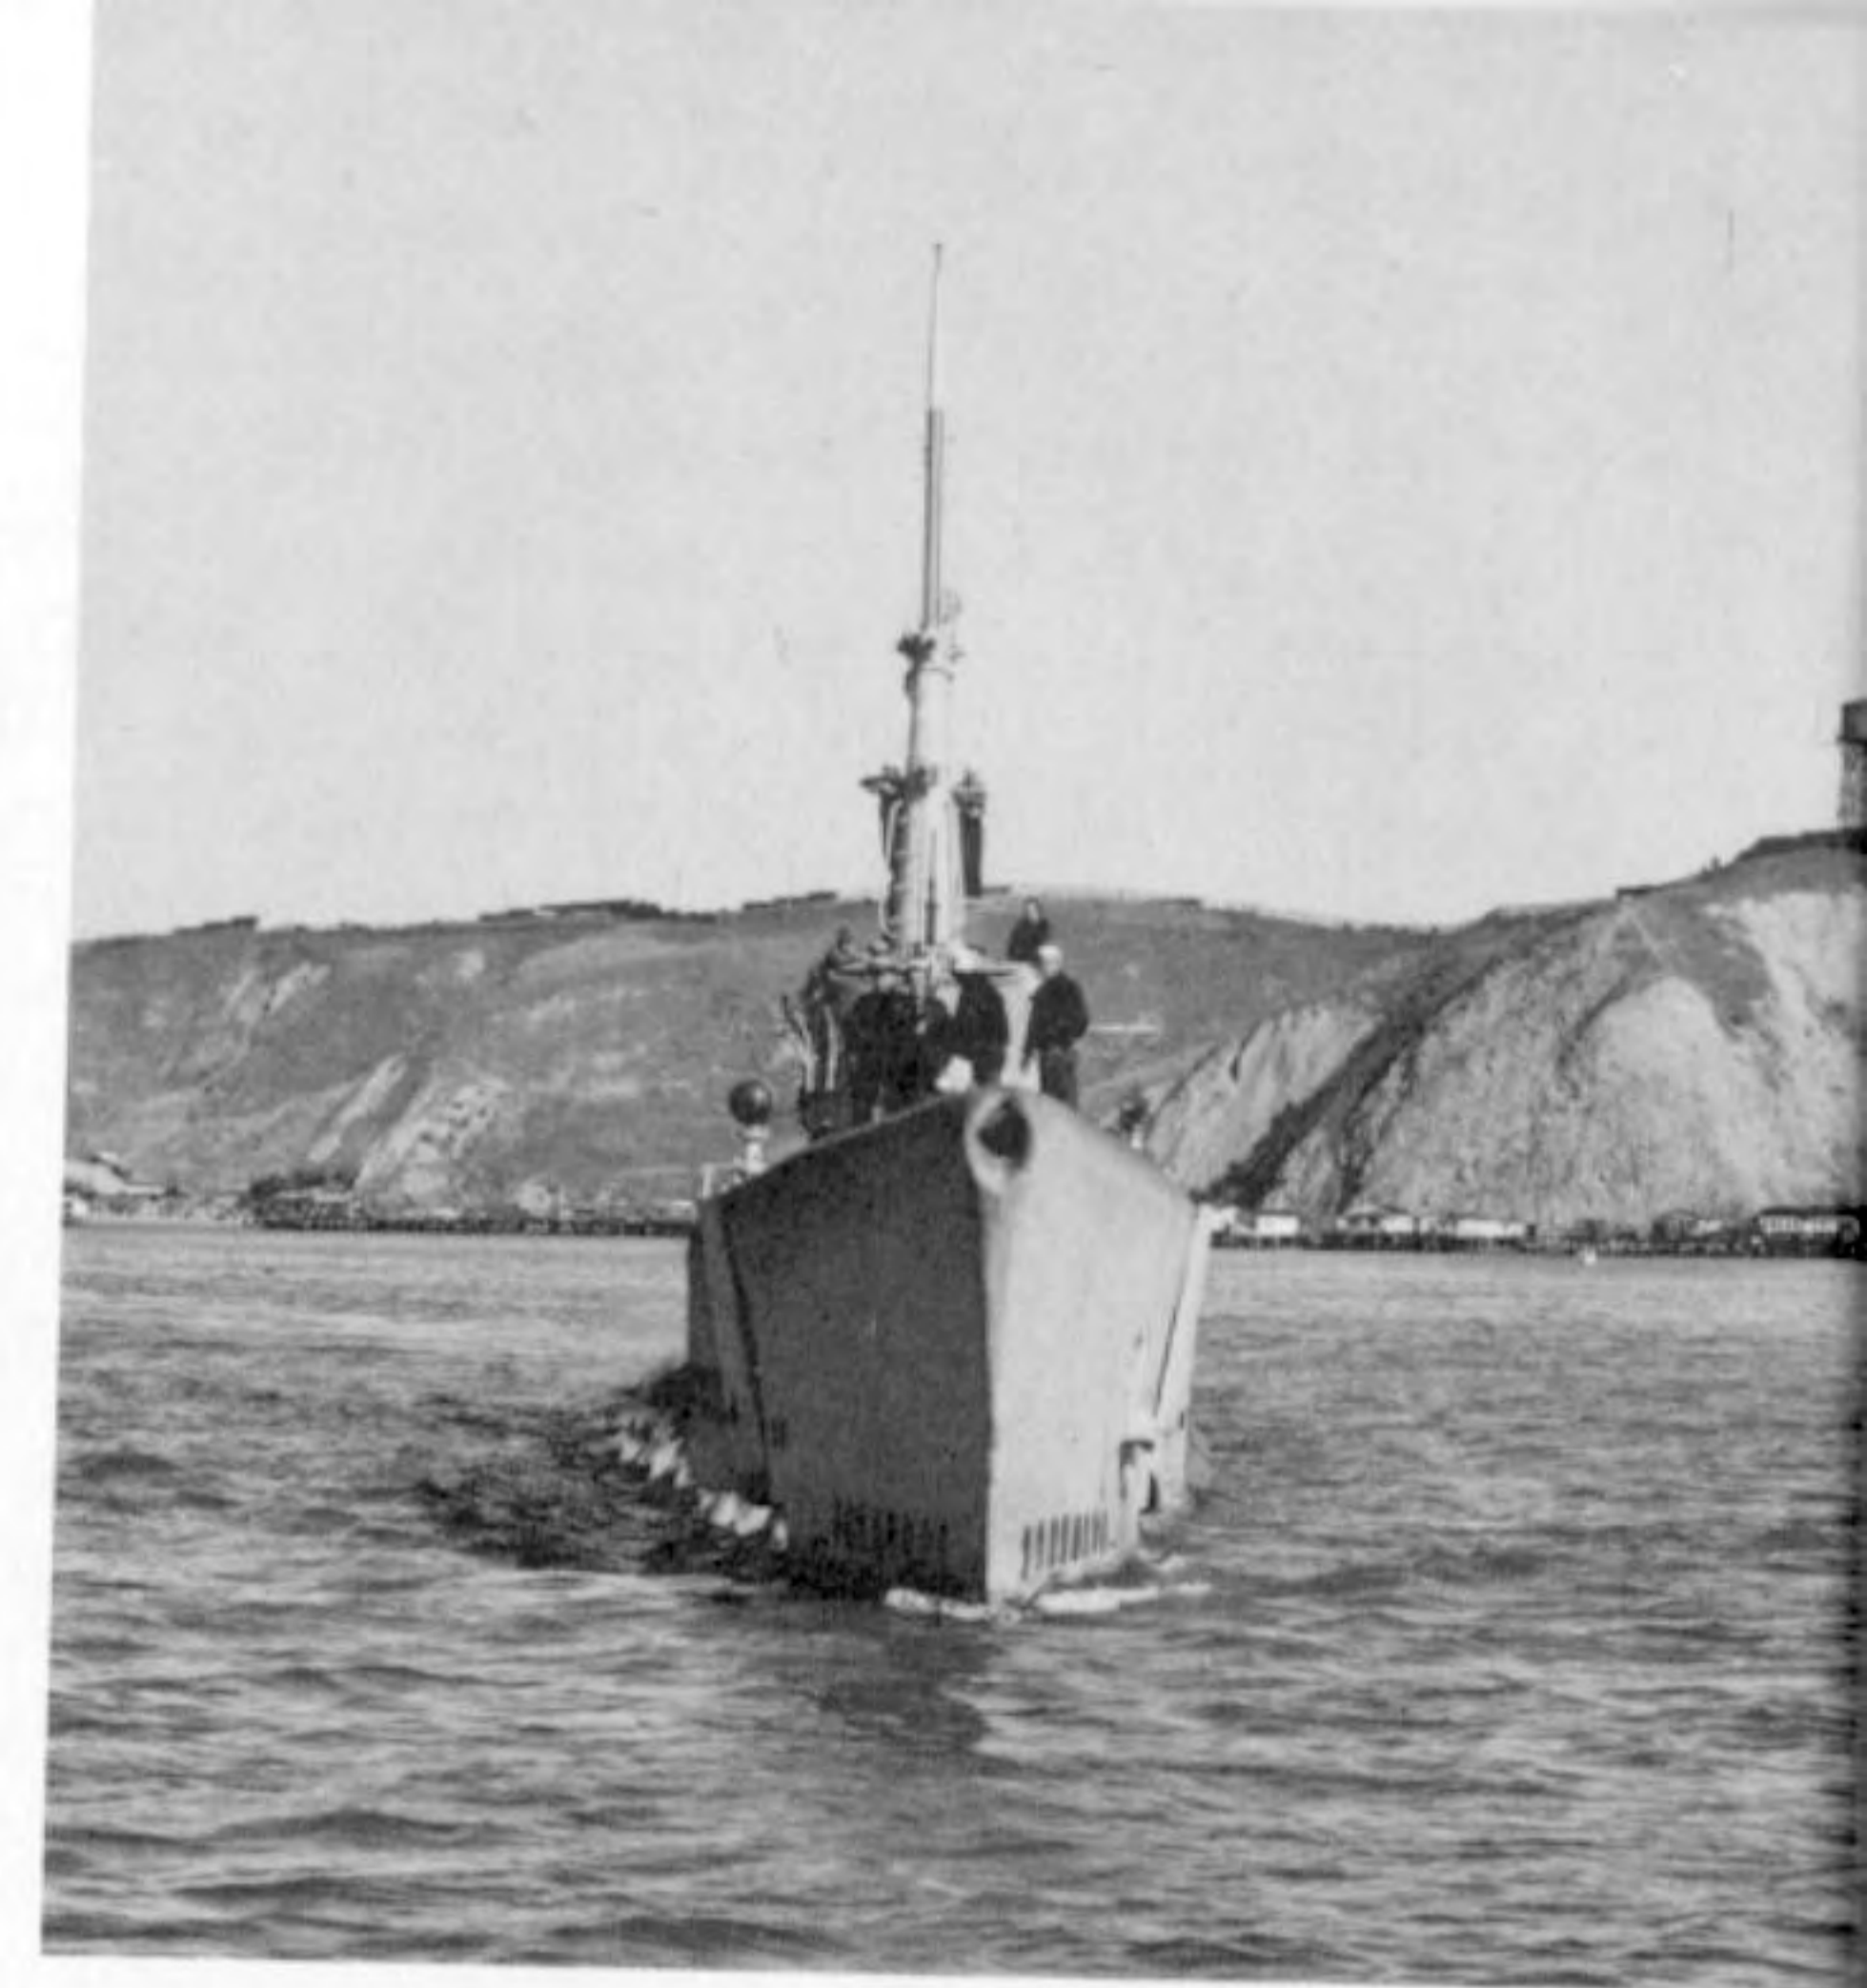
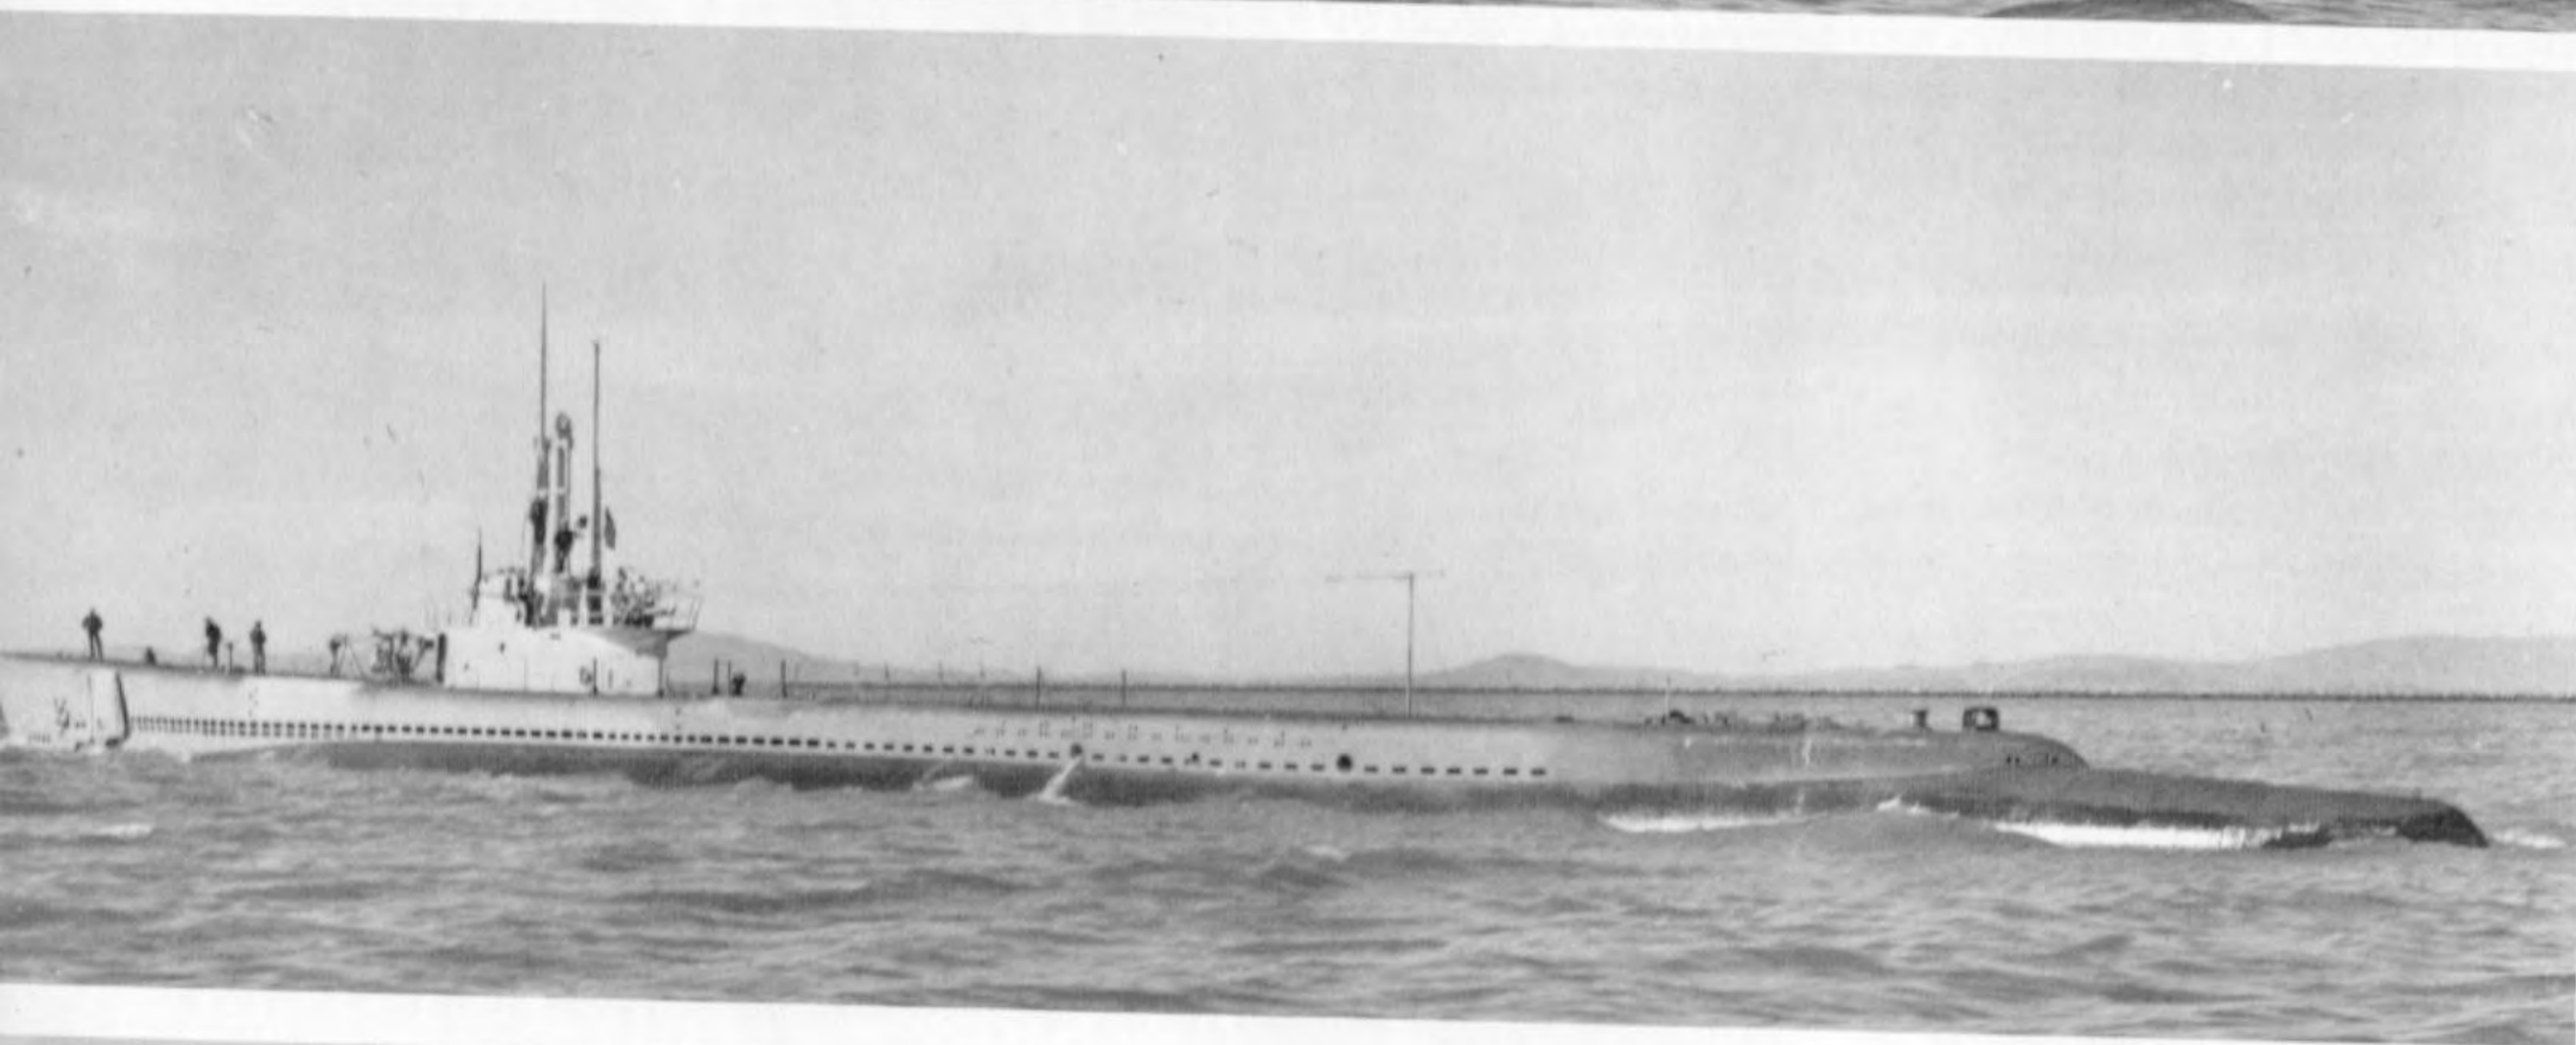
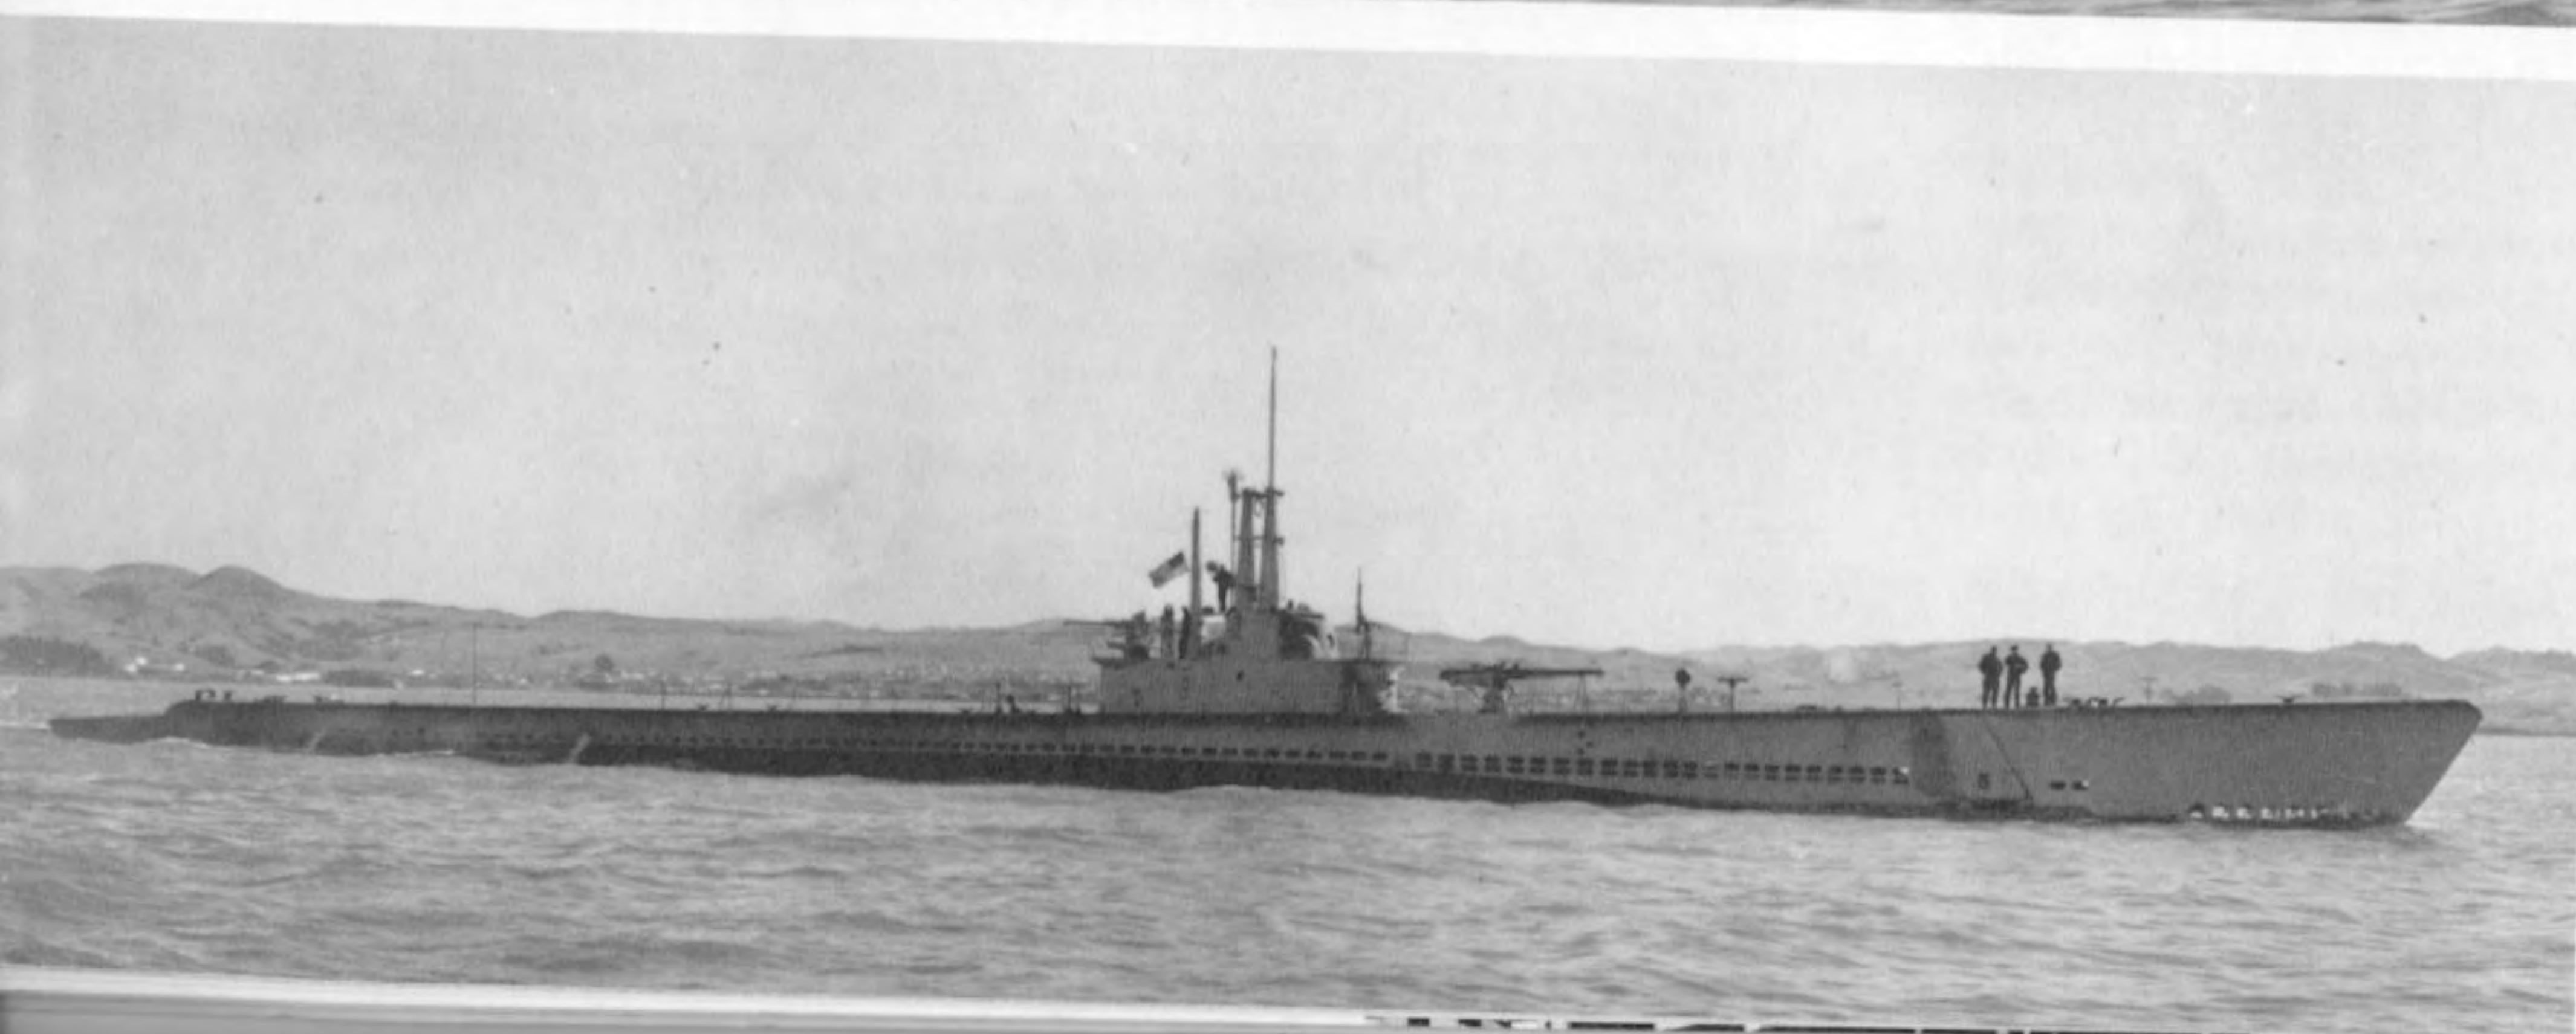
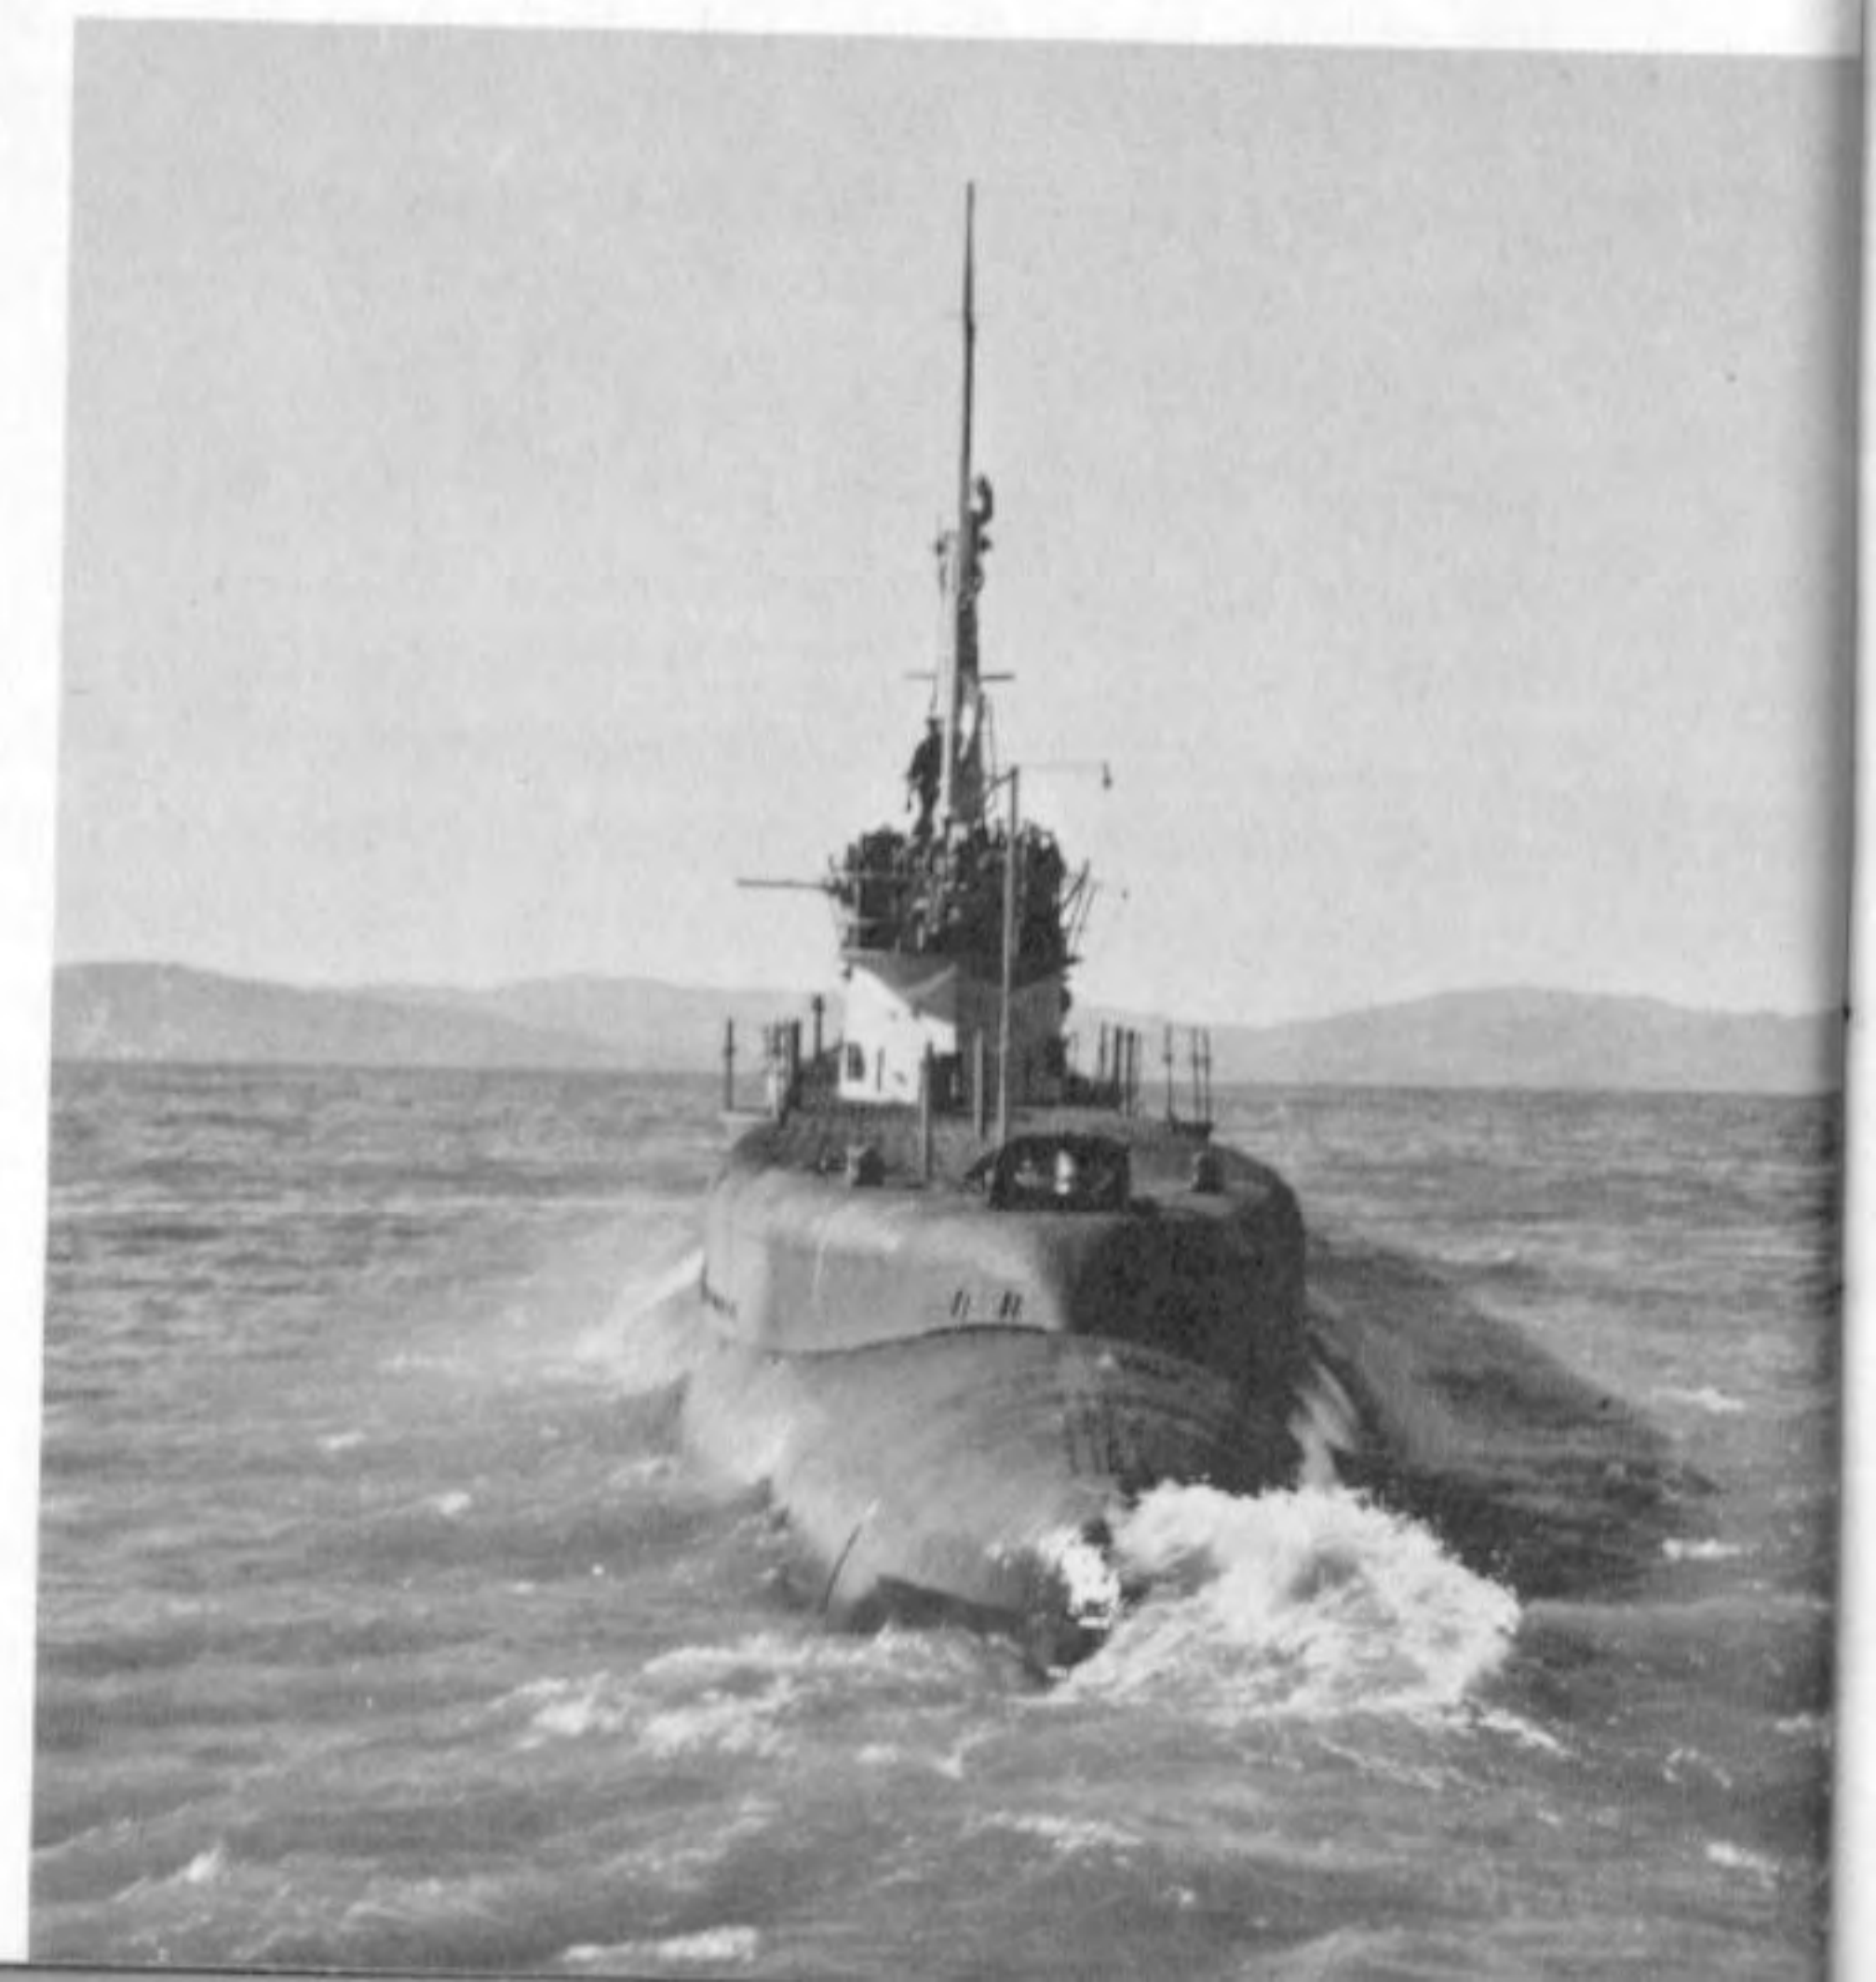
On 24 November 1944, Bowfin was photographed off Mare Island in this 'round the ship sequence: port bow, port quarter, starboard bow, dead ahead and dead astern. She had just completed her first major overhaul after six War Patrols.
