A VISUAL GUIDE TO THE U.S. FLEET SUBMARINES
PART TWO: SALMON & SARGO CLASSES
1936-1945
(2nd Edition, August 2011)

DAVID L. JOHNSTON

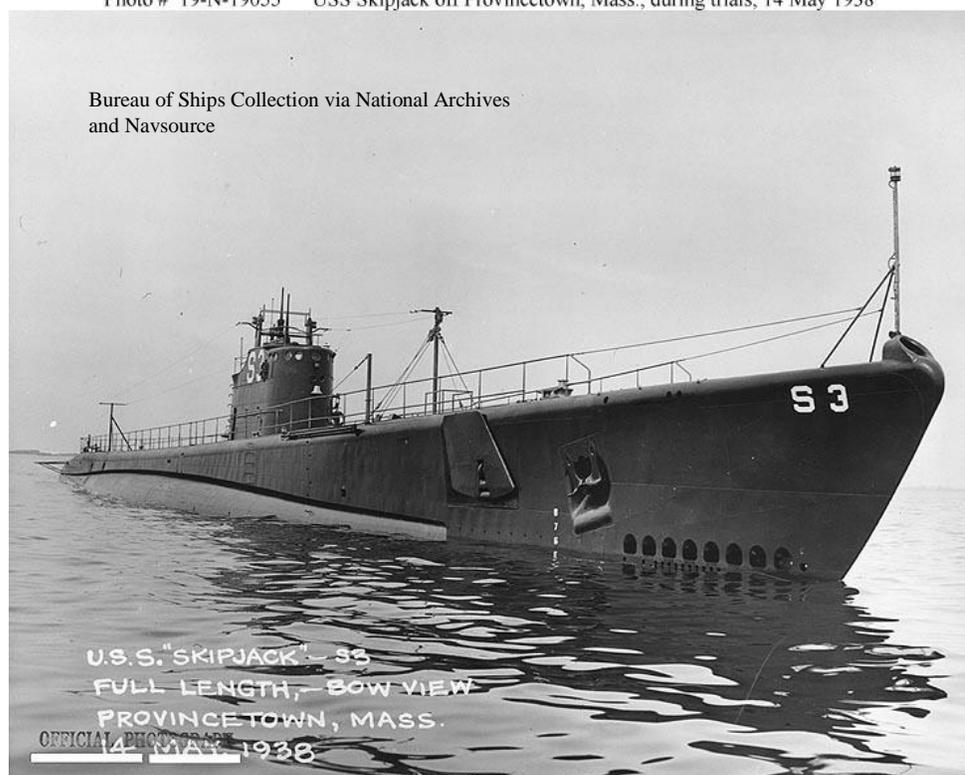
Photo # 19-N-19055 USS Skipjack off Provincetown, Mass., during trials, 14 May 1938

These boats all had a prominent ring-type “bullnose” towing fairlead raised above the most forward tip the bow. Note the lack of free flooding limber holes for the superstructure aft of the bow planes. Operational doctrine of the time did not heavily emphasize quick diving times, thus the urgency to quickly flood the superstructure was absent. Limber holes for these three boats were not added until the war started, when a harsh reality provided a strung urgency to quickly reduce dive times. All of the *Salmon/Sargo* boats had two anchors on either side of the superstructure, forward of the bow planes. The aft superstructure ran all the way to the tip of the stern in a manner similar to the P’s. Note also the continuance of the class identifier symbols on the forward hull and fairwater. This began to cause confusion because many boats of the old S-class (i.e. *S-1*, *S-11*, etc.) were still in commission. Accordingly, the practice was halted with *Squalus* (S11, SS-192) and the identifiers were removed from all previous boats and replaced with hull numbers in 1939. The following photo of *Seal* will give a good view of the details of the conning tower fairwater of this group.

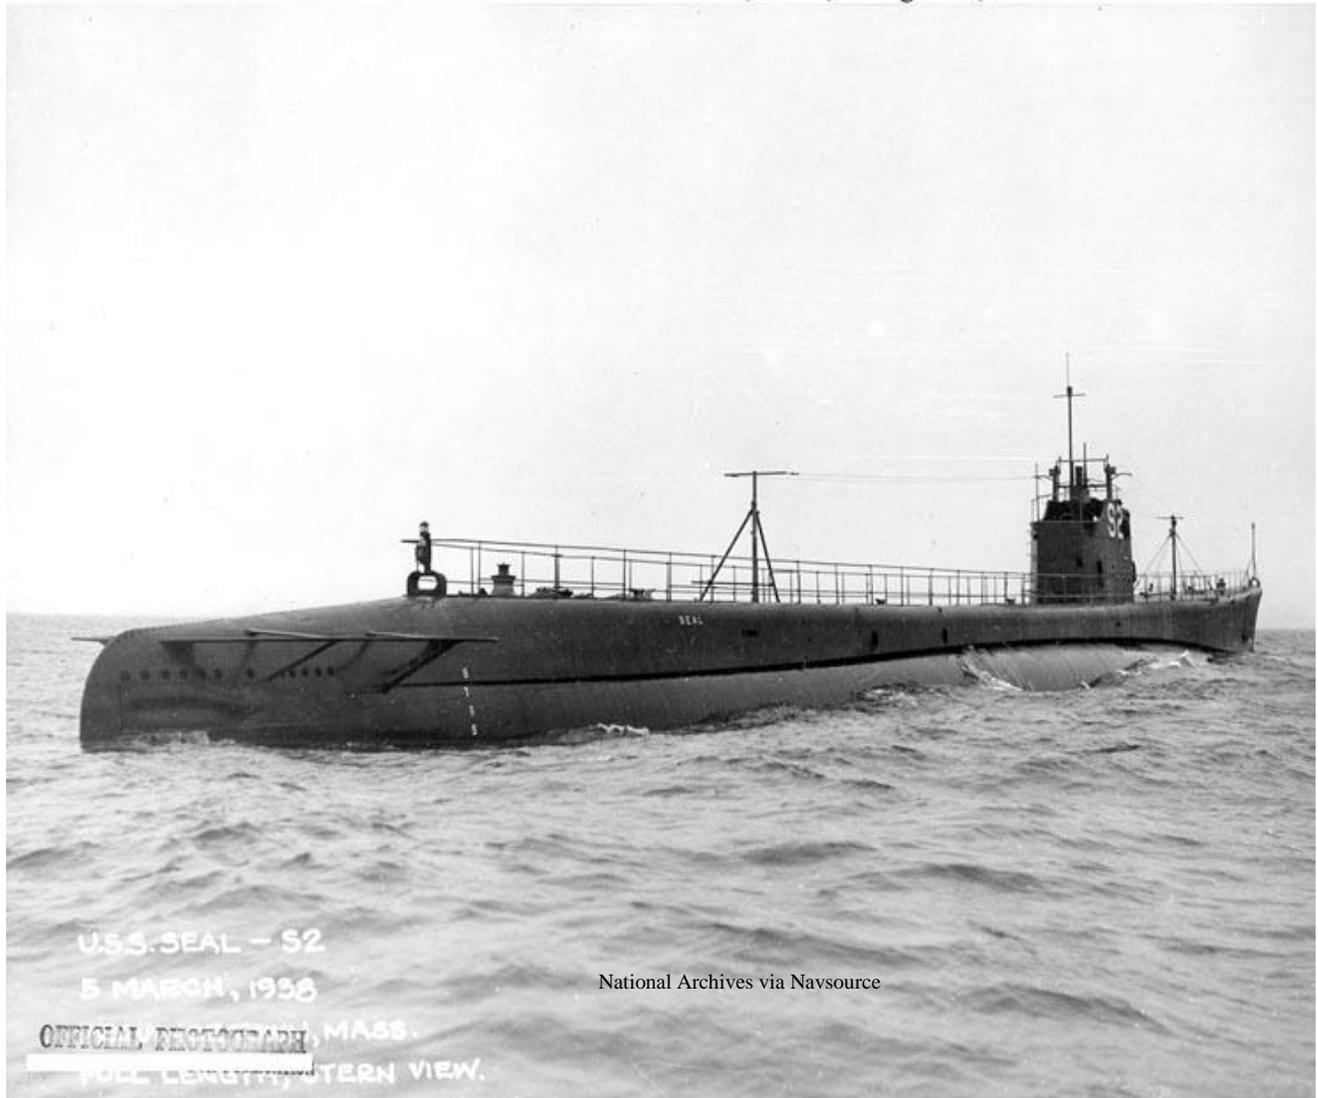
Photo # 19-N-19021 USS Seal off Provincetown, Mass., during trials, 5 March 1938

Salmon, *Seal*, and *Skipjack* had two 34-foot periscopes and thus had very small shears. Two rounded top stanchions were placed on either side of the shears, providing an anchor point for the long radio aerials that ran all the way from a mast situated halfway up the forward deck to a mast halfway down the aft deck. These stanchions also acted as structural supports for the periscope shears. Just aft of the stanchions, the top edge of the fairwater curves gracefully downward about three feet and runs aft forming the edges of the bulwark that surrounds the cigarette deck. This edge terminates at the aft end of the fairwater, which descends vertically down to the main deck, just forward of a hatch leading to the crew's berthing compartment. The rectangular opening in the side of the fairwater allows the gun crew access to the main deck after exiting the interior of the boat through a watertight door in the aft end of the conning tower.

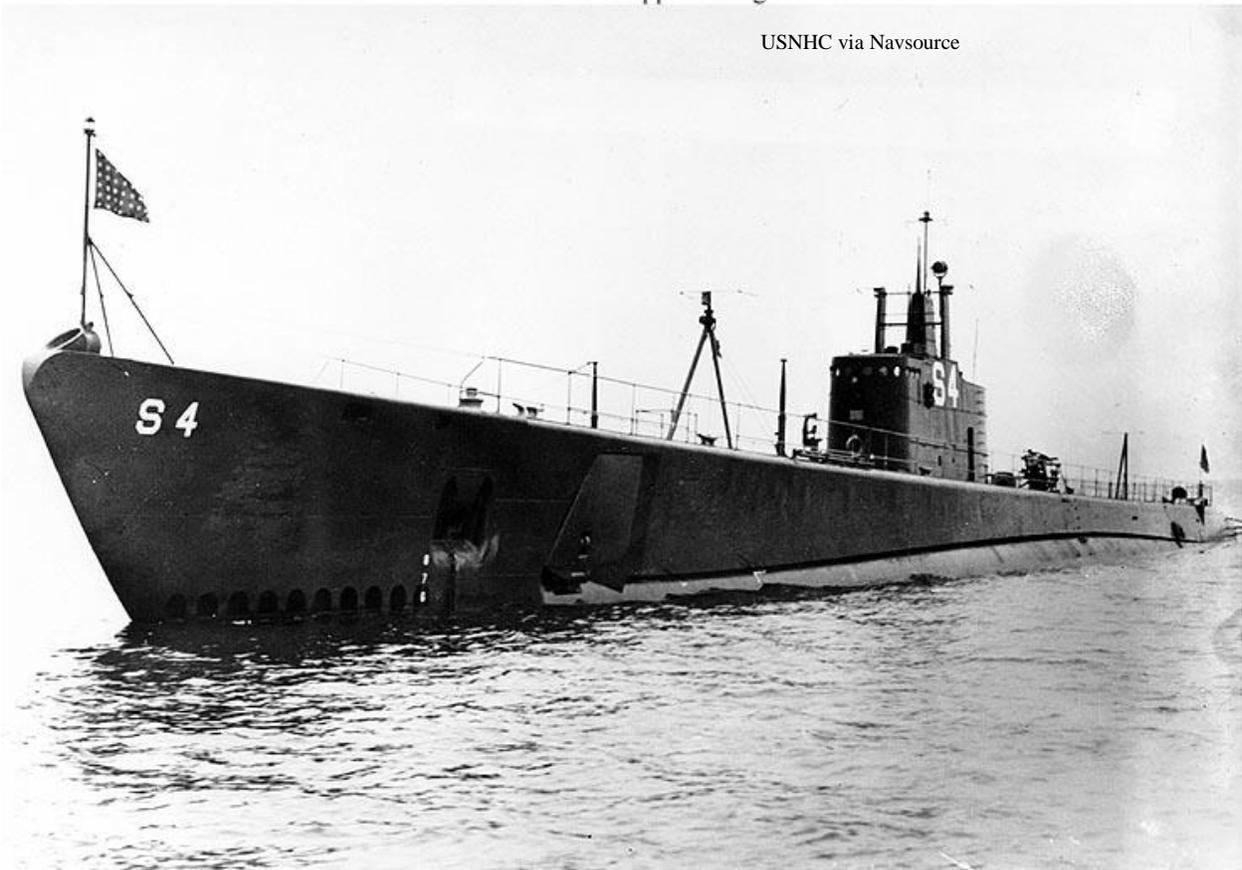
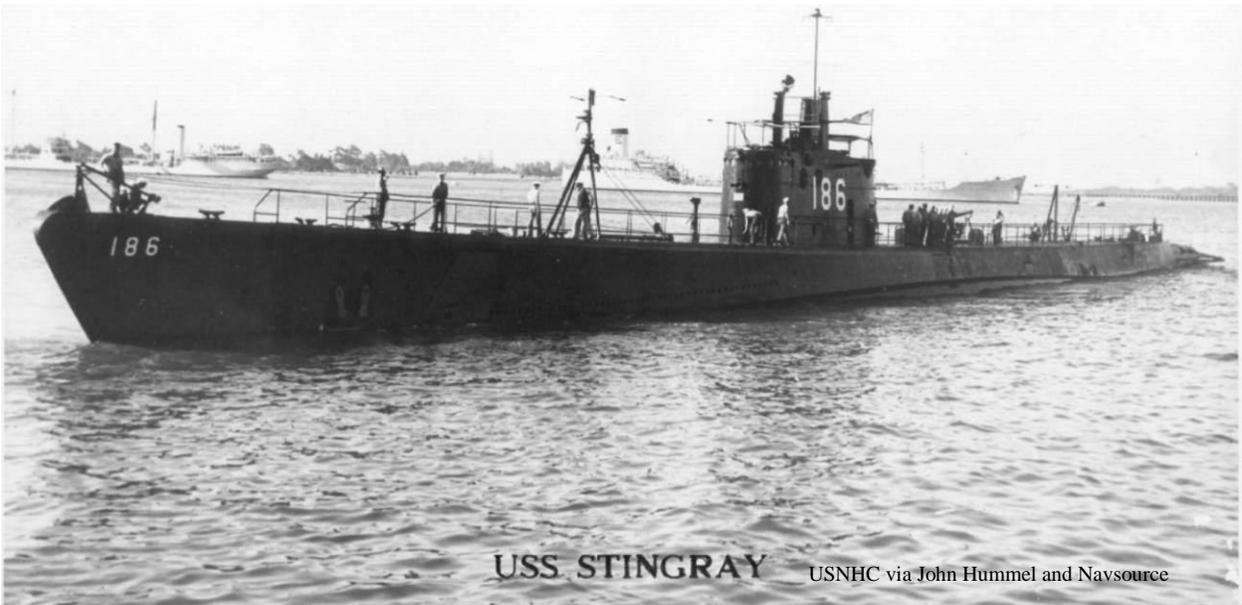
Photo # NH 99096 USS Snapper during the later 1930s

The radio aerial masts on the forward and aft decks were of a bipod design, instead of the wire braced monopod of the earlier boats. The upper edges of the cigarette deck bulwark are slightly higher than the EB design. The hatch to the crew's quarters that was sited right at the aft end of the fairwater in the EB boats was located about six feet farther aft in the Government design. The single biggest change came from the replacement of one of the 34-foot periscopes with a 40-foot model, necessitating a taller and more substantial shear structure. Accordingly, the support stanchions on either side of the shears are taller as well. This feature makes these boats easy to spot. Continuing the practice of the three EB boats, as built these boats also lacked any limber holes in the superstructure aft of the bow planes. However, sometime in 1940 one row of small

limber holes was added to at least *Stingray*. These holes ran in a line parallel to the curvature of the bottom edge of the superstructure, about 18 inches above that bottom edge. It is quite possible that *Snapper* and *Sturgeon* had them added too. Note in the *Stingray* photo that she had a modification to edges of the cigarette deck bulwark. There was a portion of it flared outward on each side. This was probably to accommodate an improved field of fire for the machine gun that was mounted there. This was a post-commissioning mod and all three boats received it.

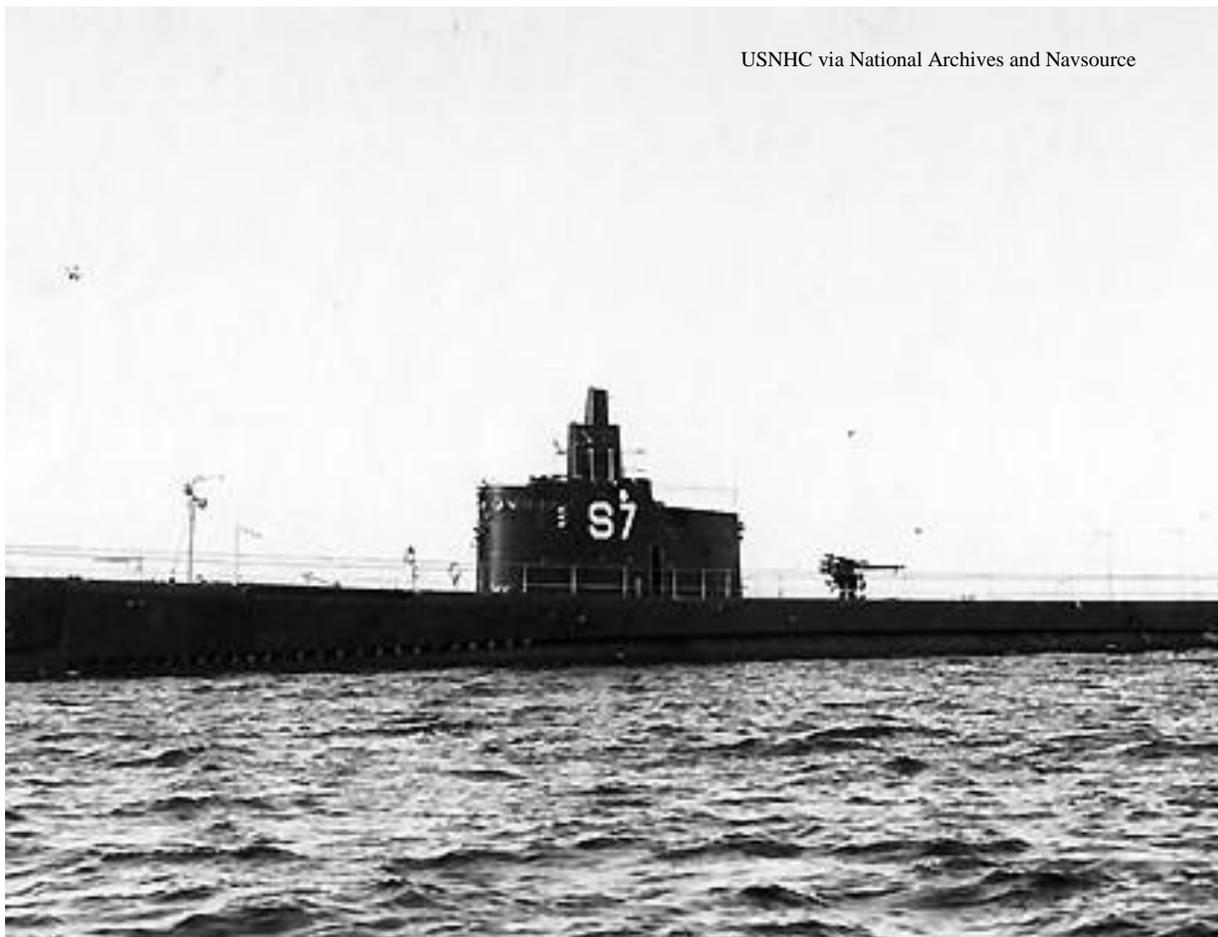
This shot of *Sargo* gives a good idea of the shears arrangement. The I-beams are not visible as they are covered by the fairwater plating. The shape of the fairwater itself is also distinctive. The

EB built boats had the upper edge of the fairwater descend vertically directly aft of the shears, then curve sharply to the horizontal. Both the leading and trailing edges of the fairwater are vertical. A row of semi-circular limber holes were situated at the bottom edge of the superstructure, directly above the tank tops. These holes ran from the bow planes to the forward edge of the fairwater. The photo below of *Sargo*, taken from the port quarter, will also show these features.

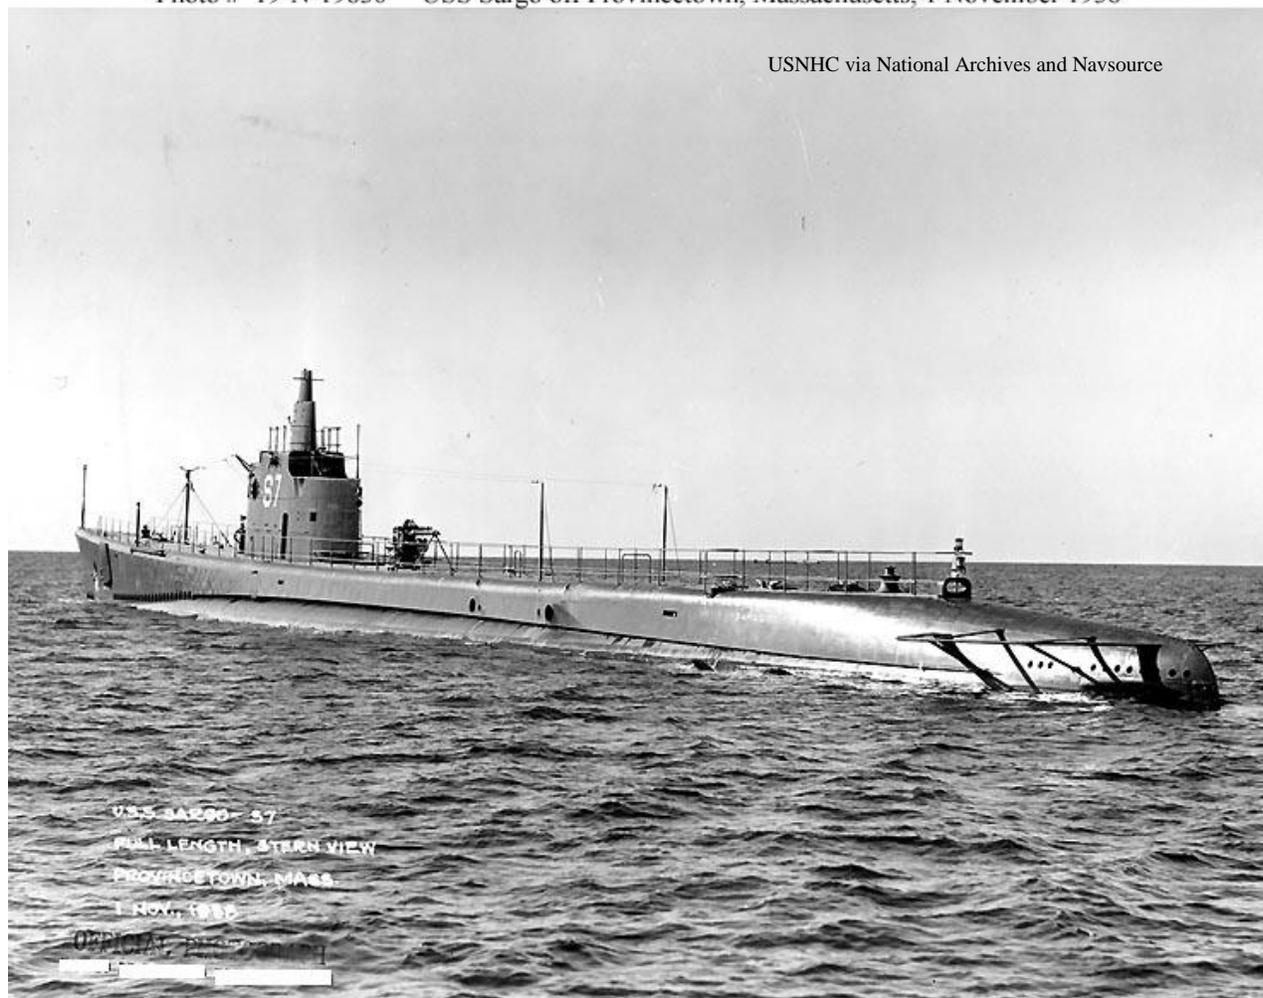
Photo # 19-N-19830 USS Sargo off Provincetown, Massachusetts, 1 November 1938

Note also how the I-beams on either side of the shears provided excellent lookout platforms. One other feature of the EB boats of this group was a new bullnose design. These three boats (*Sargo*, *Saury*, and *Spearfish*) had the bullnose faired into the bow buoyancy tank as shown in the construction photo below of *Saury*. Note also in this photo the conning tower and shears I-beam installation on the *Sargo* under construction on the right side of *Saury*. In a well-intentioned but ultimately misguided attempt to increase firepower, all of the *Salmon/Sargos* had four non-firing torpedo stowage tubes inside the superstructure, stacked vertically, on either side of the conning tower. Although these tubes were not yet installed on either boat in the photo below, a general sense for where the tubes were mounted can be obtained. The procedure for removing these reload torpedoes from their tubes and getting them below to the forward torpedo room proved to be tedious and time consuming and executing this evolution in enemy held waters ultimately proved to be more dangerous than what it was worth. The stowage tubes were removed from all boats early in the war.

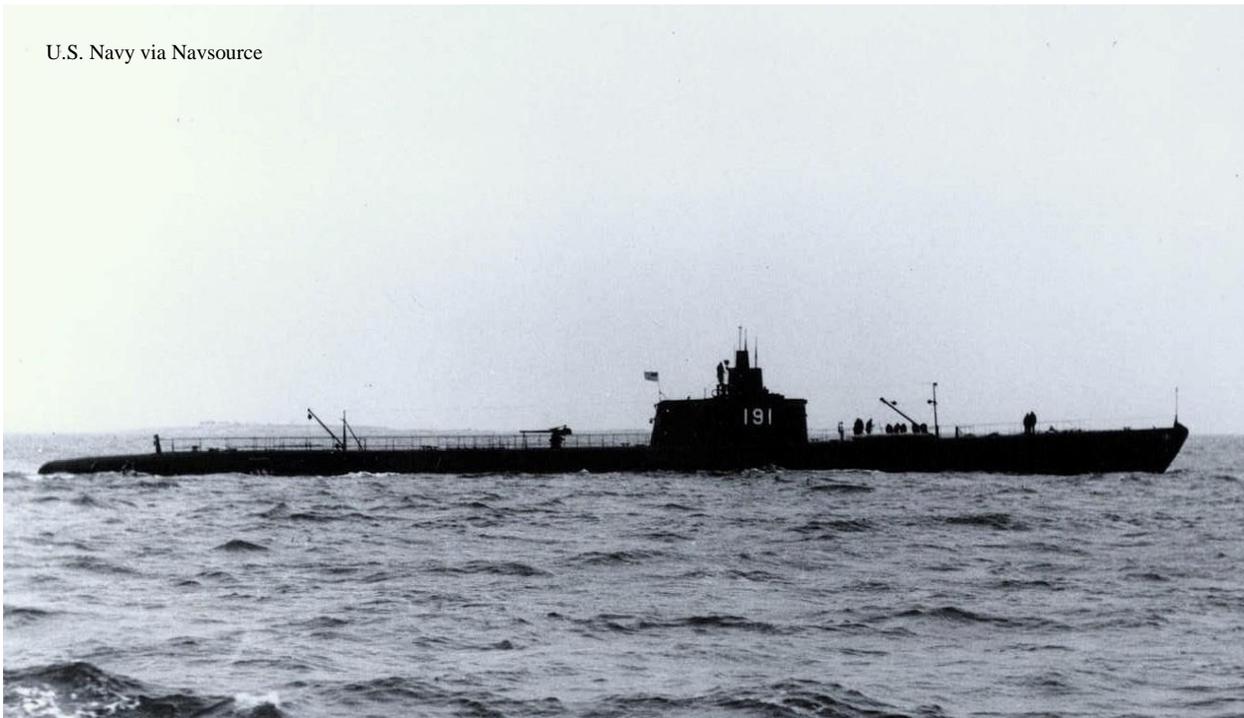
The photo above of *Sculpin* shows the different shape of the upper edge of the cigarette deck bulwark, substituting the sharply curved/horizontal configuration with one that is more gradually

tapered. Also, the trailing edge of the fairwater tapers at an angle to the main deck, as opposed to straight down in the EB design. The Government design boats retained the ring type above-the-deck bullnose of the previous *Salmons*.

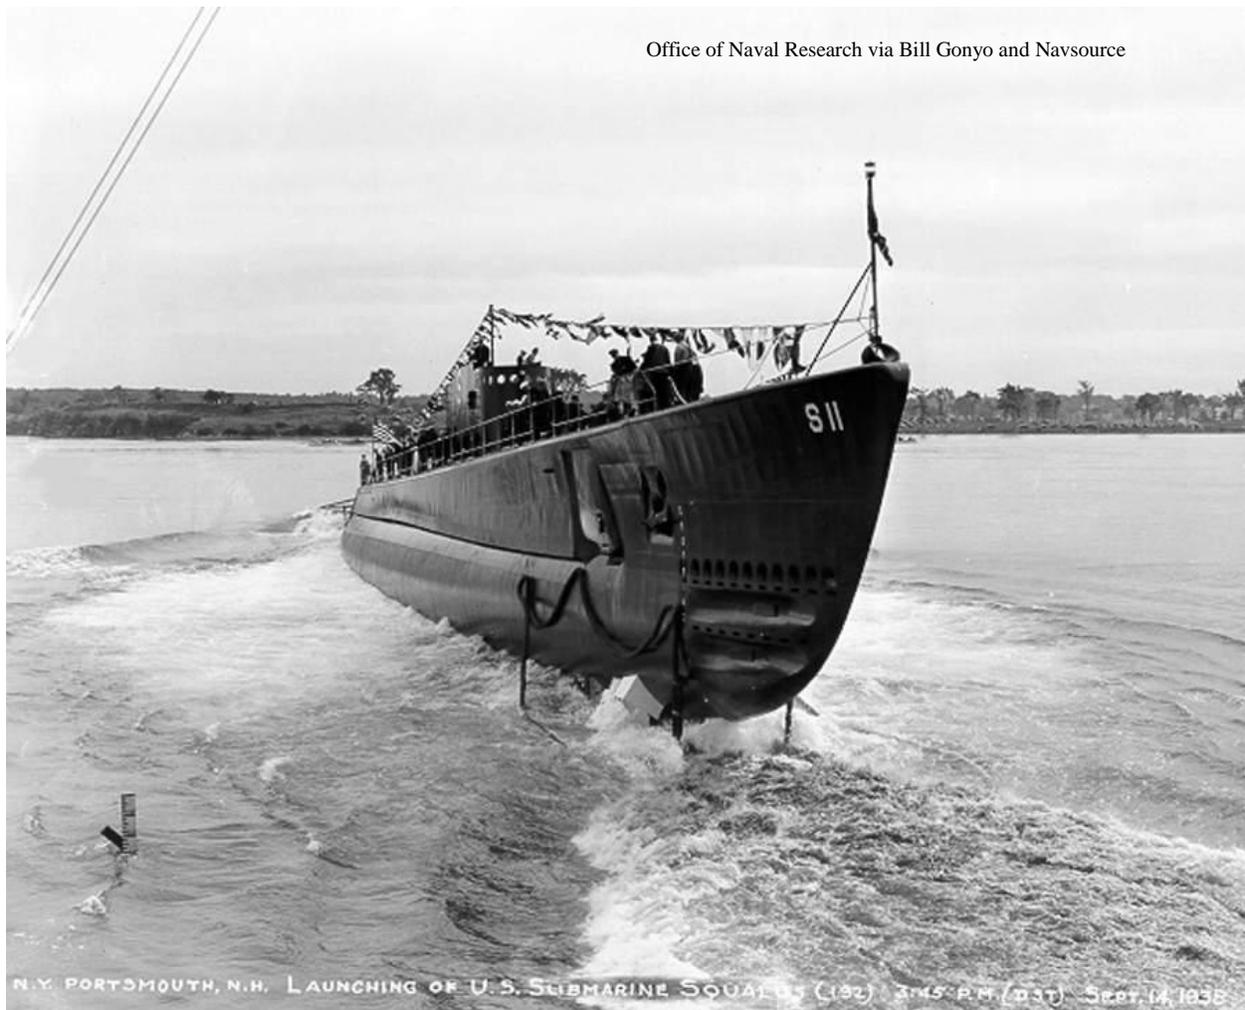
This launch day shot of the ill-fated *Squalus* shows the ring bullnose at the bow and also illustrates that the Government boats lacked the limber holes at the bottom edge of the superstructure. The EB designers were leading the way at this time with some new and innovative design elements, the faired bullnose and limber holes being just two examples. The efficacy of the EB features eventually won over the more conservative Bureau designers and these features were eventually retrofitted into the Government boats, or incorporated into the plans for new boats. Two other items are of note in this photo. *Squalus* was the last boat launched with the class identifiers (S11) on her hull instead of the hull number (192), and she slid down the ways without her periscopes and shears, a common practice at Portsmouth at the time. They were installed in the post launching fitting out phase.

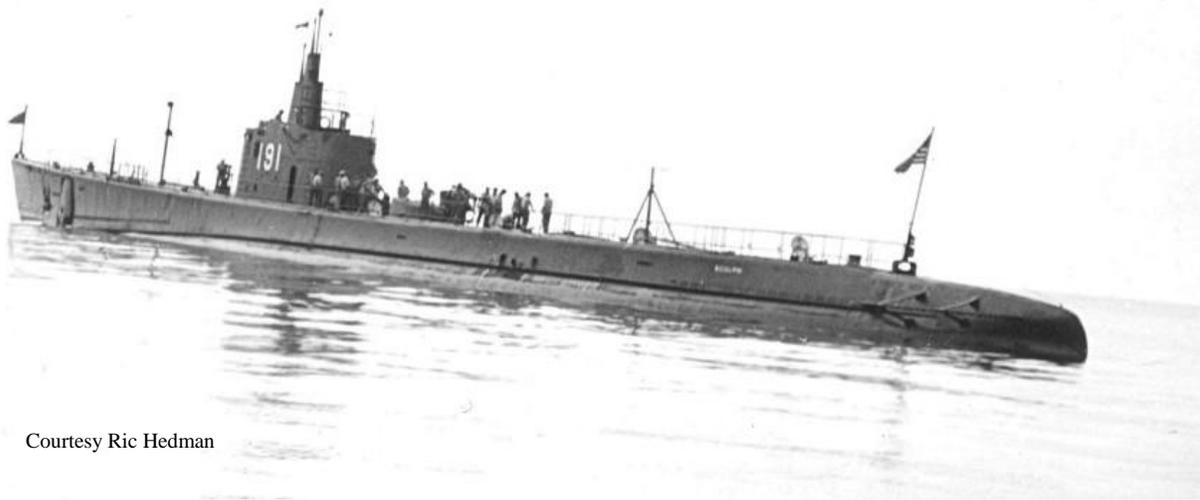
This photo of *Sculpin*, taken on 22 June 1939 during the *Squalus* salvage operation shows that in a manner similar to *Snapper* she had a row of small limber holes added after launch and commissioning.

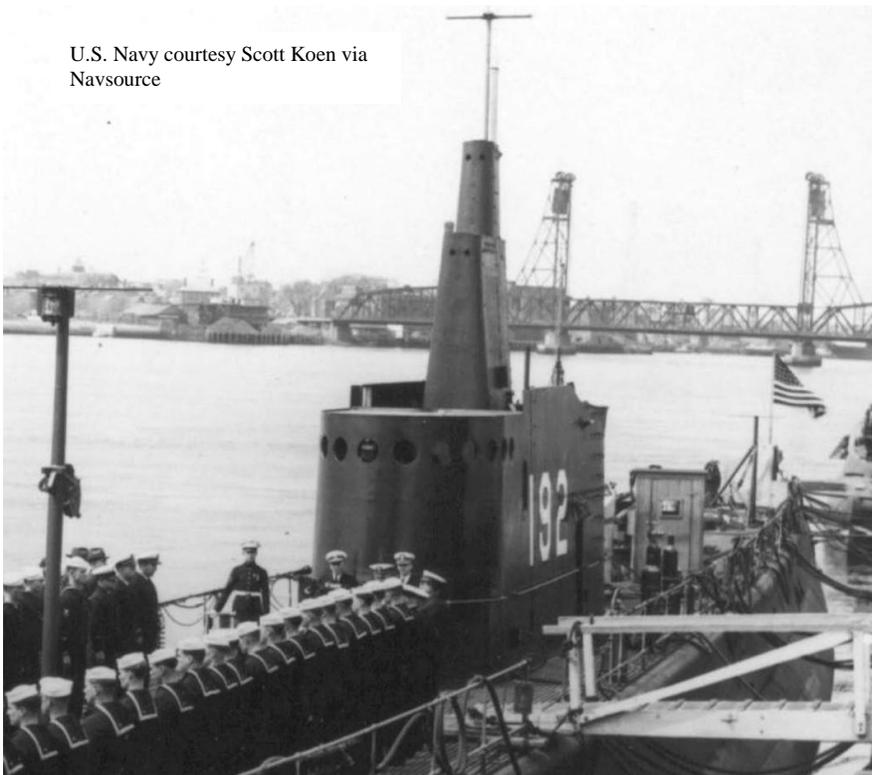
beams from inside of the conning tower fairwater. This eliminated the handy lookout platforms on each side of the shears. Visually, this modification is difficult to spot and is not very apparent in most photos. However, this photo of the salvaged and newly re-commissioned *Squalus* (now *Sailfish*) shows how the horizontal portions of the I-beams have been removed, effectively lowering the lookout platforms to roughly the same level as that of the bridge watch standers.

A serious problem arose during the construction of these boats in that they turned out badly overweight. Back in 1933 the earlier fleet boats *Cachalot* and *Cuttlefish* had come off the ways considerably underweight due to an aggressive weight control program instituted by both EB and Portsmouth. Extra lead ballast had to be added to the boats in order to achieve the desired stability specifications. Because of this experience, designers at both yards became rather cavalier about weight control and by the time *Sculpin* and *Squalus* slid down the ways the situation had caught up to them and the boats could not pass stability requirements. In particular they were top-heavy. One of the solutions to this problem was to cut away redundant portions of the topside framing. The most notable part of this action was the removal of portions of the I-

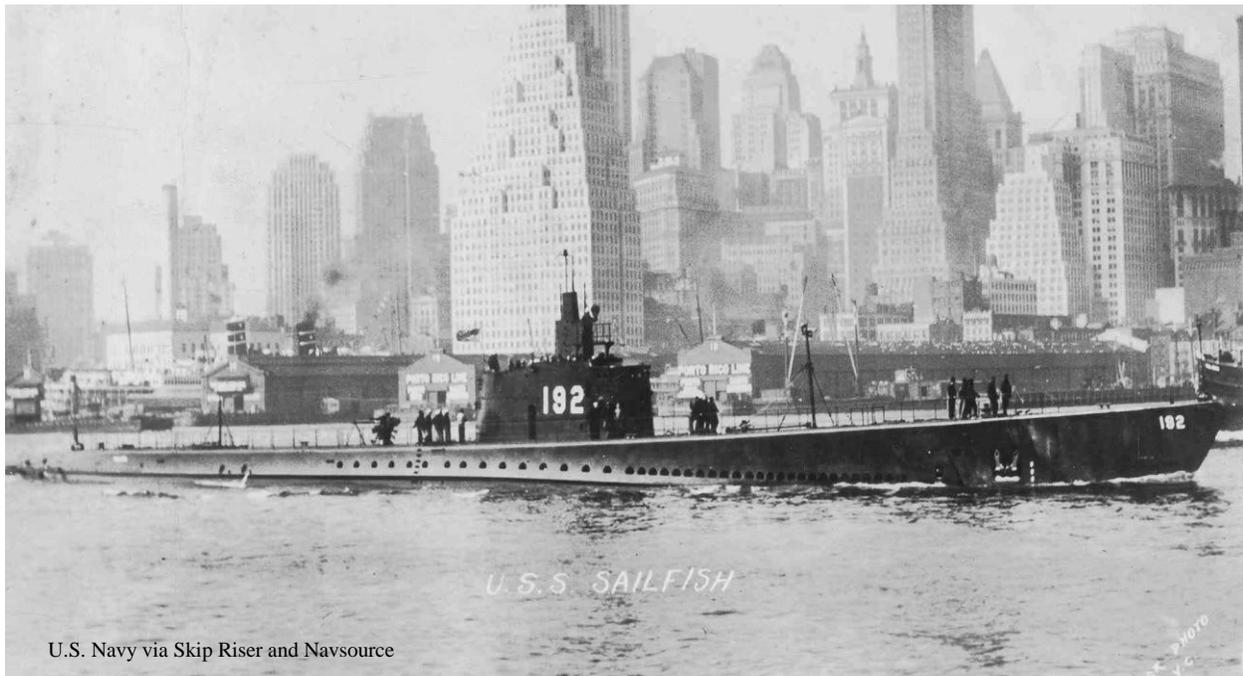
In this photo of *Sailfish*, taken on the Hudson River in late 1940 crewmen can be seen standing between the shears and the outer plating of the fairwater with only their heads and shoulders visible. This would not be possible if the I-beams and the lookout platforms were in place. Note also that *Sailfish* is now sporting a set of prominent limber holes in the superstructure. Only the three Government boats of this group were this badly affected. The EB boats, while still heavy, were apparently barely able to meet the requirements by redesigning engine mounts and eliminating redundant valves and piping runs. Their I-beam ribs and lookout platforms were unaffected. This bad experience by the Government yards (and to a slightly lesser extent by EB) caused all submarine construction yards to become stringent weight watchers. By the time the *Gato* class came along in 1941 a large enough weight margin had been built up that new equipment could be easily added without adversely effecting stability.

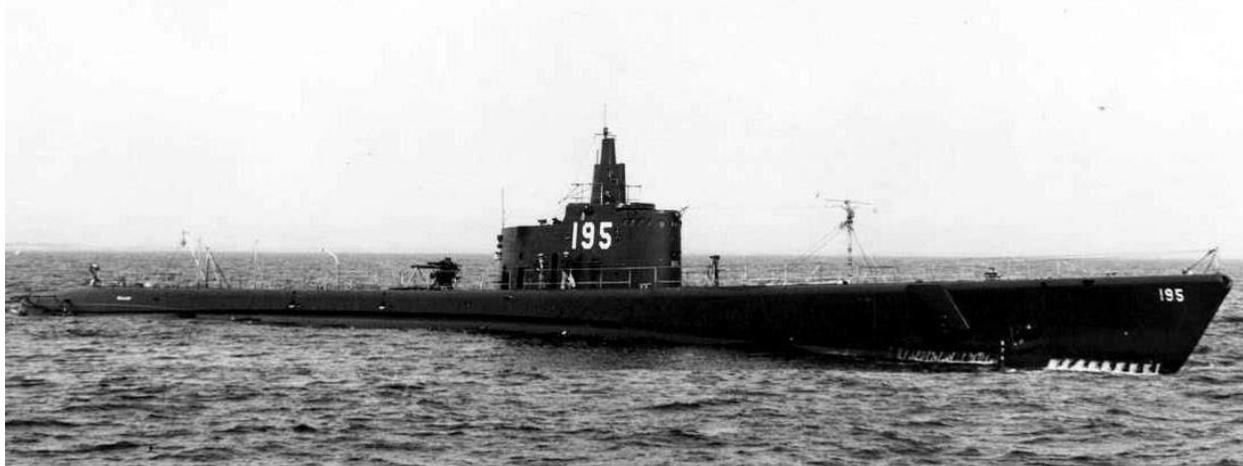
Sealion is shown above on 06 October 1939 about five weeks prior to her commissioning. Very little distinguishes these boats visually from their earlier sisters. EB continued the practice of the faired in bullnose and the row of semi-circular limber holes aft of the bow planes. *Sealion* had the shortest commissioned life of any of the *Salmon/Sargos*. Struck by bombs while in overhaul at Cavite Navy Yard in the Philippines on 10 December 1941, she was wrecked beyond repair and was deliberately sunk alongside the pier on 25 December 1941. She was the first submarine casualty of the war.

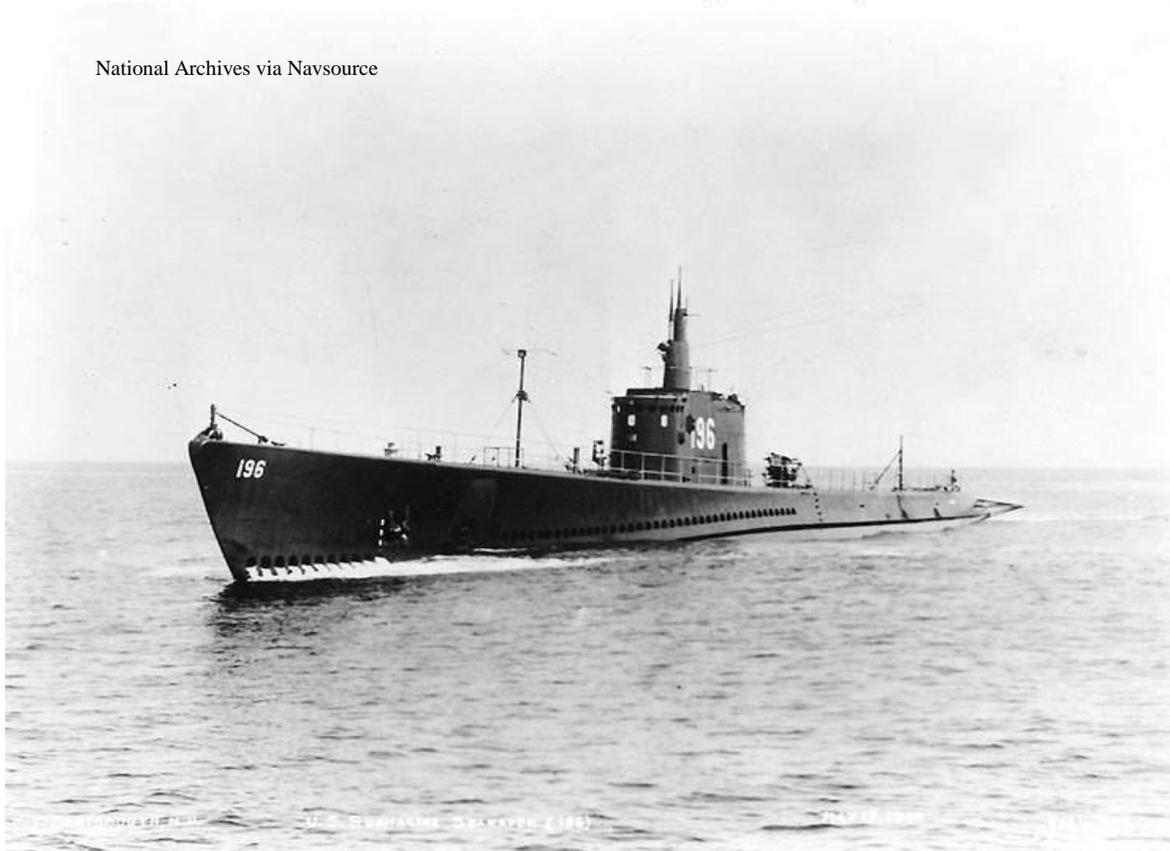
Photo # 19-N-21882 USS Searaven during trials, 13 May 1940

This photo of *Searaven* shows her with a row of limber holes in the superstructure. Both of the Government boats of this group were launched without them, but they were added prior to commissioning. Despite the fact that their presence improved dive times, the conservative Bureau engineers did not add limber holes as part of the original design until the *Gato* class started rolling off the ways in 1941. The light colored oval plates on the front end of the fairwater are transducers for the QCG passive sonar. The position of these plates allowed passive sonar use when bottoming of the boat prevented the use of the keel mounted transducers. The above deck ring type bullnose also continued as a hallmark of the Government design. Previous hard lessons in weight control had been learned and by carefully redesigning other areas (piping runs and machinery foundations in particular) sufficient weight margin had been built up to enable the reintroduction of the desirable I-beam supports in the conning tower fairwater.

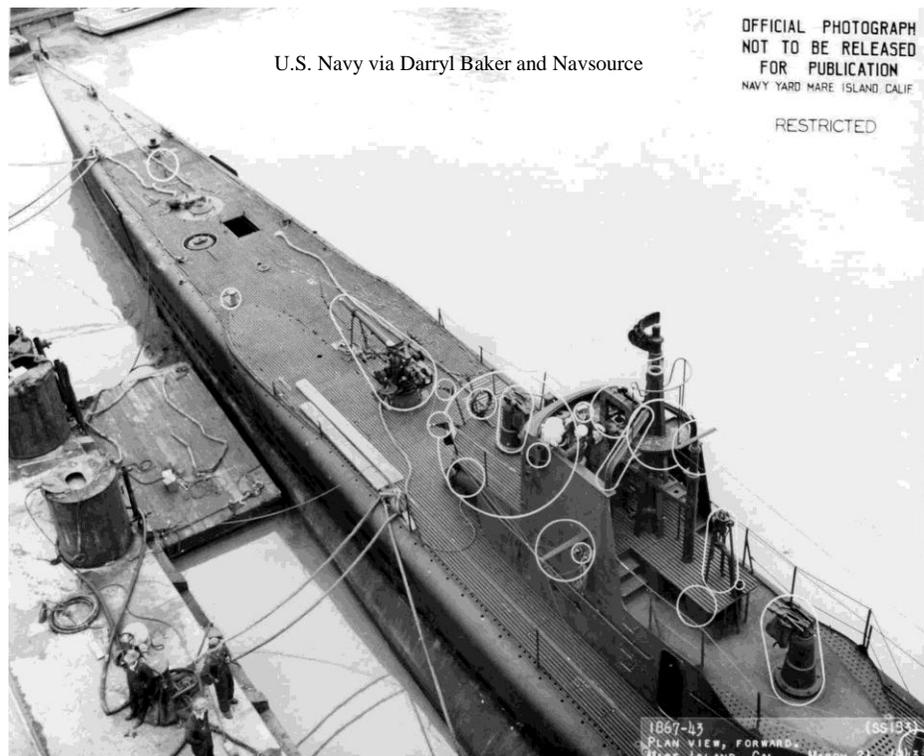
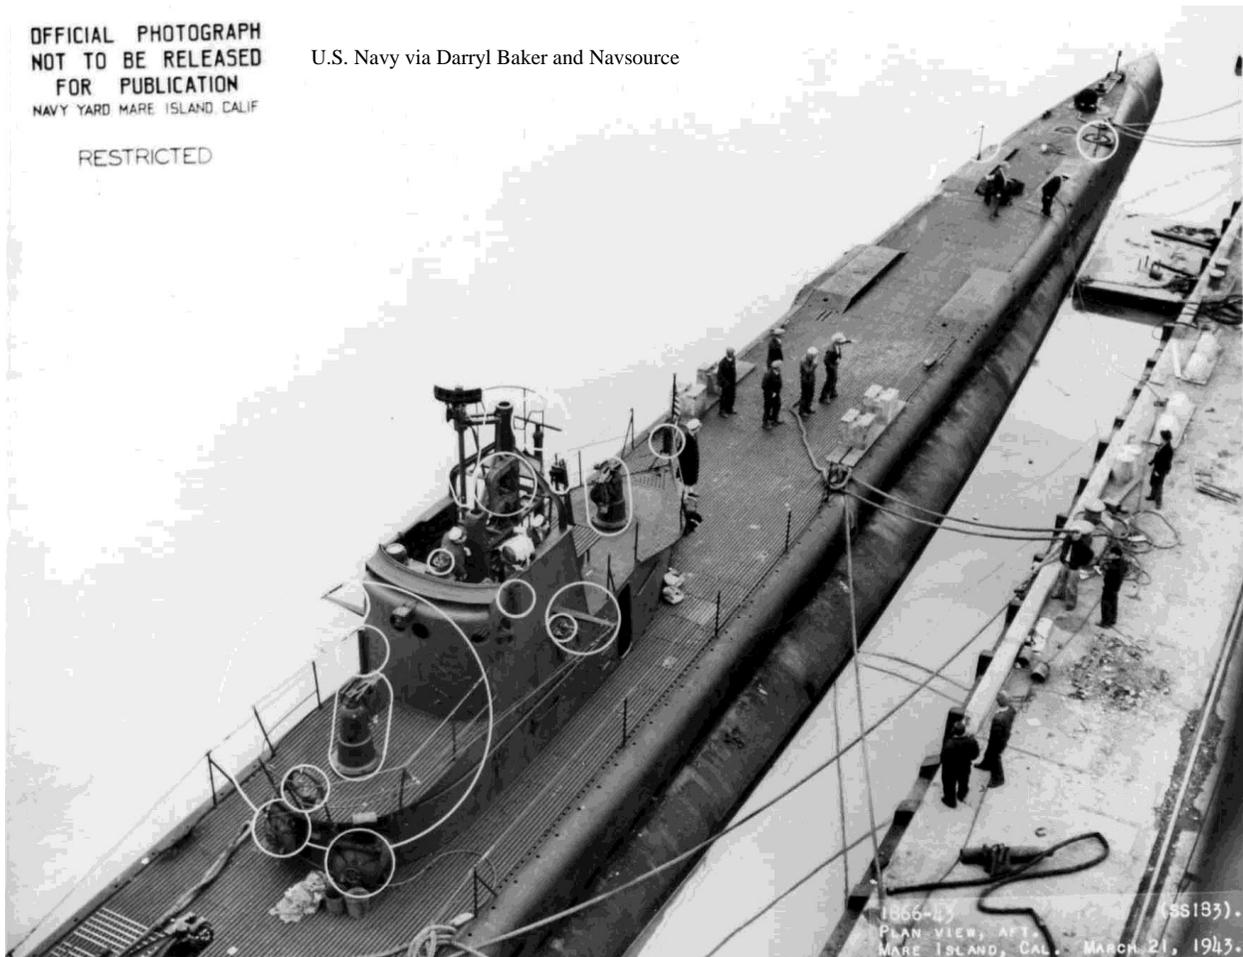
Salmon, *Seal*, and *Skipjack*, the EB built members of this class, all received similar modifications. These photos of *Seal*, taken on 21 Mar 1943 at Mare Island show a configuration that was typical for these three boats in the mid-war period. In this configuration they were broadly similar to a *Gato* class Mod 3. However, there are several important differences due to the original design of the periscope shears.

At this point, she retained both 34-foot periscopes, with one letting into the control room and one in the conning tower. The #2 periscope is supported by two braces, angled inward from the outer edges of the bridge fairwater. SD radar has been added on a separate thin mast aft of the scopes, and SJ radar added between the two scopes, offset to starboard in order to clear the shorter #1 scope housing. There is a large square low frequency communications loop antennae sited between the scopes. TBT brackets have been added to the bridge and on a tripod sited on a raised platform aft of the SD mast. The forward and aft fairwater gun decks sport the early, solid base Mk. 5 mounts for the 20 mm automatic cannon. The guns themselves are dismantled and stored below when not in use. At this time *Seal* still has her 3⁷/50 caliber deck gun, sited forward of the fairwater and two ready service ammo lockers have been added underneath the forward fairwater gun deck. On either side of the deck gun are the oblong deck hatches that originally covered the two small boats, which have already been sent ashore. On the aft deck you can see the raised platforms that cover the larger mufflers of her new GM-Winton 16-278A diesel engines. These hardy and reliable engines were welcomed replacements for the heavily despised Hooven, Owens, Rentschler (HOR) double acting diesels, hated by the crews for their gross unreliability and frequent breakdowns.

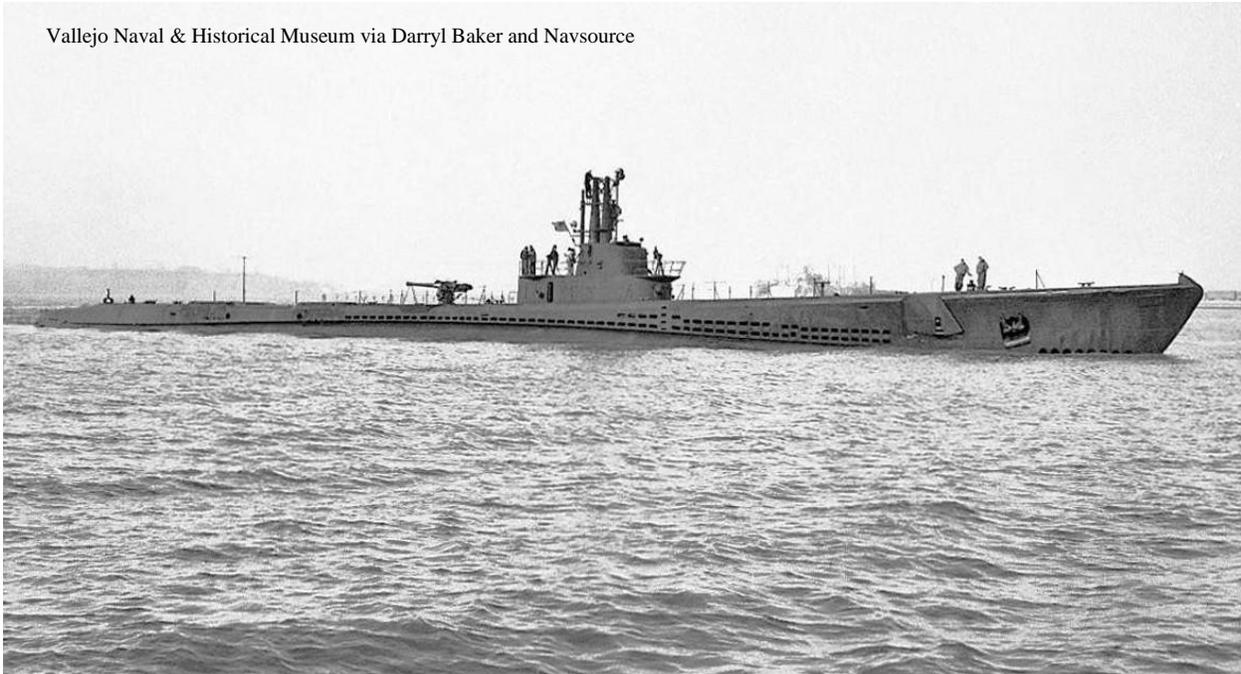
The class boat *Salmon* is shown here in August 1944. The resemblance to a *Balao* class boat is undeniable. However, she still retains her ring type bullnose, and the aft superstructure still runs all the way to the stern. These two features will identify her as a *Salmon* class boat. Curiously, despite the fact that she was built by EB, subsequent modifications gave her a limber hole pattern in the superstructure that resembles that of a Government built *Gato* or *Balao*.

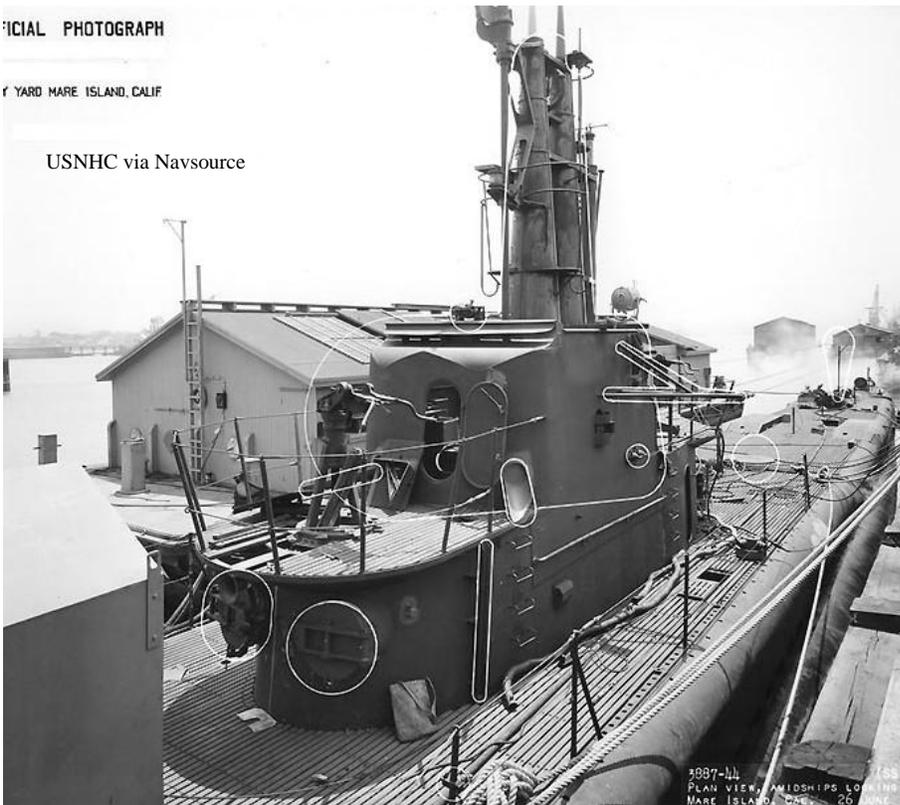
Seal, shown here in June 1944 has most of the late war modifications typical of later fleet boats. The SJ radar has been moved from its' original starboard position and is now mounted directly forward of the shears with the SD radar mast directly aft. The 20 mm gun mounts are now the later tripod Mk. 10 type, and an access door for the forward fairwater gun deck has been cut into the bridge fairwater. The bridge wind venturi has been rebuilt and repositioned.

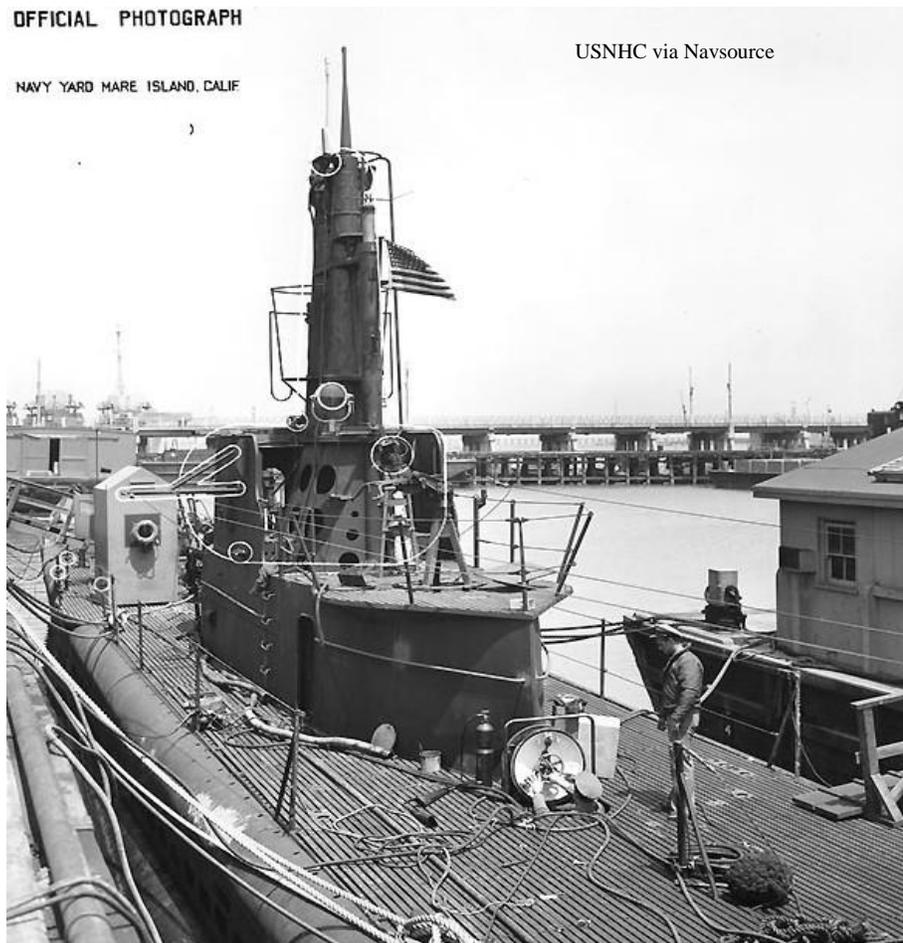
This view of *Seal* from astern shows the downward flared support structure for the periscope shears, virtually identical to the *Balao* class configuration. Lookout platforms with safety railings have been installed on either side of the shears, at the same approximate height as the platforms on the later “covered wagon” boats. She has retained the TBT mount just aft of the shears. This became an important feature as night surface attacks became an important facet of evolving submarine tactics.

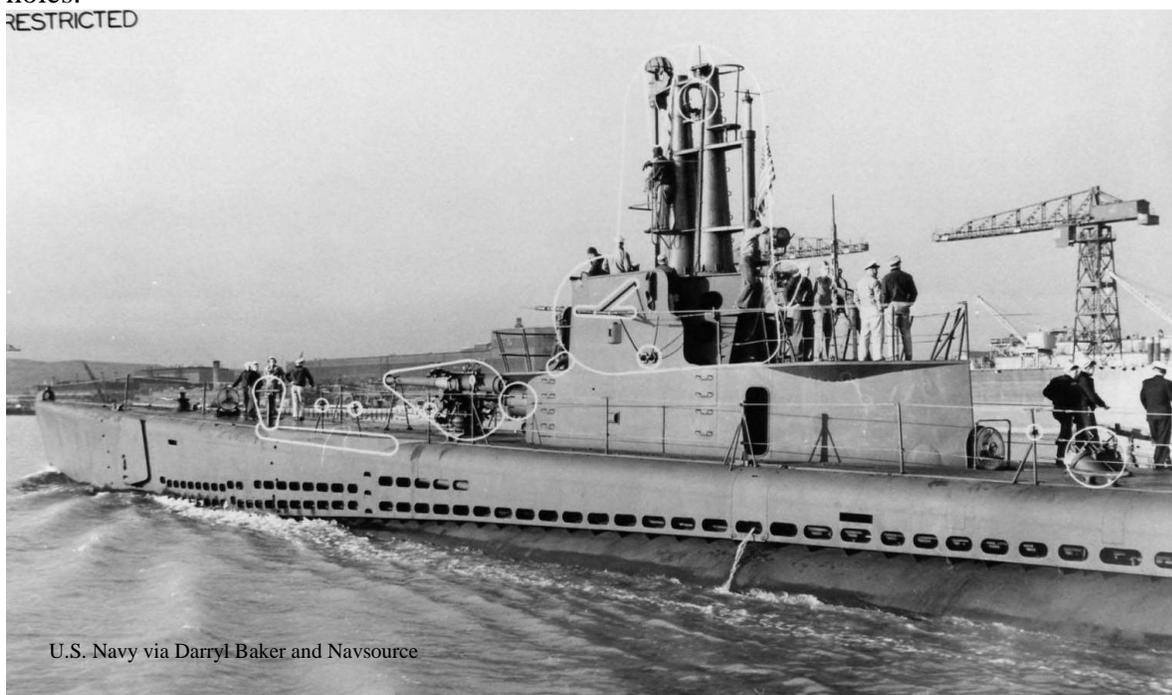
Skipjack, shown below in July, 1944 shows a very similar configuration, but with the 4”/50 caliber gun mounted forward, vice the aft position shown on *Salmon* above. She also has the Government style limber holes.

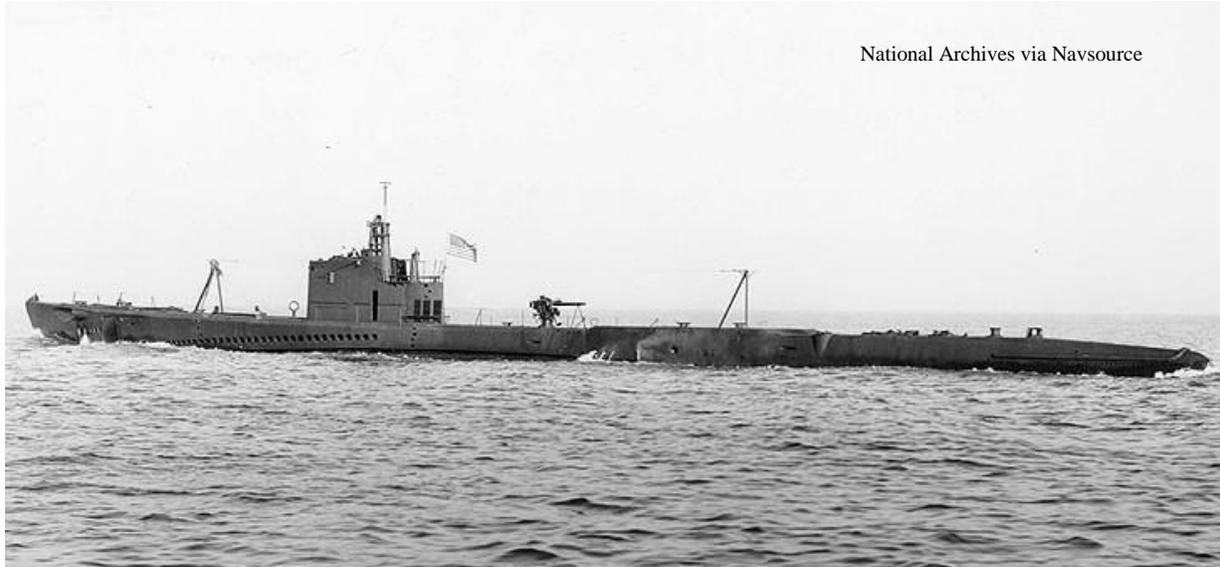
This photo shows *Stingray* in October 1942 after an overhaul at Mare Island. She sports a modification that is roughly analogous to a *Gato* class Mod 2A. The bulwark around the cigarette deck has been cut down and the plating removed from around the periscope shears. A Mk. 5 mount for the 20 mm cannon has been added to the cigarette deck, but the 3"/50 caliber deck gun has been retained in the aft position. SD radar has been added just aft of number two periscope and as you will see in the photo below SJ radar added on a mast sited on the starboard side of the bridge. Louver type slits have been cut in the fairwater around the main air induction valve and a small circular radio direction finding (DF) loop has been placed on the deck just forward of the fairwater. However, her most prominent feature at this time was the addition of two external torpedo tubes in the superstructure forward of the bow planes. Most of the earlier P-class boats had received this modification as an attempt to increase firepower. These tubes were not accessible from the interior of the boat, being loaded prior to going on patrol. The weapons in
