A VISUAL GUIDE TO THE U.S. FLEET SUBMARINES
PART TWO: SALMON & SARGO CLASSES
1936-1945
(2nd Edition, August 2011)

DAVID L. JOHNSTON

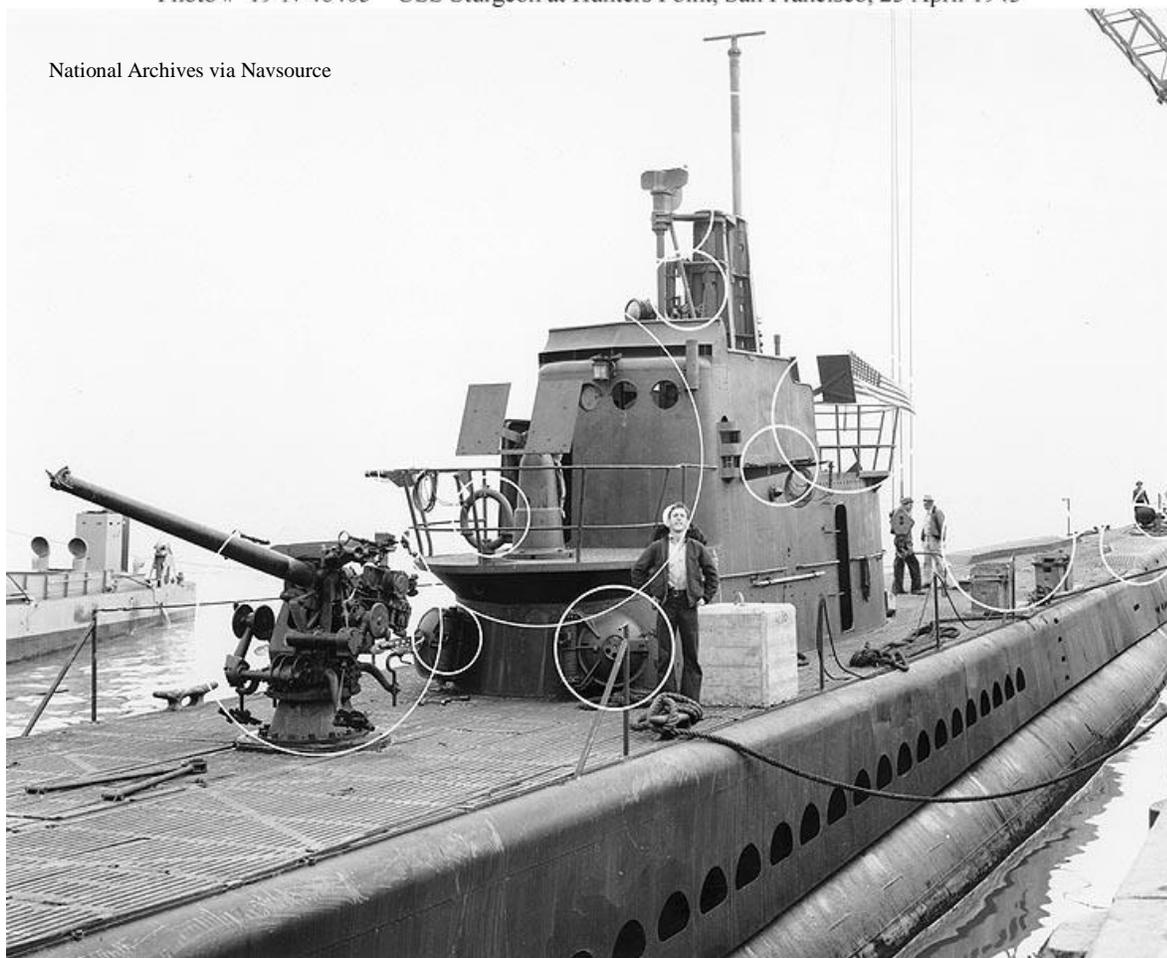
Photo # 19-N-46405 USS *Sturgeon* at Hunters Point, San Francisco, 23 April 1943

Snapper and *Sturgeon* received a similar modification to their fairwaters, although it is likely that they did sometime in 1942. By 1943 they had been modified again, this time receiving the rough equivalent of a *Gato* Mod 3. Notice in the photo below of *Sturgeon* that the navigation bridge has been

cut away and replaced with a gun deck, sporting a Mk. 5 solid base 20 mm gun mount and a DF loop. The revised bridge fairwater retains a portion of the circular windows and a high wind venturi has been installed. At this time *Sturgeon* still retains the shorter 34 foot #1 periscope. The aft cigarette deck is about two and a half feet higher than the forward gun deck, a distinguishing feature of these three boats. The 3⁷/₅₀ caliber deck gun has been moved to the forward position and two ready service ammo lockers have been added under the forward fairwater gun deck. The 3⁷/₅₀ is slightly elevated and the bipod barrel brace is laying flat on the deck. This Government built boat displays a set of EB style limber holes in the superstructure.

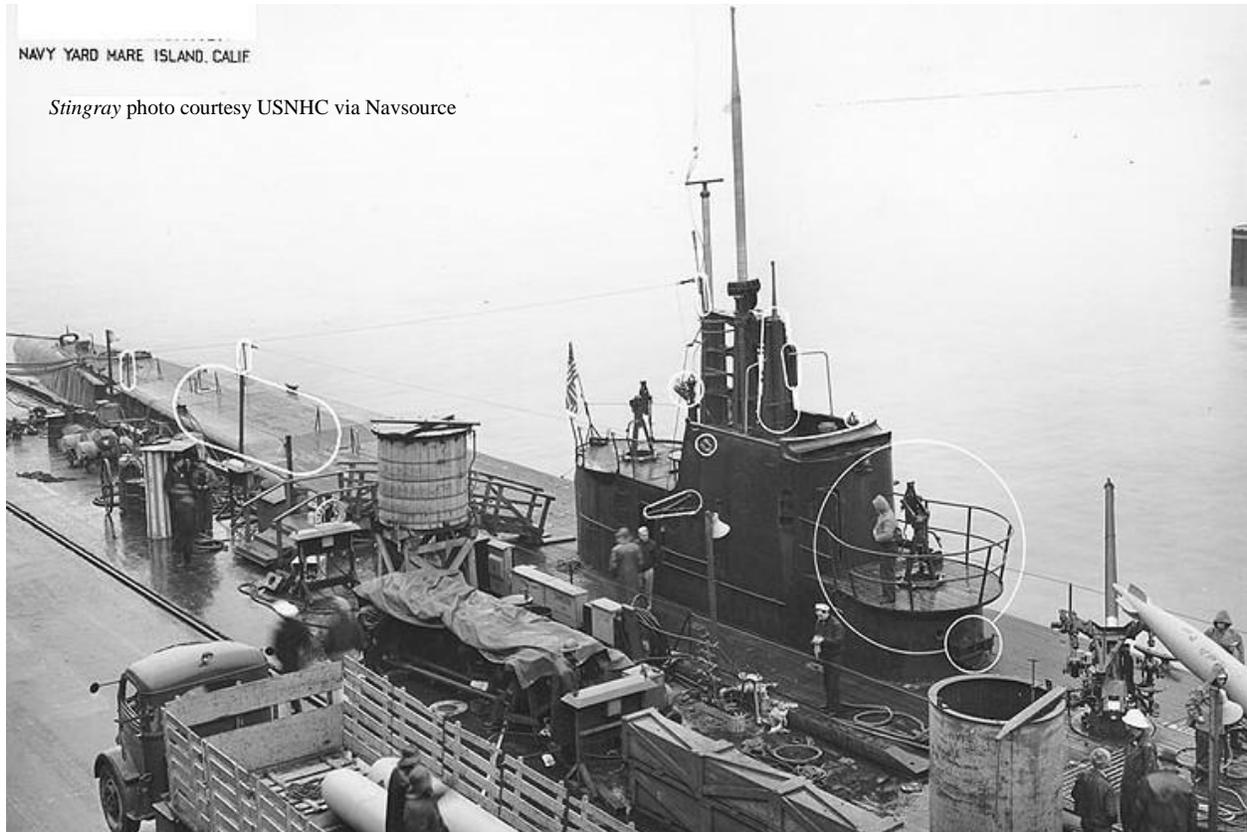
The progression of modifications can be seen in the January 1944 photo of *Stingray* below. Both 20 mm mounts have been changed to the lighter, open Mk. 10 versions. She has had her short 34-foot periscope removed and replaced with a standard 40-foot model, with both scopes now letting into the conning tower. The SJ radar, however, has been retained in the starboard bridge position. A door has been cut into the bridge fairwater to allow easier access to the forward 20 mm mount, and the bridge fairwater has lost the circular windows (she may not have had them at all in this version). Note in both the *Sturgeon* and *Stingray* photos that there are raised platforms over the engine mufflers on the after deck. This usually indicates a re-engining with bigger, more powerful engines. The three Government built *Salmons* all had the hardy and rugged GM-Winton 16-248 diesels as part of their original equipment. Appendix 1 of Alden's *The Fleet Submarine in the U.S. Navy* does not indicate that these three boats were ever re-engined. The

presence of these raised platforms suggest that these boats received new water-cooled mufflers to replace the smaller air cooled units that were originally installed.

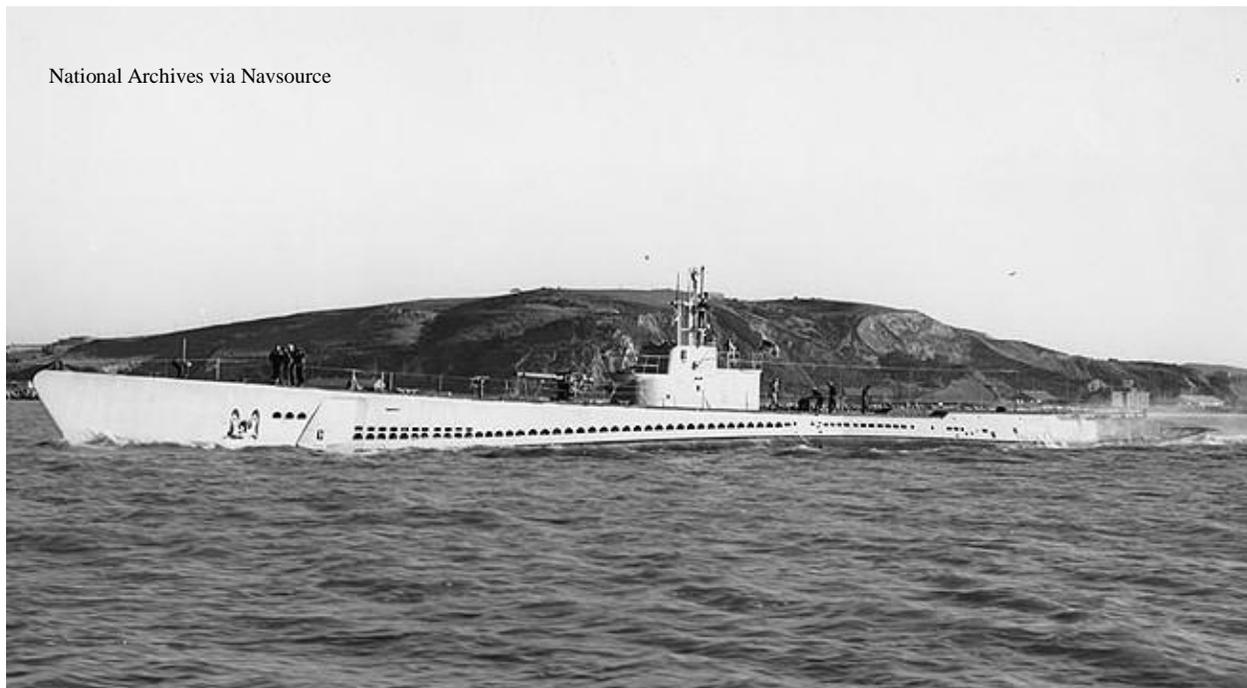
By 1945 these boats had received their final modifications. *Snapper* is shown below in this configuration. Note her odd combination of both EB and Government style limber holes.

The periscope shears had been reworked and simplified. To reduce periscope vibration at higher speeds, the shears had been thickened and strengthened. Both the SJ and the SD radar masts were

now located aft of the periscopes. *Balao* style lookout platforms were placed on each side of the shears. *Snapper* retained her high cigarette deck and this bulk made her easy to distinguish.

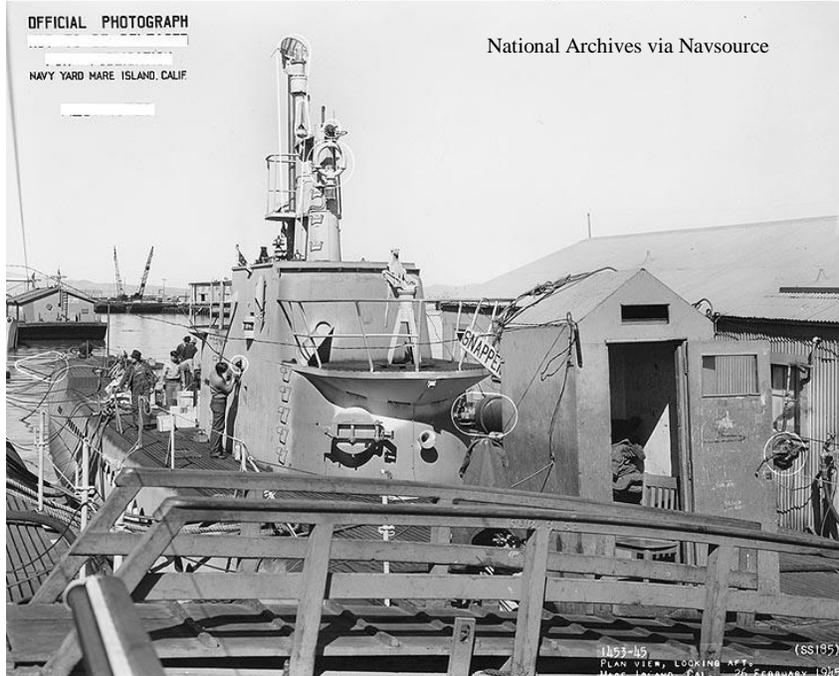
Photo # 19-N-80176 USS Snapper at the Mare Island Navy Yard, 26 February 1945

A circular ammo passing scuttle was cut into her bridge fairwater and a semi-circular tray enabled the easy passing of rounds to crewmen on deck for the 4"/50 caliber deck gun. Directly below the forward 20 mm gun deck is the horn for the air whistle. Note also that a prominent DF loop has been installed on the forward edge of the #1 periscope shear. The wind venturi mounted on the upper edge of the bridge fairwater is very minimal in size, reflecting the amazing variety of designs for this

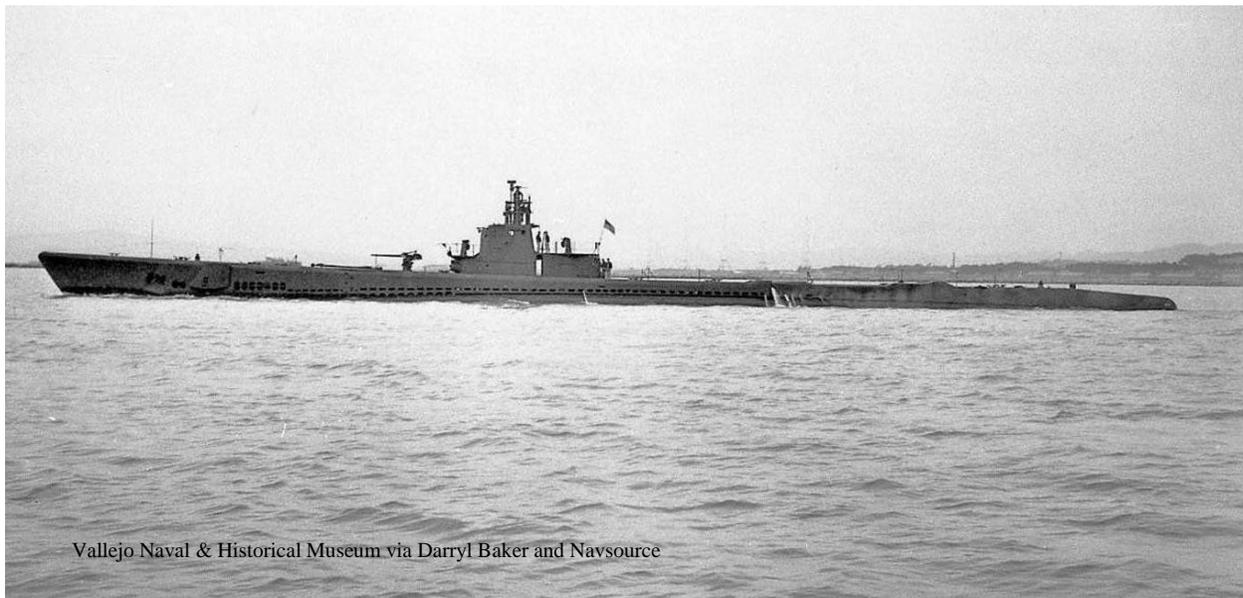
Both the forward and after portions of the conning tower fairwater have been cut down to provide gun platforms for 20 mm automatic cannon (with Mk. 5 solid mounts). At this point she still has one 34 foot and one 40 foot periscope, with the correspondingly one low/one high periscope shears. SJ radar is mounted to starboard of the shears, with the support brackets attached to the higher #2 periscope shear. The SD radar mast is directly aft of the shears. These boats were also original recipients of the greatly disliked HOR diesels. In this photo you can just see the raised muffler covers on the aft deck for the new GM-Winton 16-278A's that replaced the HOR's. *Sargo* has also received additional limber holes aft of the bow planes and her 3"/50 caliber deck gun has been moved forward. *Saury* was in a very similar configuration at this time.

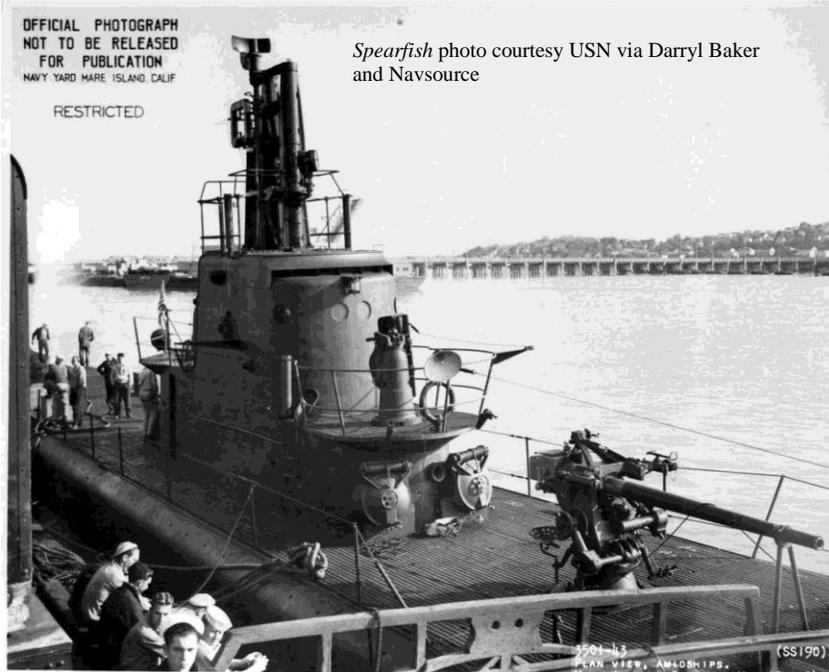
On 12 May 1943 *Spearfish* of this group emerged from overhaul closely resembling her two EB sisters, but with one important difference. She has received a 40-foot replacement for her original 34 foot #1 scope, with a correspondingly higher shear. You can also see in this photo the two ready access ammo storage lockers underneath the forward 20 mm gun deck. In an attempt to speed diving, a line of small circular holes has been drilled along the upper edge of the superstructure. These holes would allow trapped air to

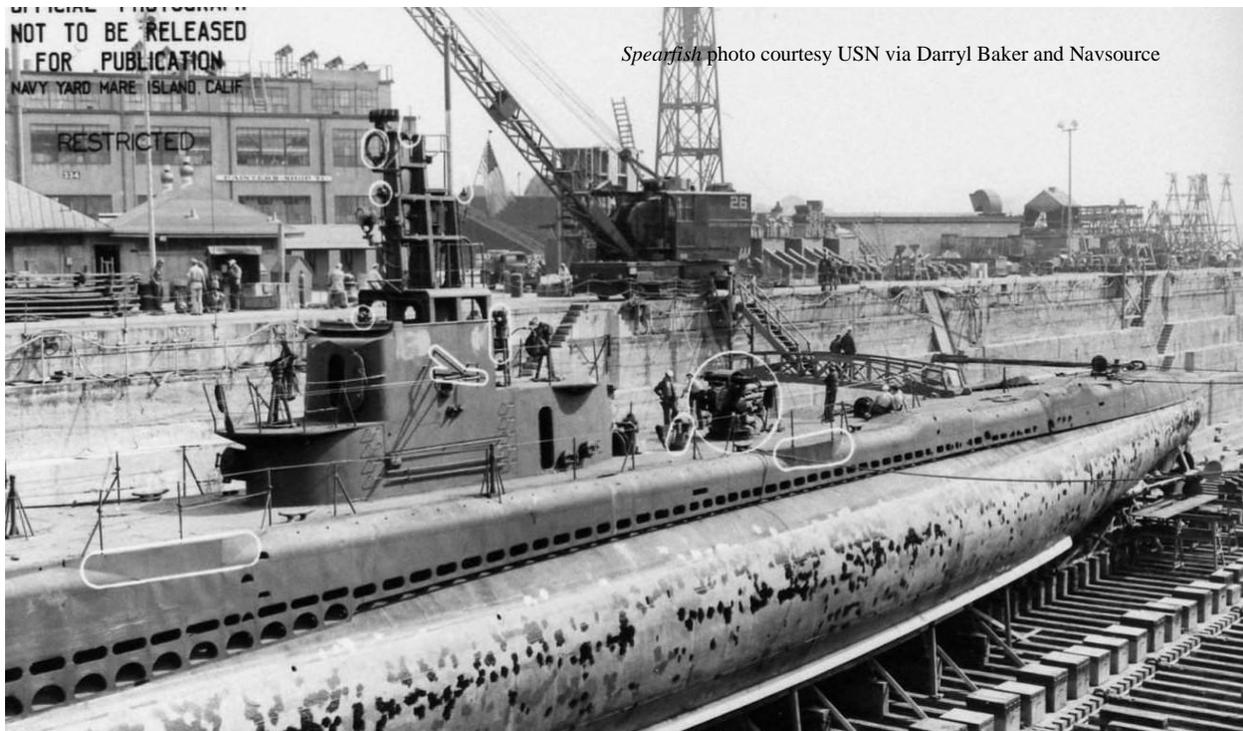
Sargo and *Spearfish* (shown above) had the bridge lowered in a fashion similar to a *Gato* Mod 4, exposing the covered wagon ribs, although *Saury* apparently did not have this done. All three boats now had two 40-foot periscopes, but the SJ radar stayed in its regular starboard side location. *Spearfish* has acquired a 5"/25 caliber deck gun in the aft position (rare for a *Salmon/Sargo* class boat) and she has retained her three bladed propeller.

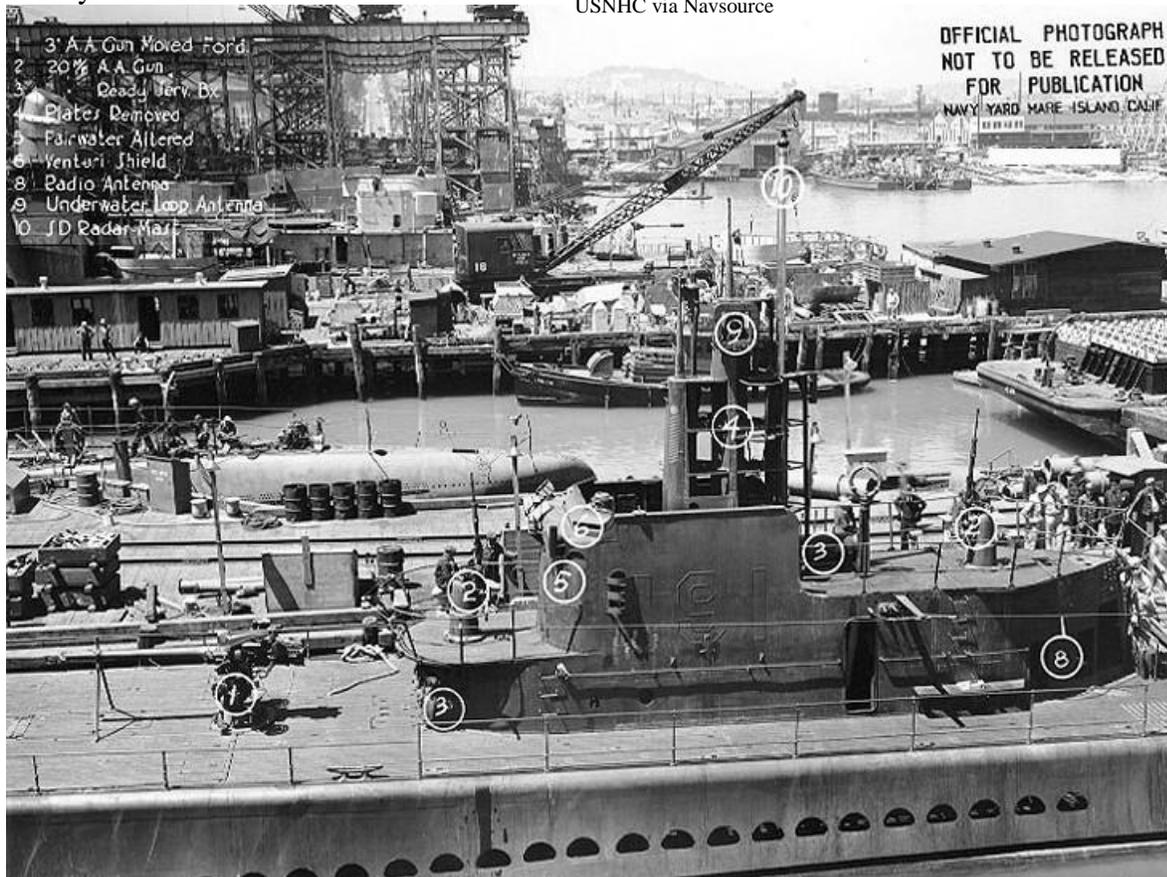
- 1 3" A.A. Gun Moved Forward
- 2 20mm A.A. Gun
- 3 Ready Jerry Boat
- 4 Plates Removed
- 5 Fairwater Altered
- 6 Venturi Shield
- 8 Radio Antenna
- 9 Underwater Loop Antenna
- 10 SJ Radar Mast

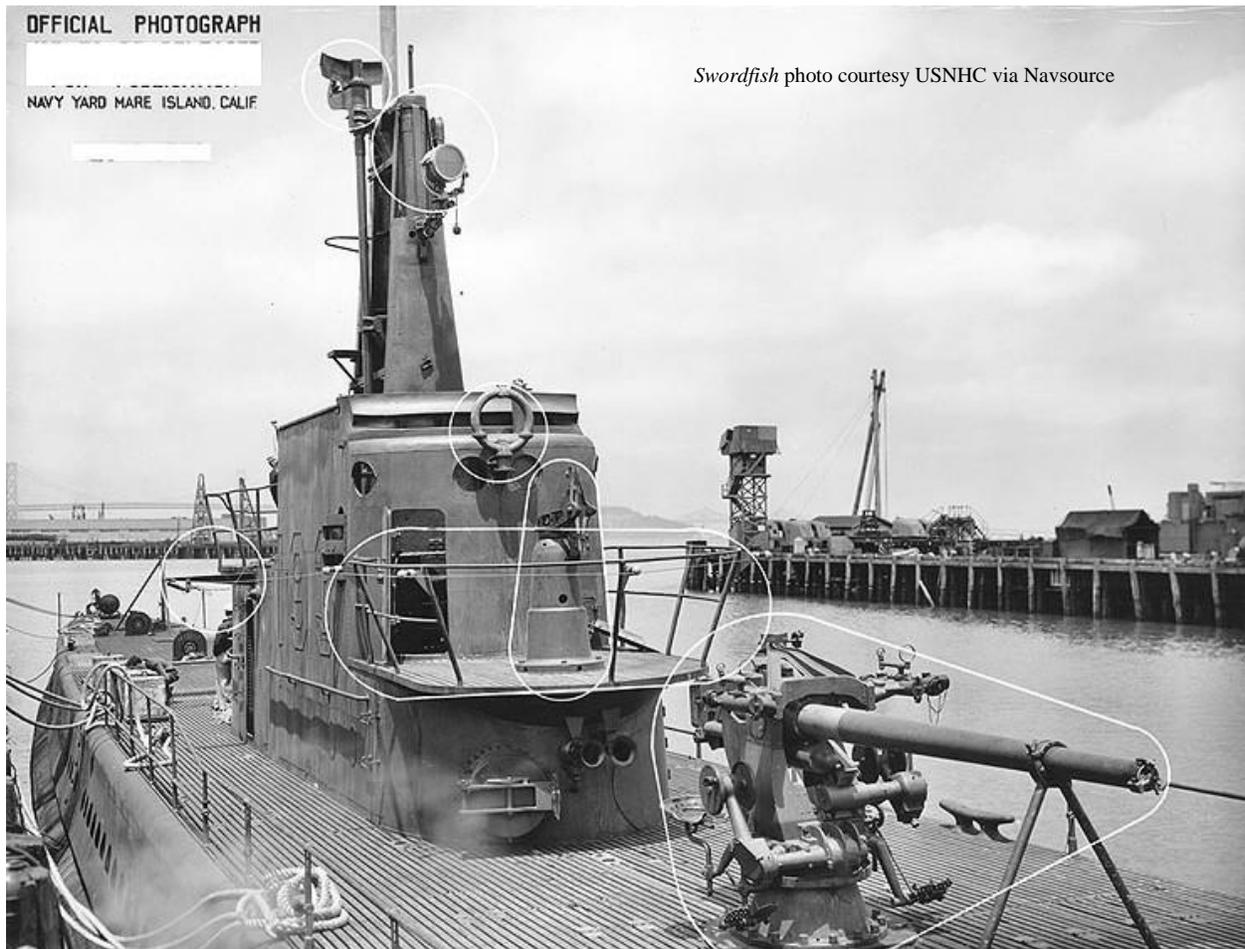
The one major difference from the EB built boats is the lack of the covered wagon ribs. As stated earlier, they had been removed during the initial construction phase as a weight saving measure, with the shears structure being accordingly redesigned with beefier, thicker support tubes, which is now very apparent when compared to the EB versions. *Sculpin* and *Sailfish* were very similar in this period, but *Swordfish* (shown above on 13 June 1943) has received a 40-foot replacement for her #1 periscope with the shear lengthened accordingly. These boats were not re-engined as their original GM-Winton 16-248 diesels proved to be quite satisfactory in service.

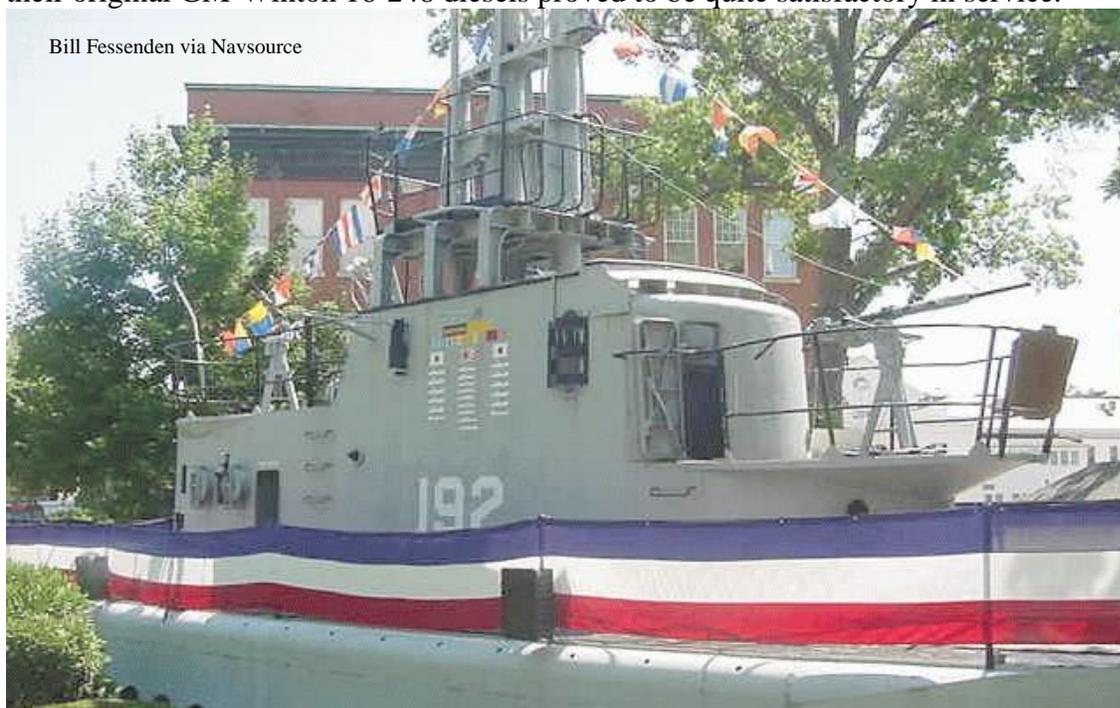
The color photo shows the superstructure/fairwater/shears of the *Sailfish* as it currently sits on the grounds of the Portsmouth Naval Shipyard in Kittery, Maine. *Sailfish* is unique among all of the fleet boats as she is the only boat originally built without the covered wagon ribs to have them added later (probably in her June 1944 overhaul at Mare Island). Why is not immediately apparent, but it may have had to do with water flow vibration problems with the periscopes. Removing the covered wagon ribs during construction may have exacerbated this issue and this added bracing is how it was eventually solved for *Sailfish*. *Sculpin* was lost six months after the photo above was taken and thus never received this modification. It is likely that this is also the case with *Swordfish*, but the existing photographic record does not confirm her final configuration.

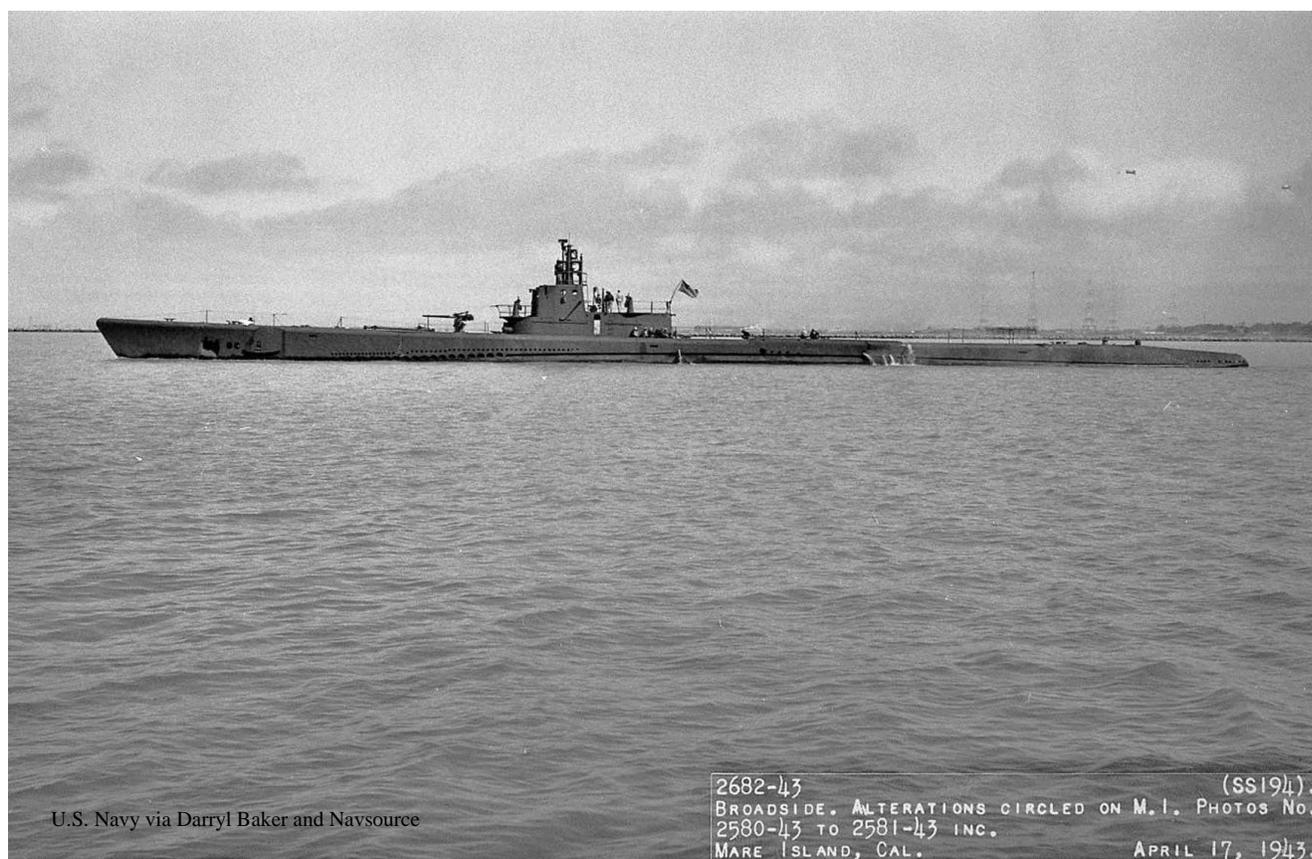
The four FY-38 boats of the *Sargo* class were subjected to basically the same modifications that the *Sargo*, *Saury*, & *Spearfish* received, and at roughly the same times. These boats received the Mod 3 equivalent during overhauls in the spring and summer of 1943 and the Mod 4 equivalent in mid 1944. *Sealion* of course received no modifications to her as built configuration, owing to her loss on the 2nd day of the war. Shown below is *Seadragon* on 17 April 1943, looking very much like her FY-37 EB sisters during the same period.

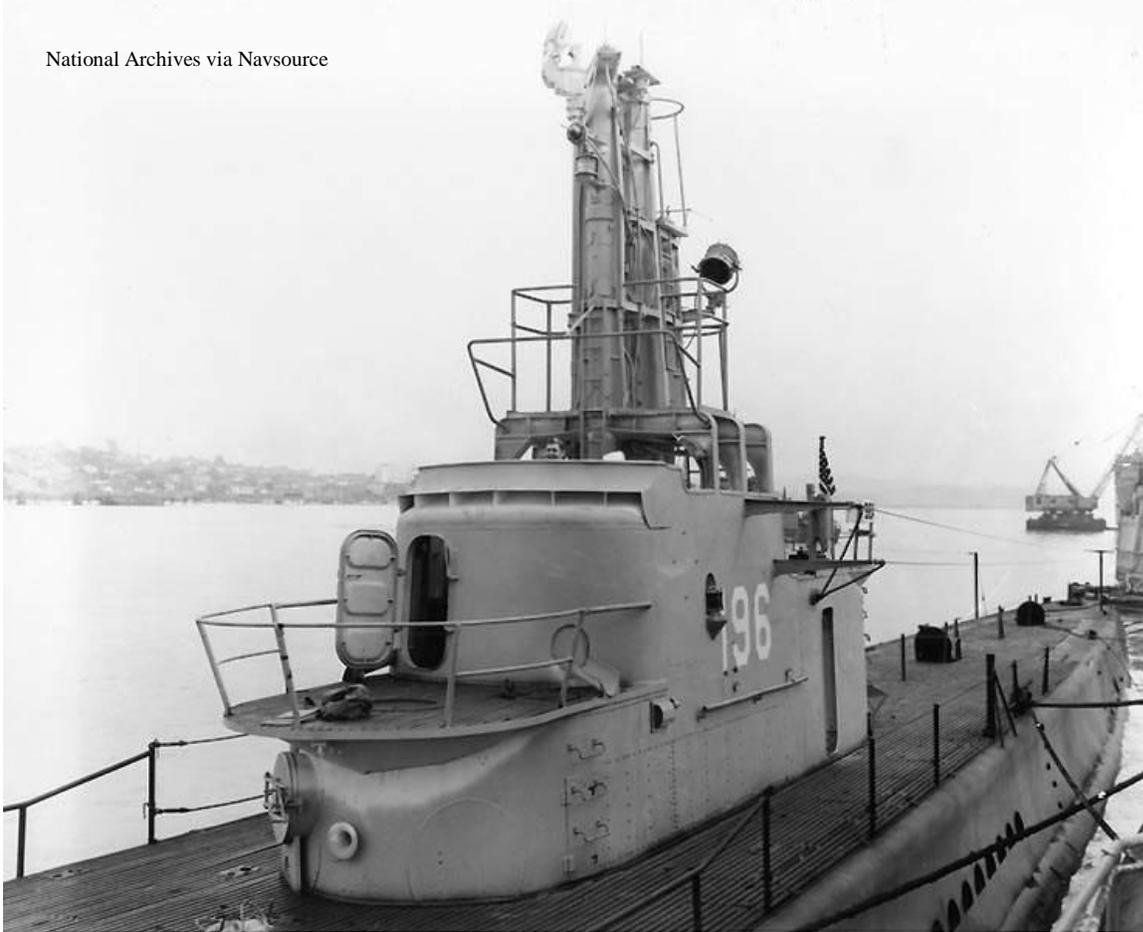
The other survivor of this group was *Searaven* and she is shown below in a post war photo. Sporting a Mod 4 equivalent, she looks very much like a late war Mod 4 *Gato*. However, she retains her class typical starboard side mount for the SJ radar. In addition, her cigarette deck is higher than what is typical for the *Gato* class boats. This high cigarette deck is a common wartime modification feature on all of the Government built *Salmon/Sargo* class boats and is indicative of a larger main air induction valve design that required more space. The cigarette deck on the EB boats was very nearly the same height as the forward fairwater gun deck.

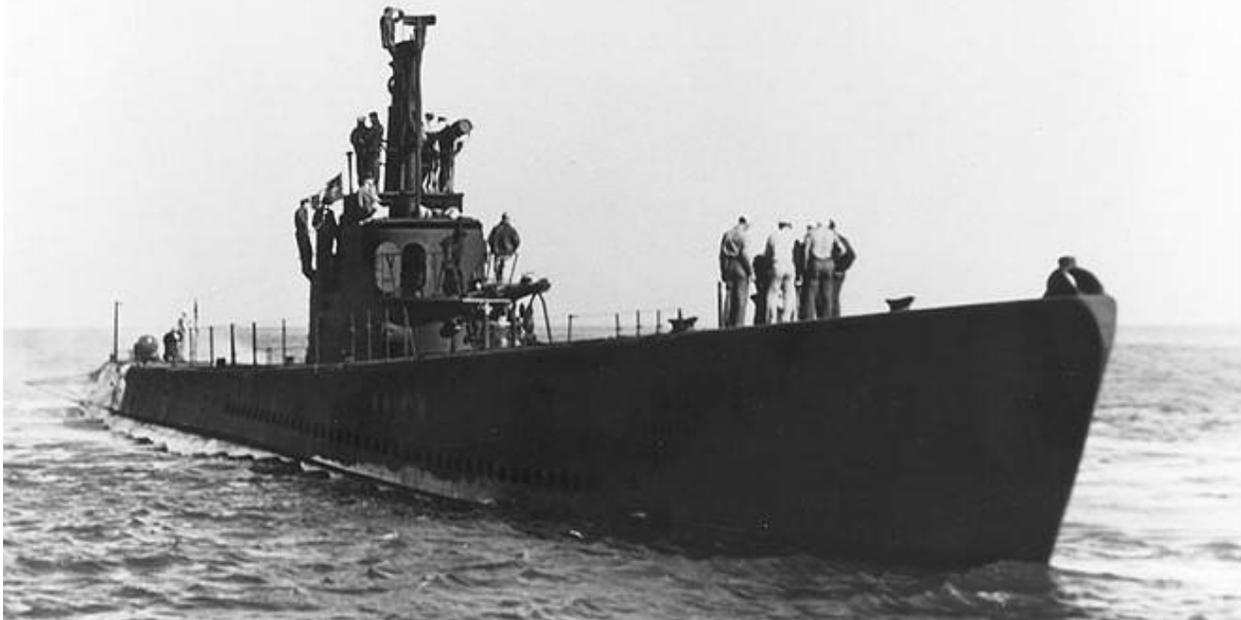
Seawolf photo courtesy USNHC and Navsource

Seadragon finished the war in a very similar configuration, but she had two vertically mounted ready service ammunition lockers on the forward edge of the forward fairwater gun deck, as opposed to the single horizontal locker shown here on *Searaven*. The hard fighting but ill-fated *Seawolf* received a similar Mod 4 equivalent before her tragic loss in a friendly fire incident on 3 October 1944. Note, though in the photo below her SJ radar was mounted forward of the shears.
